**Section 106 and 4(f) Public Documents
Supplemental Information: Potential Impacts and Mitigation
for Historic Properties and Public Parks
SW Corridor Light Rail Project
Draft – December 15th, 2020**

This technical memo details the potential SW Corridor Light Rail Project impacts to protected historic properties and parks resources, as well as the proposed mitigations. This memo is intended for public review and comment.

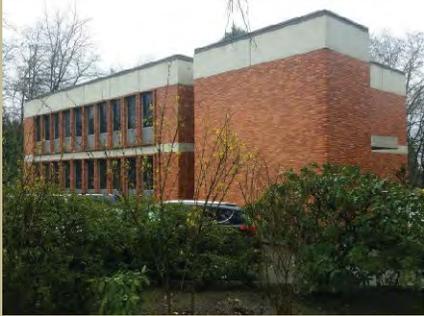
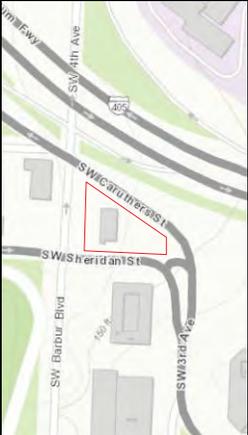
Project ID Survey # Acquisition	Resource Name Address & Assoc. Address Property ID Historic Name	Construction Date Resource Type Primary Style Primary Siding	NRHP Status	Integrity Comments / Notes	Photograph of Resource	Location
SW_11871 1 PARTIAL	Duniway Plaza 2400 SW 4TH AVE PORTLAND R777501500 Farley Building	1967 Building Modern Commercial Standard Brick	Recommended Eligible/Contributing	Originally served as patent, trademark, and copyright offices of L.R. Geisler, Oliver D. Olson, Eugene M. Eckelman, and Eugene D. Farley.

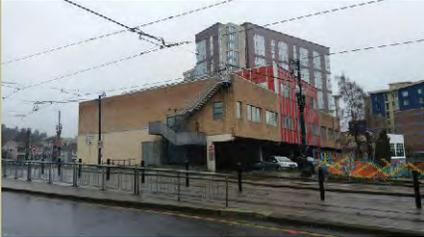
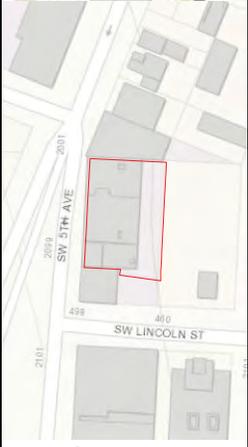
SW_15042 2 NO IMPACT	2000 SW 5TH AVE PORTLAND R140902090	1965 Building Modern Period Other Standard Brick	Previously Recorded as Not Eligible/Out of Period (2007); Recommended Eligible/Contributing for PSU RLS survey (2020); Recommended Eligible/Contributing

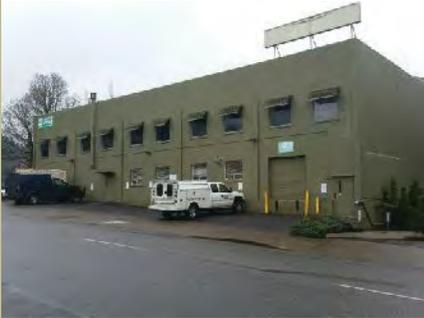
SW_15043 3 PARTIAL	2130-2136 SW 5TH AVE PORTLAND R140902190	1959 Building Commercial Concrete Block	Recommended Not Eligible/Non-Contributing	This building has no historical associations of significance under Criteria A through D.

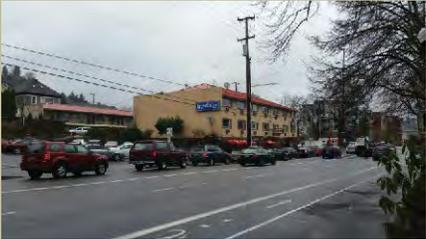
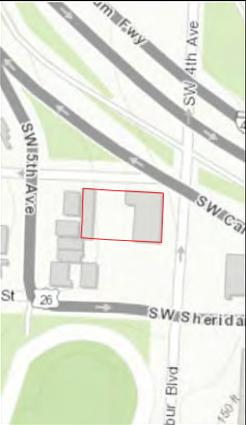
Project ID Survey # Acquisition	Resource Name Address & Assoc. Address Property ID Historic Name	Construction Date Resource Type Primary Style Primary Siding	NRHP Status	Integrity Comments / Notes	Photograph of Resource	Location
SW_3506 4 FULL	2401 SW 4TH AVE PORTLAND R140902480 Caravan Motor Hotel	1962 Building Commercial Concrete Block	Recommended Not Eligible/Non-Contributing	This building has no historical associations of significance under Criteria A through D.

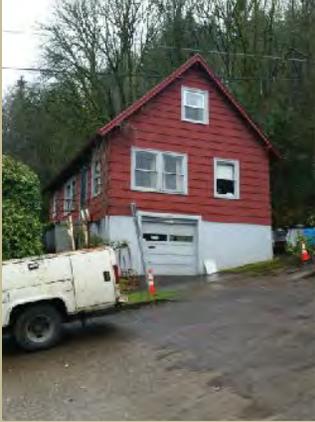
SW_16111 5 NO IMPACT	420 SW HOOKER ST PORTLAND R140907680	1930 Building Craftsman Cedar Shake Shingle	Recommended Not Eligible/Non-Contributing	This building has no historical associations of significance under Criteria A through D.

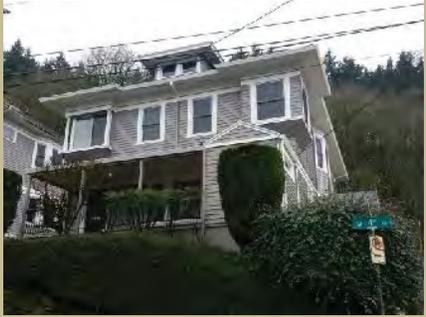
SW_7717 6 TCE	2903-2915 SW 4TH AVE PORTLAND R140907670	1908 Building Foursquare Horizontal Board	Recommended Not Eligible/Non-Contributing	Original windows and siding have been replaced, and east facade porches have been modified. Diminished historical integrity limits the building's eligibility to be listed in the NRHP.

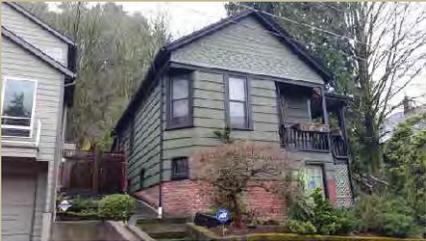
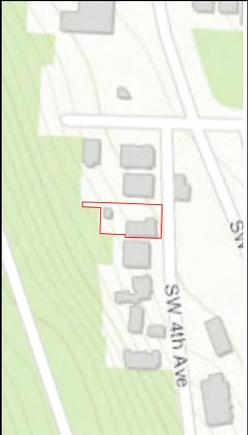
Project ID Survey # Acquisition	Resource Name Address & Assoc. Address Property ID Historic Name	Construction Date Resource Type Primary Style Primary Siding	NRHP Status	Integrity Comments / Notes	Photograph of Resource	Location
SW_8135 7 NO IMPACT	2925 SW 4TH AVE PORTLAND R140907690	1894 Building Queen Anne Cedar Shake Shingle	Recommended Not Eligible/Non-Contributing	Basement, siding, and window modifications have diminished the house's historical integrity, and limit the building's eligibility for listing in the NRHP.

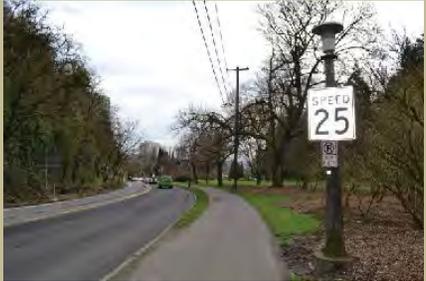
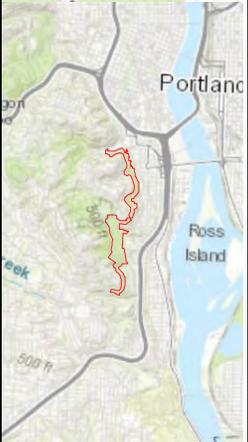
SW_16334 8 PARTIAL	SW TERWILLIGER BLVD PORTLAND R991100300 Terwilliger Parkway	1914 Site Not Applicable Not Applicable	City of Portland HRI (1984 - Rank I); Previously Documented as Eligible/Significant (1985, 2006); Recommended Eligible/Significant	Envisioned as part of the Olmsted Brothers plan for Portland parks in 1903, Terwilliger Parkway was constructed between 1910 and 1914. Completion of the Portland Aerial Tram in 2006 and other modern developments at OHSU have diminished some aspects of the park's integrity where the Southwest Corridor Light Rail project proposes the Marquam Hill Connection.

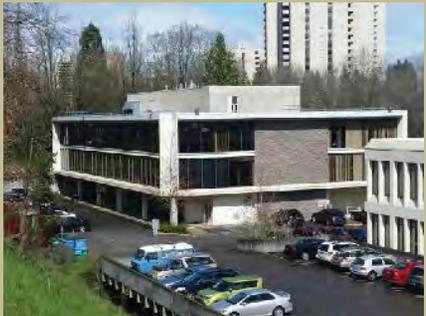
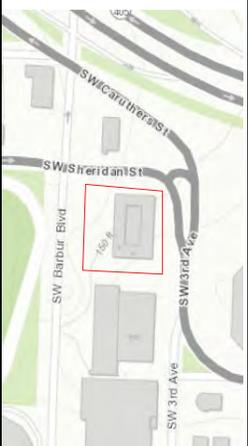
9 PARTIAL	Marquam Plaza 2525 SW 3RD AVE PORTLAND 2525 SW 3rd Avenue R777501700 Marquam Plaza	1965 Building International Concrete Panels	Previously Recorded as Eligible/Contributing (2011 - Portland Central City Modern Resources RLS 1945-1985); Recommended Eligible/Contributing	Designed by Robert Koch and constructed in the South Auditorium Urban Renewal area.

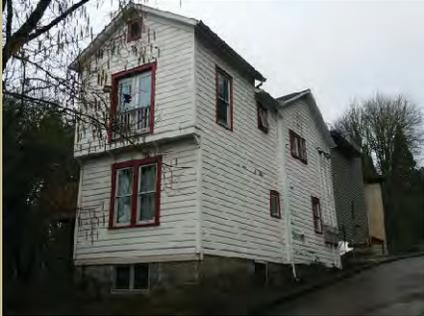
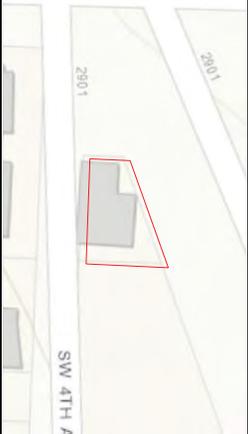
Project ID Survey # Acquisition	Resource Name Address & Assoc. Address Property ID Historic Name	Construction Date Resource Type Primary Style Primary Siding	NRHP Status	Integrity Comments / Notes	Photograph of Resource	Location
SW_12211 10 FULL	2901 SW BARBUR BLVD PORTLAND R140906760	1888 Building Victorian Era Horizontal Board	Recommended Not Eligible/Non-Contributing	This building has no historical associations of significance under Criteria A through D.

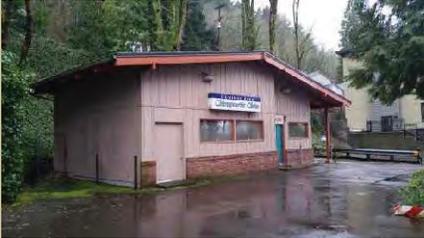
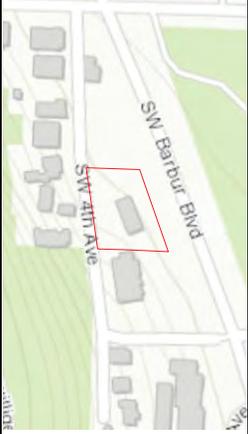
SW_2741 11 PARTIAL	3007 SW BARBUR BLVD PORTLAND R140907860	1941 Building Other / Undefined Vertical Board	Recommended Not Eligible/Non-Contributing	The building appears to have been extensively modified during the 1960s; the gable roof was likely constructed at that time. The building's diminished integrity limits its eligibility for listing in the NRHP.

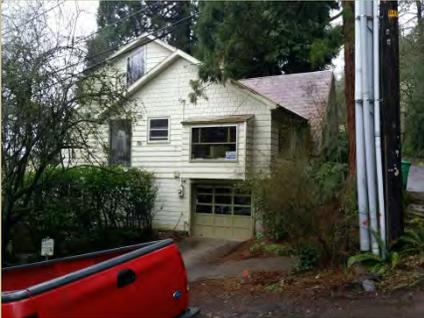
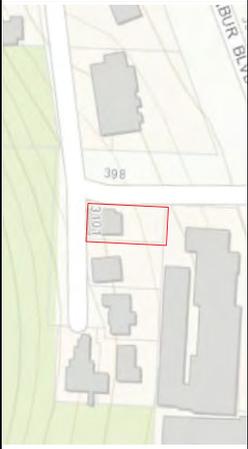
SW_12715 12 NO IMPACT	336 SW WOODS ST PORTLAND R140910550	1934 Building Minimal Traditional Horizontal Board	Recommended Not Eligible/Non-Contributing	This building has no historical associations of significance under Criteria A through D.

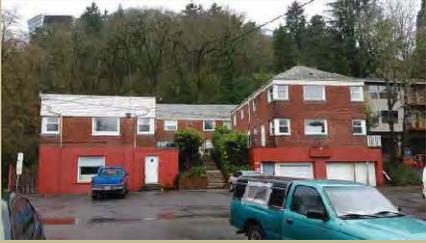
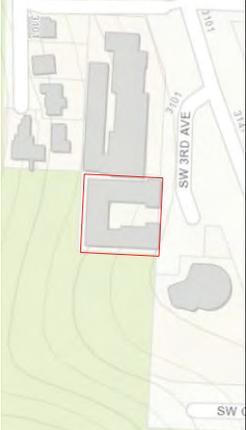
Project ID Survey # Acquisition	Resource Name Address & Assoc. Address Property ID Historic Name	Construction Date Resource Type Primary Style Primary Siding	NRHP Status	Integrity Comments / Notes	Photograph of Resource	Location
SW_10801 13 TCE	3141 SW BARBUR BLVD PORTLAND R991100320	1943 Building Georgian Standard Brick	Recommended Not Eligible/Non-Contributing	Windows are vinyl replacements; the removal of original windows appears to have necessitated the installation of new window sills. Garage doors at the lower level are also replacements. These changes have diminished the building's historical integrity, and limit its eligibility for listing in the NRHP.

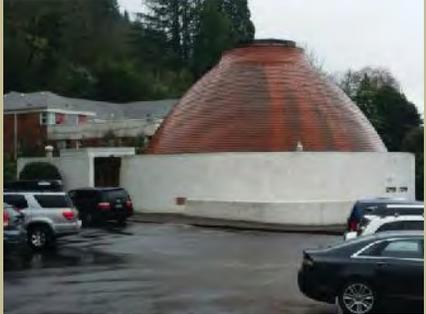
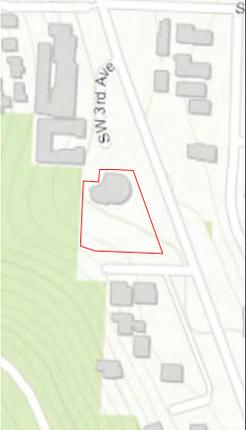
SW_3816 14 FULL	Congregation Ahavath Achim Synagogue 3225 SW BARBUR BLVD PORTLAND R140910580 Abavath Achim Synagogue	1965 Building Post-Modern Stucco	City of Portland HRI (1984 - Rank III); Recommended Eligible/Contributing

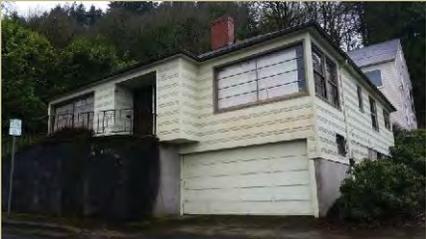
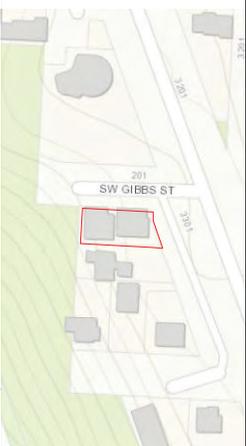
SW_6366 15 FULL	3305-3307 SW BARBUR BLVD PORTLAND R140912290	1940 Building WWII Era Cottage Horizontal Board	Recommended Not Eligible/Non-Contributing	There are two buildings on this tax parcel; a duplex fronting SW Barbur Boulevard and a house to the west that appears to have been constructed circa 1940. The duplex retains many of its original characteristics; however, the siding and windows of the house to the west have been modified. Neither building has historical associations under Criteria A through D.

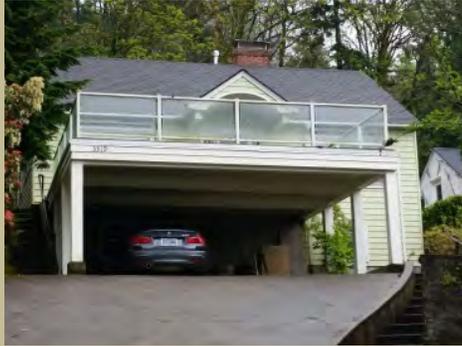
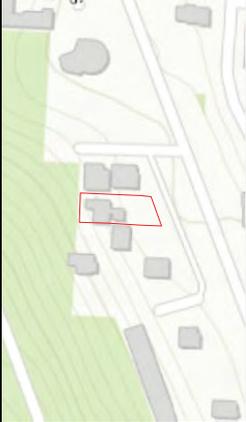
Project ID Survey # Acquisition	Resource Name Address & Assoc. Address Property ID Historic Name	Construction Date Resource Type Primary Style Primary Siding	NRHP Status	Integrity Comments / Notes	Photograph of Resource	Location
SW_1481 16 PARTIAL	3319 SW BARBUR BLVD PORTLAND R140912310	1939 Building Minimal Traditional Horizontal Board	Recommended Not Eligible/Non-Contributing	The original siding and some windows have been replaced. A modern carport/deck has been constructed at the east facade. Diminished historical integrity limits the building's eligibility for listing in the NRHP.

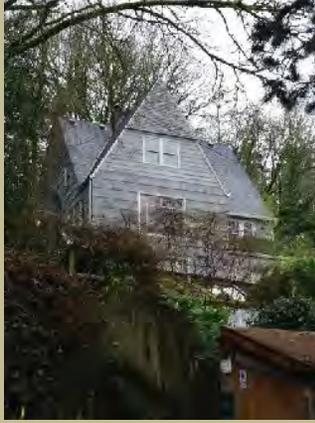
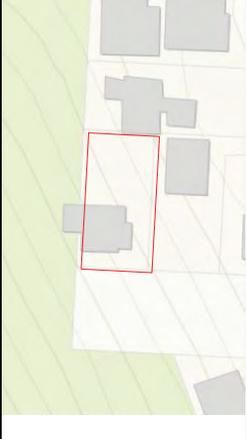
SW_7355 17 NO IMPACT	239 SW WHITAKER ST PORTLAND R140912350	1934 Building Tudor Revival Cedar Rake Shingle	Recommended Not Eligible/Non-Contributing	All visible windows appear to be vinyl replacements. Cedar rake siding is likely not original to the house. The house has no historical associations of significance under Criteria A through D.

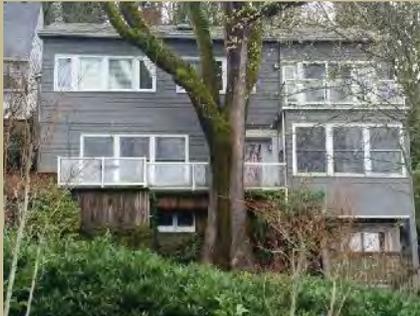
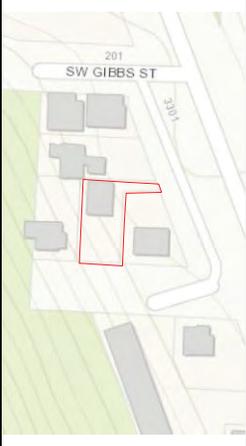
SW_4873 18 PARTIAL	225-239 SW WHITAKER ST PORTLAND R140912340	1938 Building Cape Cod Horizontal Board	Recommended Not Eligible/Non-Contributing	Plan has been extensively modified; enlarged from one- and one-half stories to two sometime after 1950. Diminished historical integrity limits the NRHP eligibility of the building.

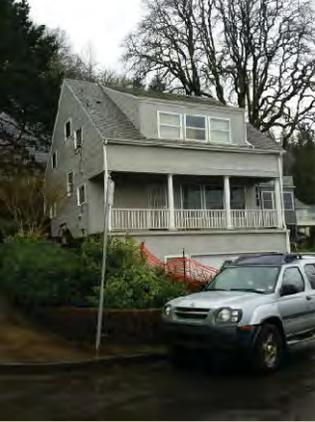
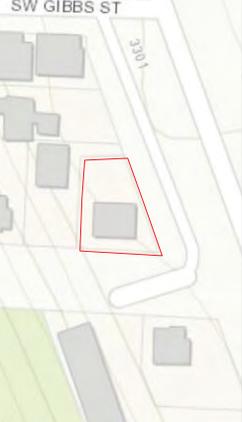
Project ID Survey # Acquisition	Resource Name Address & Assoc. Address Property ID Historic Name	Construction Date Resource Type Primary Style Primary Siding	NRHP Status	Integrity Comments / Notes	Photograph of Resource	Location
SW_8708 19 FULL	3339 SW BARBUR BLVD PORTLAND R140912320	1912 Building Vernacular Cement Fiber Siding	Recommended Not Eligible/Non-Contributing	The house has no historical associations of significance under Criteria A through D.

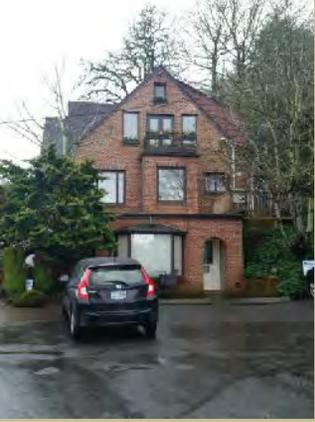
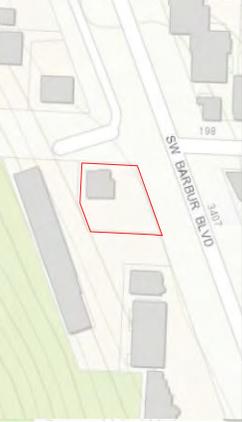
SW_11181 20 FULL	3405 SW BARBUR BLVD PORTLAND R991100520	1936 Building Tudor Revival Standard Brick	Recommended Not Eligible/Non-Contributing	All visible windows are modern replacements. A dormer has been added to the north elevation. Diminished historical integrity limits the NRHP eligibility of the building.

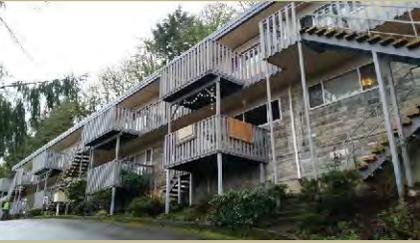
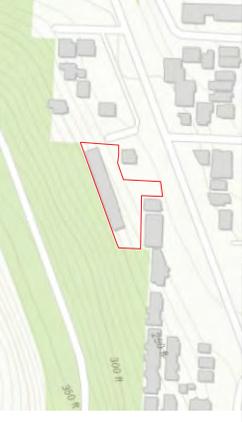
SW_851 21 NO IMPACT	Vista View Condominiums 3425 SW Barbur Boulevard PORTLAND R868620010	1966 Building Modern Period Other Vertical Board	Recommended Not Eligible/Non-Contributing	All original aluminum sliding windows have been replaced with vinyl sliding sashes. A remodeling project was underway at the time of survey. The building has no historical associations of significance under Criteria A through D.

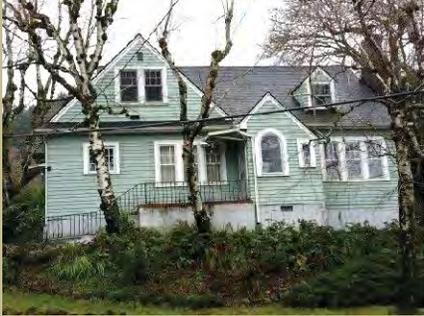
Project ID Survey # Acquisition	Resource Name Address & Assoc. Address Property ID Historic Name	Construction Date Resource Type Primary Style Primary Siding	NRHP Status	Integrity Comments / Notes	Photograph of Resource	Location
SW_10566 22 TCE	4019 SW CORBETT AVE PORTLAND R140917050	1927 Building Tudor Revival Horizontal Board	Recommended Eligible/Contributing	Siding may not be original, but does not diminish historical appearance. All original windows appear to be intact. The house is a representative example of its type and period of construction.

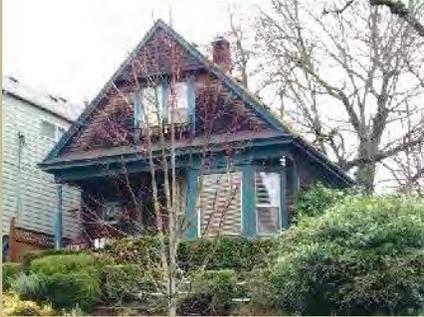
SW_20066 23 TCE	0123 SW LOWELL ST PORTLAND R649754460	1907 Building Queen Anne Shingle	Was recommended Eligible/Contributing after preliminary assessment for DEIS Recommended Not Eligible/Non-Contributing for FEIS	Original windows appear to remain in place, but are obscured from view by storm windows. Intensive-level documentation revealed that the building was moved from its original location circa 1933. Thus, it has diminished historical integrity and is not eligible for listing in the NRHP.

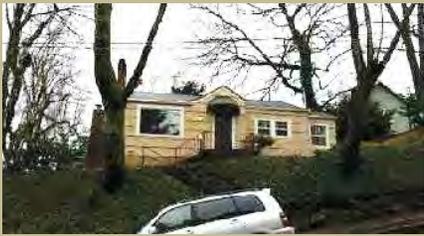
SW_8902 24 NO IMPACT	0130 SW THOMAS ST PORTLAND R140917000	1927 Building Minimal Traditional Shingle	Recommended Not Eligible/Non-Contributing	All original windows have been replaced with vinyl sashes. A detached garage is situated west of the house. The building has no historical associations of significance under Criteria A through D.

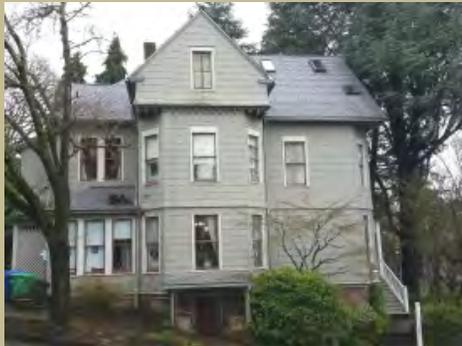
Project ID Survey # Acquisition	Resource Name Address & Assoc. Address Property ID Historic Name	Construction Date Resource Type Primary Style Primary Siding	NRHP Status	Integrity Comments / Notes	Photograph of Resource	Location
SW_1572 25 NO IMPACT	3935 SW CORBETT AVE PORTLAND R140916700	1893 Building Queen Anne Cement Fiber Siding	City of Portland HRI (1984 – Rank III); Recommended Not Eligible/Non-Contributing	Siding, window, and porch modifications diminish the house's historical integrity and limit its eligibility for listing in the NRHP.

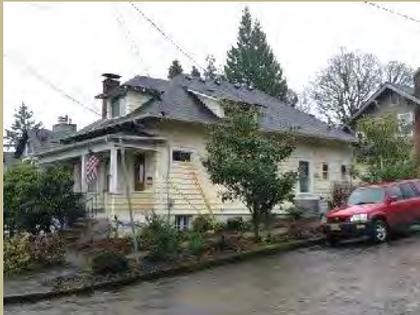
SW_16576 26 PARTIAL	0102 SW ABERNETHY ST PORTLAND R140916740	1908 Building Colonial Revival Horizontal Board	Recommended Not Eligible/Non-Contributing	Siding and window modifications diminish the house's historical integrity and limit its eligibility for listing in the NRHP.

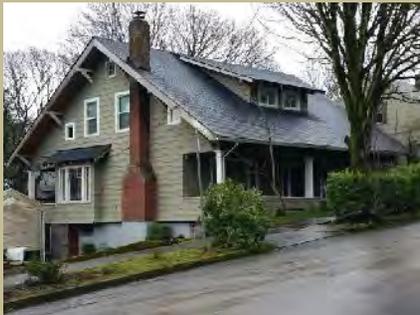
SW_9175 27 PARTIAL	3926 SW WATER AVE PORTLAND R140916730	1908 Building Craftsman Shingle	Recommended Eligible/Contributing	Some original windows have been replaced with vinyl sashes; however, the house is a good example of its type and period of construction.

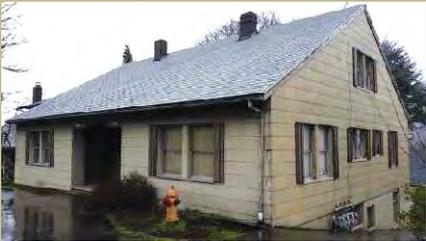
Project ID Survey # Acquisition	Resource Name Address & Assoc. Address Property ID Historic Name	Construction Date Resource Type Primary Style Primary Siding	NRHP Status	Integrity Comments / Notes	Photograph of Resource	Location
SW_8615 28 TCE	3932-3934 SW WATER AVE PORTLAND R140916710	1924 Building Colonial Revival Cedar Shake Shingle	Recommended Not Eligible/Non-Contributing	Siding does not appear to be original; aluminum storm windows obscure original wood windows. The house has no historical associations of significance under Criteria A through D.

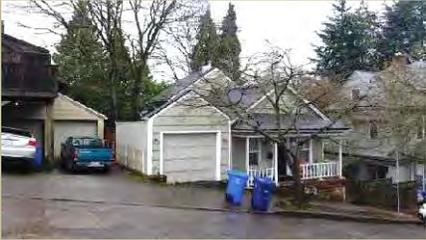
SW_21603 29 TCE	0117 SW THOMAS ST PORTLAND R140916720	1884 Building Victorian Era Cedar Shake Shingle	Recommended Not Eligible/Non-Contributing	Original windows and siding have been modified. A circa 1930 detached garage is to west. A possible addition was observed at the rear (north) elevation. These modifications diminish the house's historical integrity and limit its eligibility for listing in the NRHP.

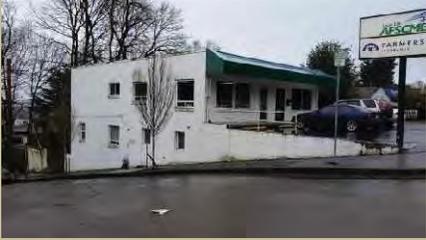
SW_15092 30 PARTIAL	4004-4006 SW BARBUR BLVD PORTLAND R140917060	1949 Building Commercial Concrete Block	Recommended Not Eligible/Non-Contributing	All original windows replaced with vinyl sashes. Diminished historical integrity limits the building's eligibility for listing in the NRHP.

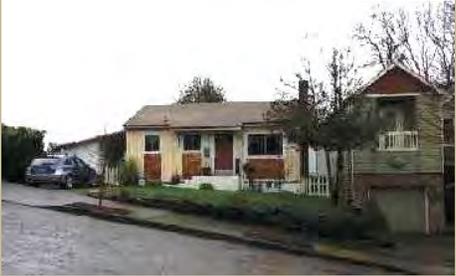
Project ID Survey # Acquisition	Resource Name Address & Assoc. Address Property ID Historic Name	Construction Date Resource Type Primary Style Primary Siding	NRHP Status	Integrity Comments / Notes	Photograph of Resource	Location
SW_4769 31 FULL	0109 SW LOWELL ST PORTLAND R140917070	1926 Building Vernacular Vertical Board	Recommended Not Eligible/Non-Contributing	Windows and siding have been extensively modified, diminishing the house's historical integrity and limiting its eligibility for listing in the NRHP.

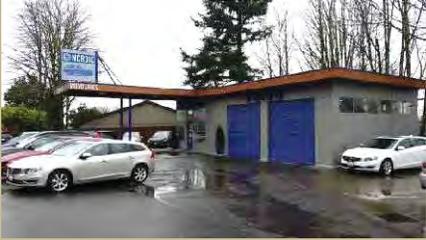
SW_17394 32 PARTIAL	3838 SW BARBUR BLVD PORTLAND R140915620	1950 Building Modern Period Other Metal Other / Undefined	Recommended Not Eligible/Non-Contributing	Modifications to the fenestration diminish the building's historical integrity and its potential to be eligible for listing in the NRHP. Most windows appear to be replacements for originals, and former window openings have been infilled and painted over.

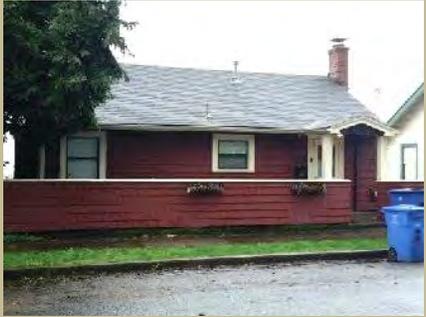
SW_21002 33 NO IMPACT	4000 SW VIEW POINT TER PORTLAND R140916990	1925 Building Craftsman Horizontal Board	Recommended Not Eligible/Non-Contributing	Original windows replaced with aluminum and vinyl sashes. This building has no historical associations of significance under Criterion A through D.

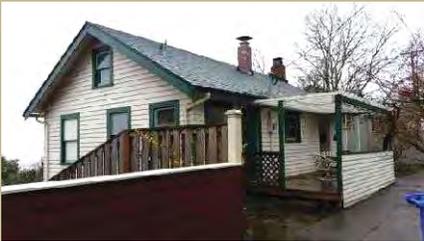
Project ID Survey # Acquisition	Resource Name Address & Assoc. Address Property ID Historic Name	Construction Date Resource Type Primary Style Primary Siding	NRHP Status	Integrity Comments / Notes	Photograph of Resource	Location
SW_11363 34 NO IMPACT	4014 SW VIEW POINT TER PORTLAND R140916980	1925 Building Craftsman Horizontal Board	Recommended Not Eligible/Non-Contributing	Second entry door and deck added to west facade. This building has no historical associations of significance under Criterion A through D.

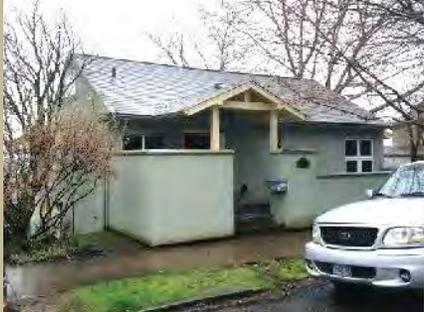
SW_7206 35 NO IMPACT	4024 SW VIEW POINT TER PORTLAND R140916970	1925 Building Craftsman Stucco	Recommended Not Eligible/Non-Contributing	Siding and window modifications diminish the house's historical integrity and its potential to be eligible for listing in the NRHP.

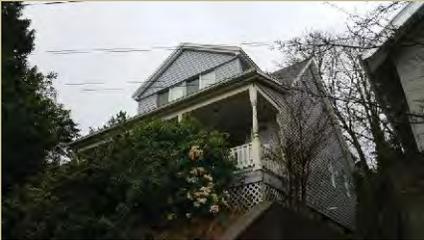
SW_20636 36 TCE	3833 SW VIEW POINT TER PORTLAND R140915550	1899 Building Vernacular Vinyl Siding	Recommended Not Eligible/Non-Contributing	Vinyl windows and siding diminish the house's historical integrity and its potential to be eligible for listing in the NRHP.

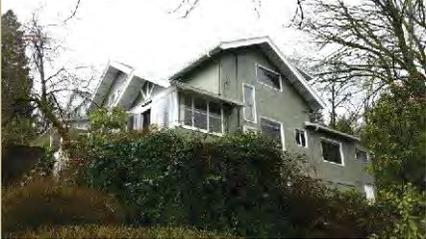
Project ID Survey # Acquisition	Resource Name Address & Assoc. Address Property ID Historic Name	Construction Date Resource Type Primary Style Primary Siding	NRHP Status	Integrity Comments / Notes	Photograph of Resource	Location
SW_15622 37 TCE	3825 SW VIEW POINT TER PORTLAND R140915540	1893 Building Vernacular Cedar Shake Shingle	Recommended Not Eligible/Non-Contributing	Modifications to windows, siding, and plan diminish the house's historical integrity and its potential to be eligible for listing in the NRHP.

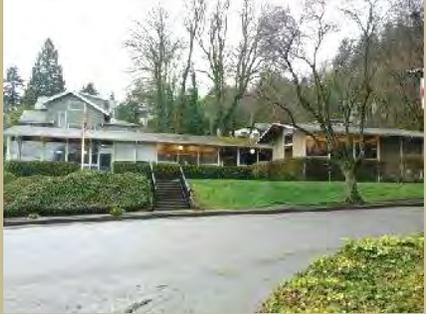
SW_11040 38 TCE	3811 SW BARBUR BLVD PORTLAND R140915520	1960 Building Northwest Regional Wood Other / Undefined	Recommended Eligible/Contributing	Designed by Potter and Robinson Architects, this building embodies distinctive characteristics of the Northwest Regional style.

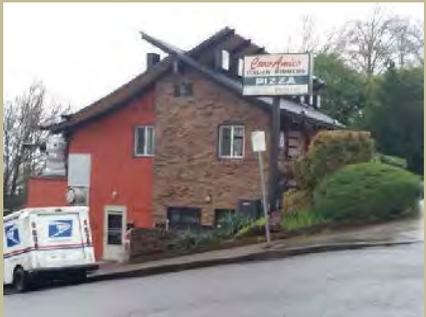
SW_12822 39 FULL	3606 SW BARBUR BLVD PORTLAND R140914190	1965 Building Modern Commercial Vertical Board	Recommended Not Eligible/Non-Contributing	Siding and window modifications detract from the building's historical character, diminishing the building's historical integrity and its potential to be eligible for listing in the NRHP..

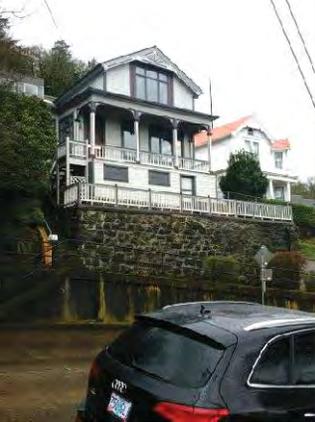
Project ID Survey # Acquisition	Resource Name Address & Assoc. Address Property ID Historic Name	Construction Date Resource Type Primary Style Primary Siding	NRHP Status	Integrity Comments / Notes	Photograph of Resource	Location
SW_11179 40 NO IMPACT	3635 SW CONDOR AVE PORTLAND R140914100	1871 Building Victorian Era Horizontal Board	Recommended Eligible/Contributing	Most original windows have been replaced; however, the house is one of the oldest identified in the project area, and it embodies distinctive characteristics of its period of construction.

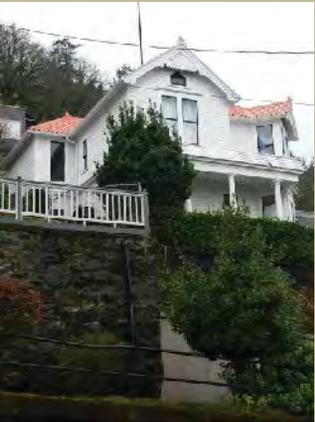
SW_9114 41 NO IMPACT	3625 SW CONDOR AVE PORTLAND R140914080 Holt-Saylor-Liberto House	1885 Building Queen Anne Horizontal Board	Individually Listed in NRHP (1978); City of Portland Historic Landmark	The building is a good representation of the Queen Anne style.

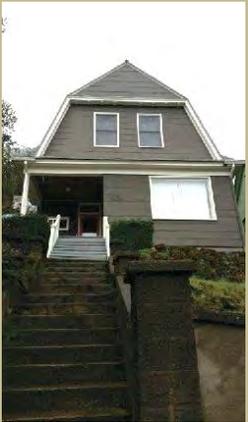
SW_21131 42 NO IMPACT	3611 SW CONDOR AVE PORTLAND R140914070	1898 Building Colonial Revival Cement Fiber Siding	Recommended Not Eligible/Non-Contributing	Original siding and windows have been modified, diminishing the house's historical integrity and its potential to be eligible for listing in the NRHP.

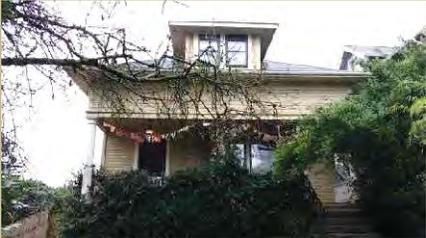
SW_1917 44 TCE	022 SW LOWELL ST PORTLAND R669101960 022 SW Lowell St.	1908 Building Colonial Revival Horizontal Board	Recommended Eligible/Contributing	Original windows likely remain but are obscured by storm windows. The house embodies distinctive characteristics of its type and period of construction.

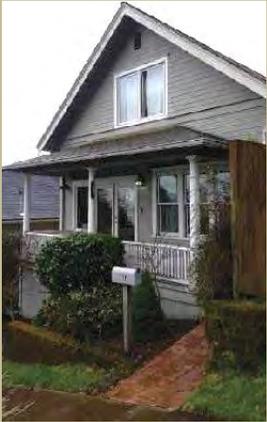
SW_19868 45 NO IMPACT	012 SW LOWELL ST PORTLAND R669101950	1908 Building Colonial Revival Horizontal Board	Recommended Not Eligible/Non-Contributing	Extensive window and door modifications have diminished the house's historical integrity and its potential to be eligible for listing in the NRHP.

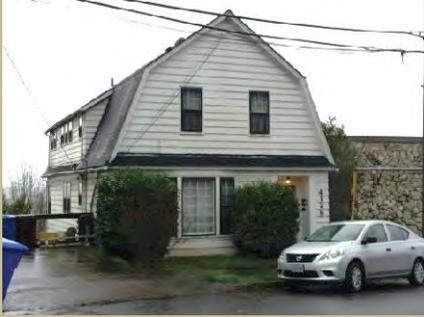
Project ID Survey # Acquisition	Resource Name Address & Assoc. Address Property ID Historic Name	Construction Date Resource Type Primary Style Primary Siding	NRHP Status	Integrity Comments / Notes	Photograph of Resource	Location
SW_14225 46 NO IMPACT	4126 SW VIEW POINT TER PORTLAND R669101920	1908 Building Colonial Revival Horizontal Board	Recommended Not Eligible/Non-Contributing	This building has no historical associations of significance under Criteria A through D.

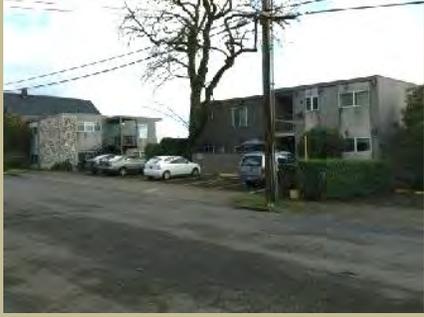
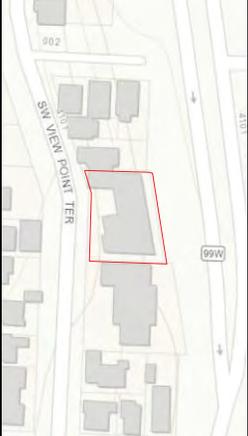
SW_5147 48 FULL	021 SW BANCROFT ST PORTLAND R669101890	1906 Building Colonial Revival Horizontal Board	Recommended Not Eligible/Non-Contributing	All windows have been replaced with vinyl sashes, and porch modifications were observed. The building's diminished historical integrity limits its eligibility for listing in the NRHP.

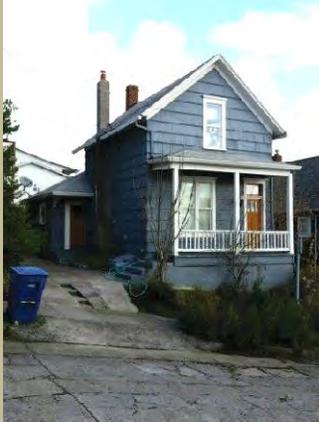
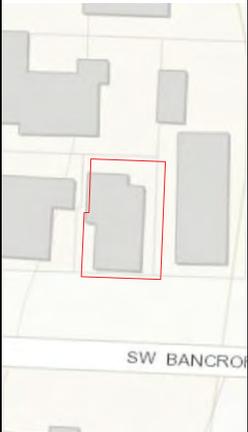
Project ID Survey # Acquisition	Resource Name Address & Assoc. Address Property ID Historic Name	Construction Date Resource Type Primary Style Primary Siding	NRHP Status	Integrity Comments / Notes	Photograph of Resource	Location
SW_3420 49 FULL	015 SW BANCROFT ST PORTLAND R669101860	1890 Building Victorian Era Cedar Shake Shingle	Recommended Not Eligible/Non-Contributing	Window, porch, and siding modifications; second chimney added after construction. The building's diminished historical integrity limits its eligibility for listing in the NRHP.

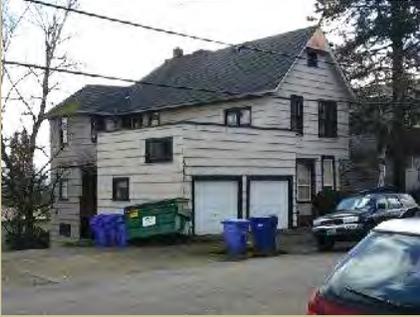
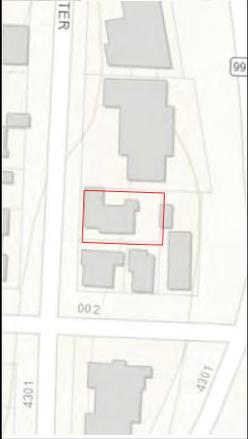
SW_3700 50 TCE	4234 SW VIEW POINT TER PORTLAND R669101870	1894 Building Queen Anne Cedar Shake Shingle	Recommended Not Eligible/Non-Contributing	Modifications to plan, cladding, and windows. The building's diminished historical integrity limits its eligibility for listing in the NRHP.

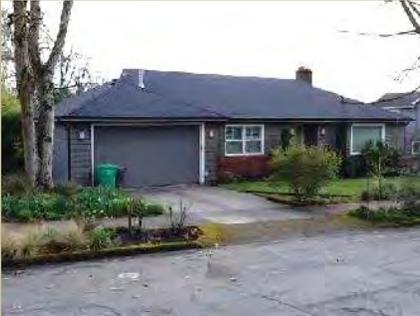
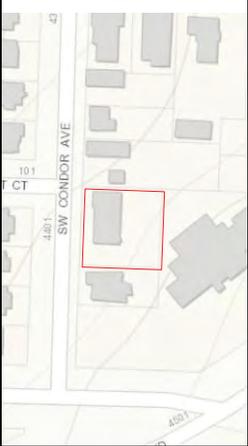
SW_22467 51 NO IMPACT	4400 SW CONDOR AVE PORTLAND R669102560	1948 Building Ranch Horizontal Board	Recommended Not Eligible/Non-Contributing	All original windows replaced with vinyl sashes; siding also appears to be a modern replacement. The building's diminished historical integrity limits its eligibility for listing in the NRHP.

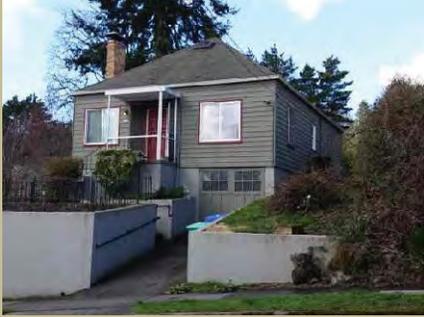
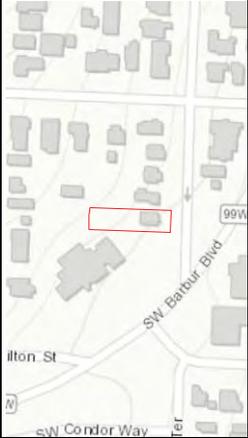
Project ID Survey # Acquisition	Resource Name Address & Assoc. Address Property ID Historic Name	Construction Date Resource Type Primary Style Primary Siding	NRHP Status	Integrity Comments / Notes	Photograph of Resource	Location
SW_4417 52 PARTIAL	4341 SW VIEW POINT TER PORTLAND R669102430	1942 Building WWII Era Cottage Horizontal Board	Recommended Not Eligible/Non-Contributing	Siding and windows are modern. The building's diminished historical integrity limits its eligibility for listing in the NRHP.

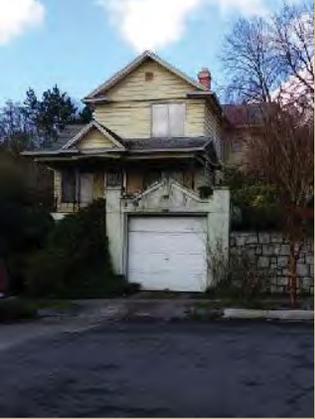
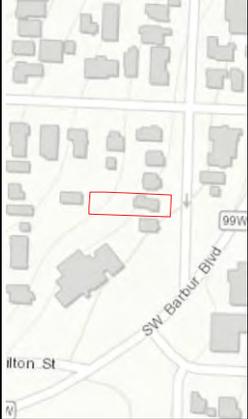
SW_18281 53 PARTIAL	4331 SW VIEW POINT TER PORTLAND R669102340	1908 Building Colonial Revival Synthetic Other / Undefined	Recommended Not Eligible/Non-Contributing	Modifications to the siding and windows of the house diminish its historical appearance and integrity, limiting the house's eligibility for listing in the NRHP. An associated garage is situated east of the house.

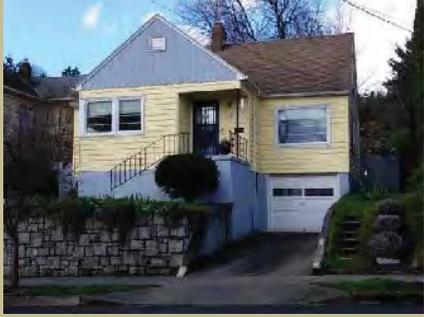
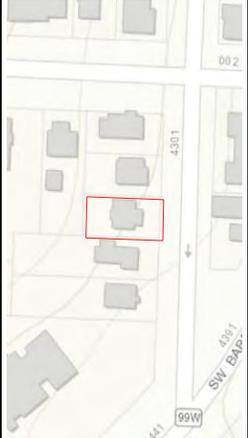
SW_18600 54 NO IMPACT	4323 SW VIEW POINT TER PORTLAND R669102420	1941 Building Minimal Traditional Horizontal Board	Recommended Not Eligible/Non-Contributing	Siding and window modifications diminish historical integrity and appearance, limiting the house's eligibility for listing in the NRHP.

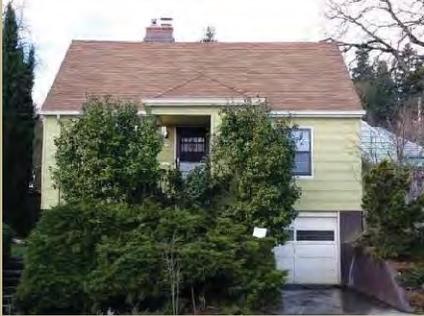
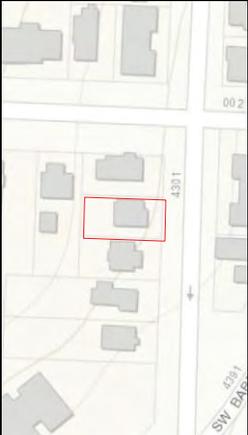
Project ID Survey # Acquisition	Resource Name Address & Assoc. Address Property ID Historic Name	Construction Date Resource Type Primary Style Primary Siding	NRHP Status	Integrity Comments / Notes	Photograph of Resource	Location
SW_10180 55 NO IMPACT	4315 SW VIEW POINT TER PORTLAND R669102410	1941 Building Minimal Traditional Horizontal Board	Recommended Eligible/Contributing	High level of integrity. Distinctive mixture of Minimal Traditional and World War II-era styles.

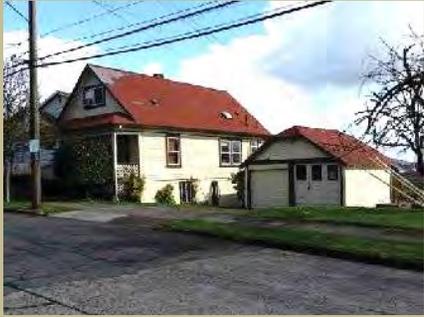
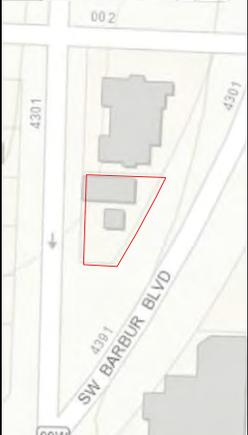
SW_7075 56 FULL	4320 SW VIEW POINT TER PORTLAND R669101700	1910 Building Colonial Revival Horizontal Board	Recommended Not Eligible/Non-Contributing	All original windows replaced with vinyl sashes; west facade porch modifications were also observed. The building's diminished historical integrity limits its eligibility for listing in the NRHP. A detached garage is situated to the house.

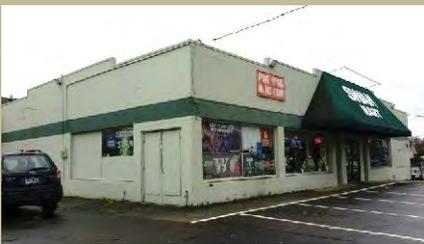
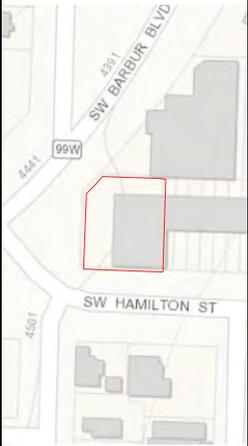
SW_128 57 FULL	4440 SW BARBUR BLVD PORTLAND R669101600	1948 Building Commercial Poured Concrete	Recommended Not Eligible/Non-Contributing	Retains some original steel sash windows. However, this building has no historical associations of significance under Criteria A through D.

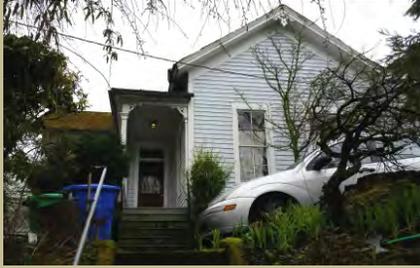
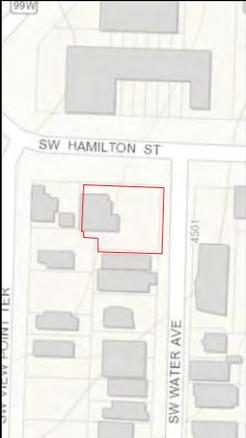
Project ID Survey # Acquisition	Resource Name Address & Assoc. Address Property ID Historic Name	Construction Date Resource Type Primary Style Primary Siding	NRHP Status	Integrity Comments / Notes	Photograph of Resource	Location
SW_2591 58 NO IMPACT	018 SW HAMILTON ST PORTLAND R669101280	1885 Building Victorian Era Horizontal Board	Recommended Eligible/Contributing	Embodies distinctive characteristics of its type and period of construction.

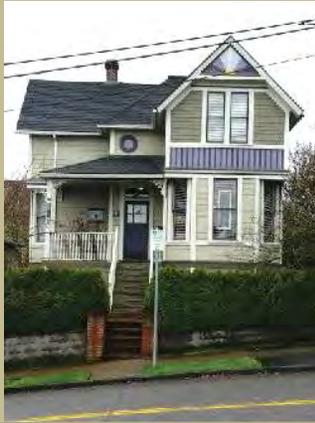
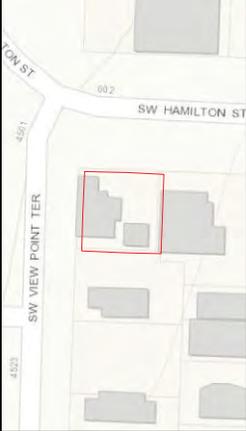
SW_8693 59 NO IMPACT	04 SW HAMILTON ST PORTLAND R669101370	1885 Building Queen Anne Horizontal Board	Recommended Eligible/Contributing	Embodies distinctive characteristics of its type and period of construction. The associated garage does not contribute to the NRHP eligibility of the house.

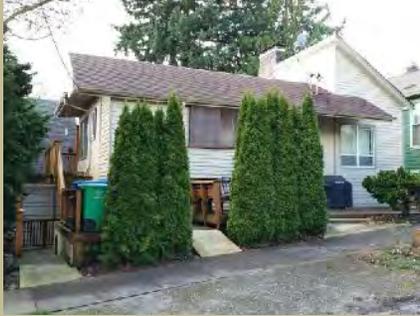
SW_8398 60 EASEMENT	212-214 SW HAMILTON ST PORTLAND R354250350	1893 Building Vernacular Horizontal Board	Recommended Not Eligible/Non-Contributing	Extensive modifications to siding, windows, plan, and roof diminish the building's historical integrity and it potential to be eligible for listing in the NRHP.

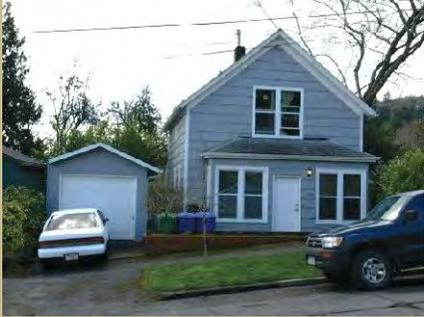
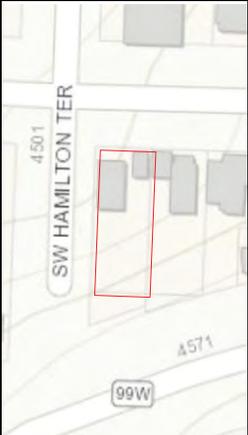
Project ID Survey # Acquisition	Resource Name Address & Assoc. Address Property ID Historic Name	Construction Date Resource Type Primary Style Primary Siding	NRHP Status	Integrity Comments / Notes	Photograph of Resource	Location
SW_103 61 TCE	232 SW HAMILTON ST PORTLAND R669103220	1900 Building Victorian Era Shingle	Recommended Not Eligible/Non-Contributing	The house has diminished historical integrity due to the replacement of the original windows and siding, and the original entry porch has been infilled. It is not eligible for listing in the NRHP due to a lack of historical integrity.

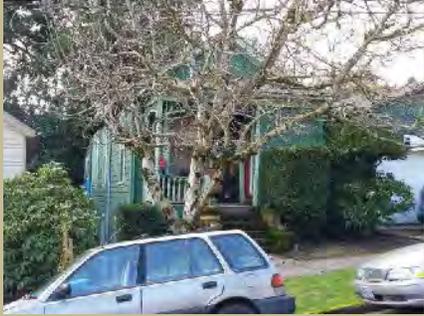
SW_6814 62 EASEMENT	218-220 SW HAMILTON ST PORTLAND R669103230	1888 Building Victorian Era Horizontal Board	Recommended Eligible/Contributing	Some window replacements; at the time of survey, work was being done at the south end of the house and was covered with a tarp. Adjacent garage to the west does not contribute to the house's NRHP Eligibility.

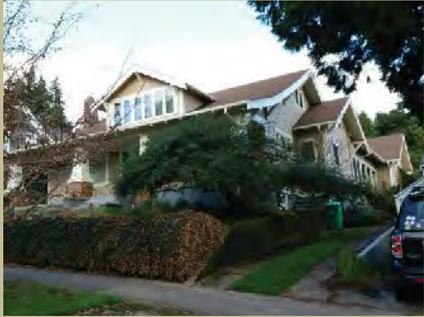
SW_17013 63 NO IMPACT	127 SW HAMILTON ST PORTLAND R669103490	1924 Building Craftsman Horizontal Board	Recommended Eligible/Contributing	Semi-attached garage situated northeast of the house replaced an original outbuilding sometime after 1950. The house is a good example of the Craftsman style in this area of Portland.

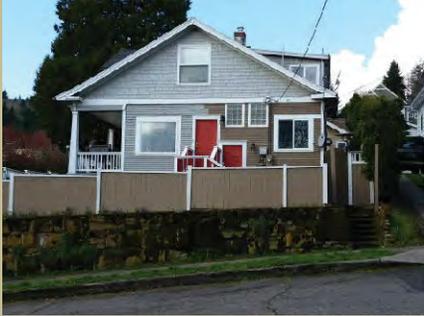
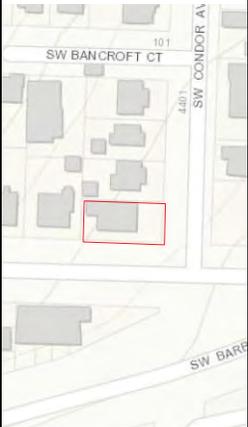
Project ID Survey # Acquisition	Resource Name Address & Assoc. Address Property ID Historic Name	Construction Date Resource Type Primary Style Primary Siding	NRHP Status	Integrity Comments / Notes	Photograph of Resource	Location
SW_3733 64 TCE	105 SW HAMILTON ST PORTLAND R669103460	1921 Building Colonial Revival Horizontal Board	Recommended Not Eligible/Non-Contributing	Extensive modifications to windows, an added south-facing dormer, and modern porch rail diminish the house's integrity and its potential to be eligible for listing in the NRHP.

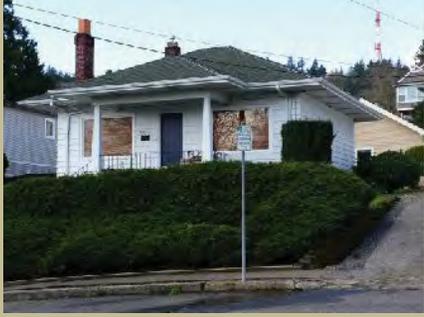
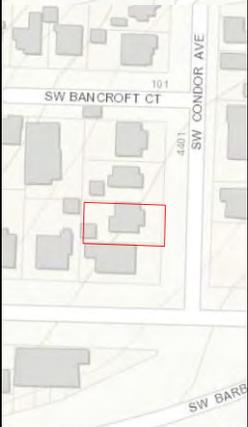
SW_3806 65 TCE	4423 SW CONDOR AVE PORTLAND R669103450	1928 Building Colonial Revival Vinyl Siding	Recommended Not Eligible/Non-Contributing	Siding is modern vinyl. Picture windows of the east facade may be historic- period replacements. The building's diminished integrity limits its potential to be eligible for listing in the NRHP.

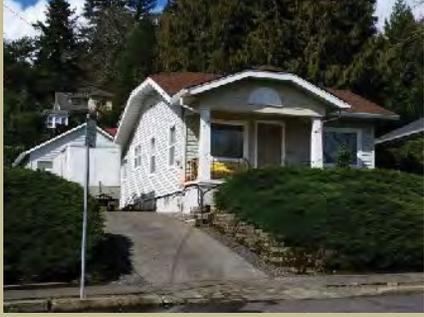
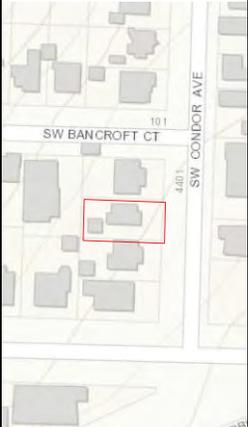
SW_3807 66 NO IMPACT	4415 SW CONDOR AVE PORTLAND R669103440	1927 Building Craftsman Aluminum Siding	Recommended Not Eligible/Non-Contributing	Windows and siding are not original to the date of construction. The building's diminished integrity limits its potential to be eligible for listing in the NRHP.

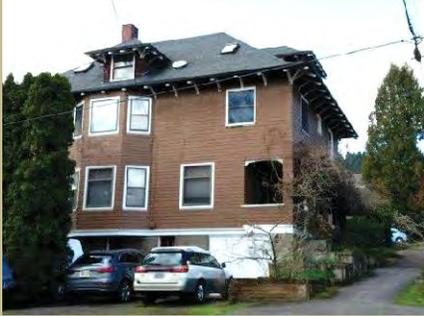
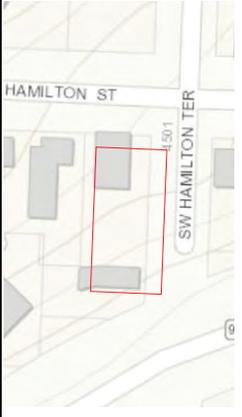
Project ID Survey # Acquisition	Resource Name Address & Assoc. Address Property ID Historic Name	Construction Date Resource Type Primary Style Primary Siding	NRHP Status	Integrity Comments / Notes	Photograph of Resource	Location
SW_9626 67 NO IMPACT	304 SW HAMILTON ST PORTLAND R669104410	1908 Building Colonial Revival Shingle	Recommended Eligible/Contributing	Storm windows obscure windows from view. Siding may not be original; however, the house embodies distinctive characteristics of its type and period of construction.

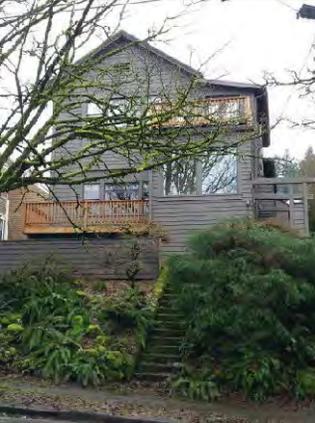
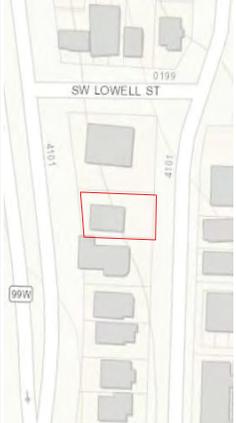
SW_14663 71 TCE	4133 SW CORBETT AVE PORTLAND R669101750 Jewish Shelter Home	1902 Building Colonial Revival Horizontal Board	Listed in NRHP (1984); City of Portland HRI (1984 - Rank II)	The building is listed under Criteria A and B, and is recommended as being eligible for listing under Criterion C.

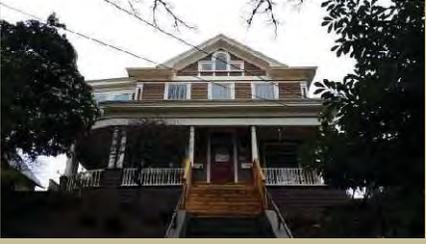
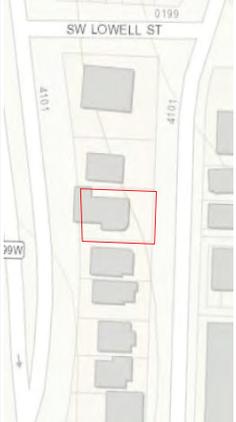
SW_12407 72 PARTIAL	4145 SW CORBETT AVE PORTLAND R669101770	1898 Building Queen Anne Horizontal Board	City of Portland HRI (1984 - Rank III); Recommended Eligible/Contributing	Recommended eligible under Criterion C.

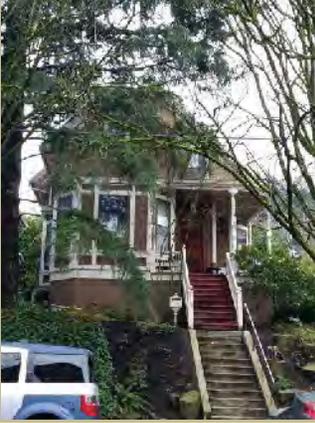
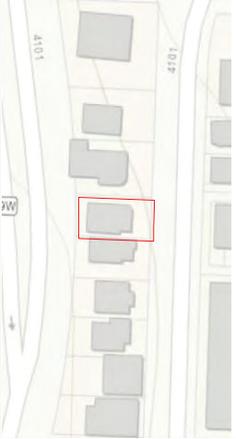
Project ID Survey # Acquisition	Resource Name Address & Assoc. Address Property ID Historic Name	Construction Date Resource Type Primary Style Primary Siding	NRHP Status	Integrity Comments / Notes	Photograph of Resource	Location
SW_11336 73 PARTIAL	4205 SW CORBETT AVE PORTLAND R669101820	1898 Building Queen Anne Horizontal Board	Recommended Eligible/Contributing	The east facade porch was enclosed at an unknown date. Windows look like replacements but do not significantly diminish the house's historical appearance or integrity. An associated historic-period garage is east of the house.

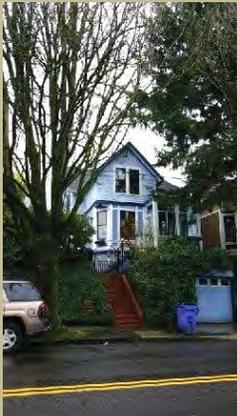
SW_17827 74 PARTIAL	4215-4217 SW CORBETT AVE PORTLAND R669101810	1890 Building Italianate Horizontal Board	Recommended Eligible/Contributing	Windows are vinyl replacements but do not significantly detract from the building's historical appearance or integrity.

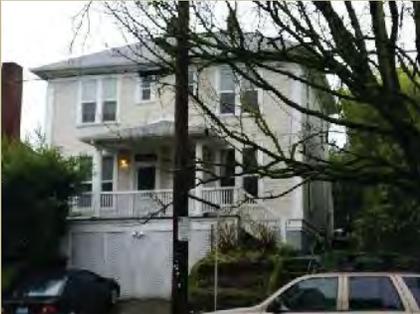
SW_1196 75 PARTIAL	4225 SW CORBETT AVE PORTLAND R669101800	1912 Building Craftsman Horizontal Board	Recommended Not Eligible/Non-Contributing	Addition constructed at northeast corner post-1950 diminished the house's historical integrity and its potential to be eligible for listing in the NRHP.

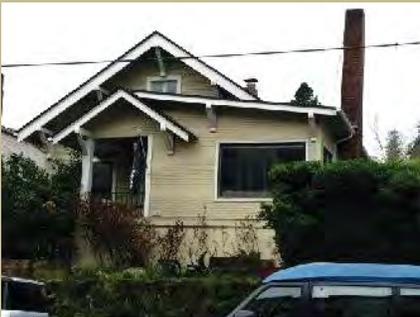
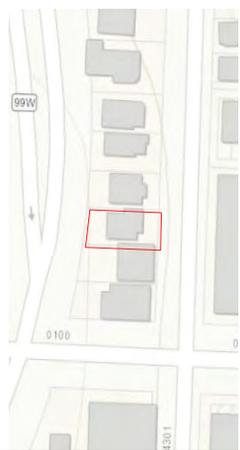
Project ID Survey # Acquisition	Resource Name Address & Assoc. Address Property ID Historic Name	Construction Date Resource Type Primary Style Primary Siding	NRHP Status	Integrity Comments / Notes	Photograph of Resource	Location
SW_17828 76 PARTIAL	4231-4237 SW CORBETT AVE PORTLAND R669101790	1906 Building Commercial Horizontal Board	Recommended Eligible/Contributing	Second story windows are modern vinyl sashes. Original bulkheads have been retained at the first story.

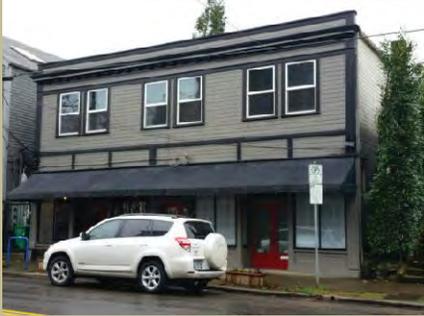
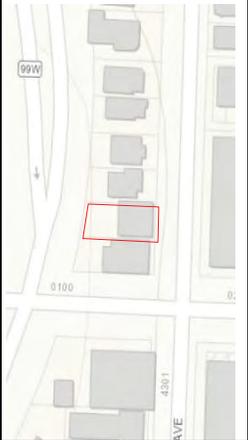
SW_1136 77 PARTIAL	4245-4247 SW CORBETT AVE PORTLAND R669101780	1892 Building Other / Undefined Horizontal Board	Recommended Not Eligible/Non-Contributing	This building has been heavily modified and no longer reflects its historical appearance. The building's diminished integrity limits its potential to be eligible for listing in the NRHP.

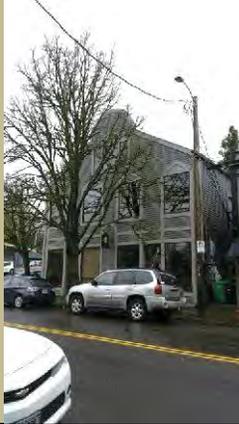
SW_1862 78 FULL	0110 SW BANCROFT ST PORTLAND R669101380	1962 Building Modern Period Other Vertical Board	Recommended Not Eligible/Non-Contributing	A detached garage is situated west of the building. This building has no historical associations of significance under Criteria A through D.

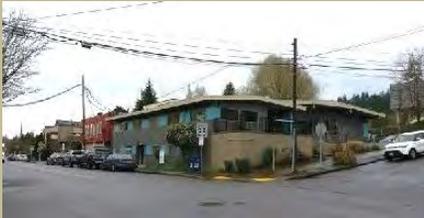
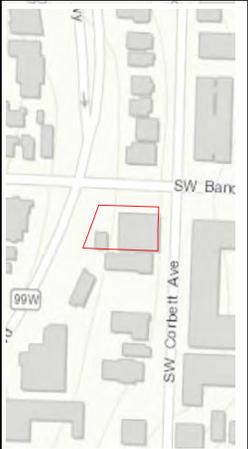
Project ID Survey # Acquisition	Resource Name Address & Assoc. Address Property ID Historic Name	Construction Date Resource Type Primary Style Primary Siding	NRHP Status	Integrity Comments / Notes	Photograph of Resource	Location
SW_19401 79 PARTIAL	Lou Stafford Insurance 4330 SW BARBUR BLVD PORTLAND R669101440 Enco Service Station	1962 Building Modern Commercial Oversized Brick	Recommended Not Eligible/Non-Contributing	Originally constructed as a gas station; in 1972 was converted for use as office space. The building's diminished integrity limits its potential to be eligible for listing in the NRHP.

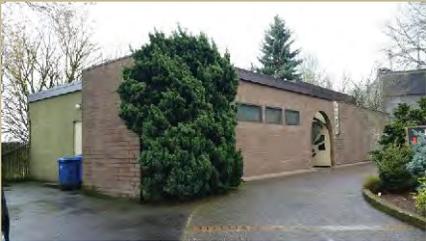
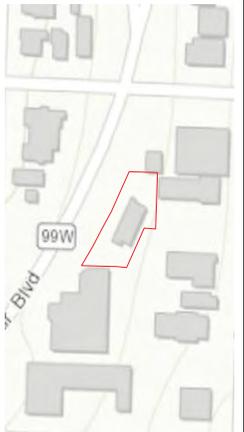
SW_3920 80 NO IMPACT	4343 SW CORBETT AVE PORTLAND R669101490	1957 Building Modern Period Other Vertical Board	Recommended Not Eligible/Non-Contributing	Windows are modern vinyl sashes. The building's diminished integrity limits its potential to be eligible for listing in the NRHP.
