**Section 106 and 4(f) Public Documents
Supplemental Information: Potential Impacts and Mitigation
for Historic Properties and Public Parks
SW Corridor Light Rail Project
Draft – December 15th, 2020**

This technical memo details the potential SW Corridor Light Rail Project impacts to protected historic properties and parks resources, as well as the proposed mitigations. This memo is intended for public review and comment.

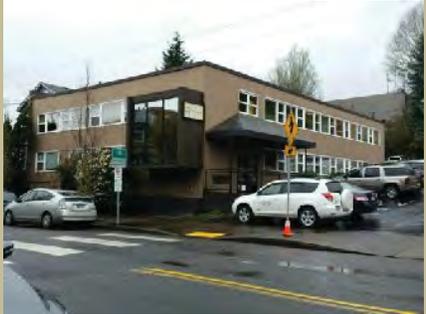
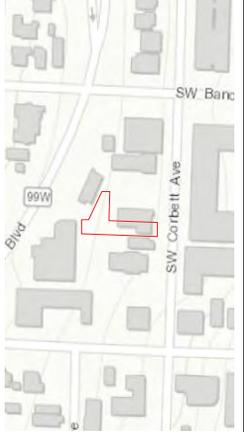
SW_3248 81 NO IMPACT	4407 SW CORBETT AVE PORTLAND R669101510	1889 Building Colonial Revival Horizontal Board	Recommended Not Eligible/Non-Contributing	Modifications to the house's plan and windows were observed. It is zoned for mixed use (residential and commercial). The building's diminished integrity limits its potential to be eligible for listing in the NRHP.

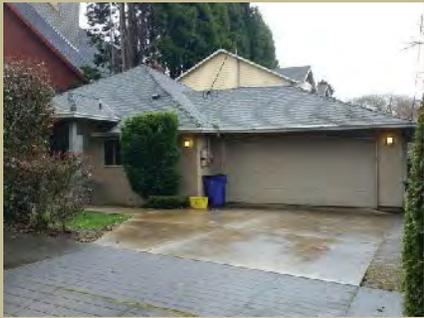
Project ID Survey # Acquisition	Resource Name Address & Assoc. Address Property ID Historic Name	Construction Date Resource Type Primary Style Primary Siding	NRHP Status	Integrity Comments / Notes	Photograph of Resource	Location
SW_12304 85 NO IMPACT	4619 SW CONDOR AVE PORTLAND R669103070	1910 Building Colonial Revival Horizontal Board	Recommended Eligible/Contributing	Embodies distinctive characteristics of its type and period of construction.

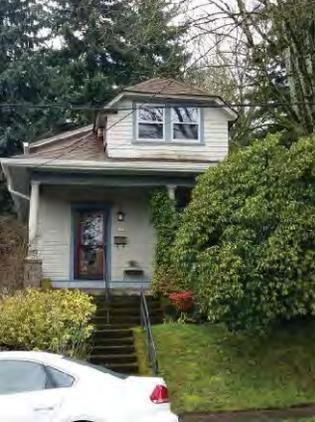
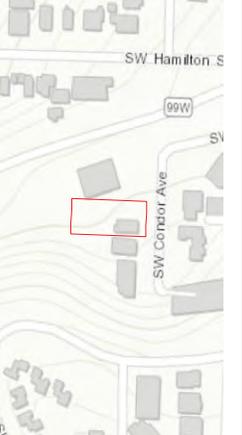
SW_1671 86 PARTIAL	4529 SW HAMILTON TER PORTLAND R669104400	1889 Building Other / Undefined Shingle	Recommended Not Eligible/Non-Contributing	Sanborn maps indicate that the house was expanded towards the west after 1950. Historic-period and modern changes to the siding and windows were observed. The building's diminished integrity limits its potential to be eligible for listing in the NRHP.

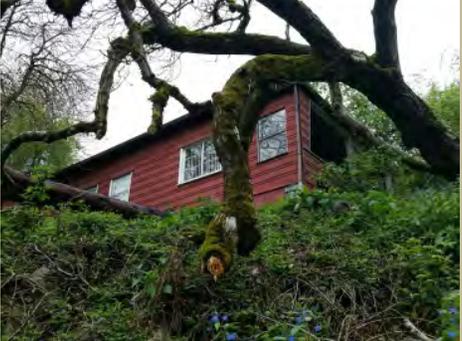
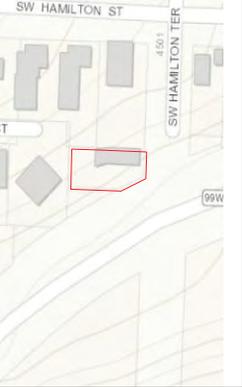
SW_11548 87 EASEMENT	354 SW HAMILTON CT PORTLAND R669104640	1894 Building Queen Anne Vinyl Siding	Recommended Not Eligible/Non-Contributing	Original siding and windows have been removed and replaced with vinyl components, diminishing the historical appearance and integrity of the house. The house has no significant associations under Criteria A through D.

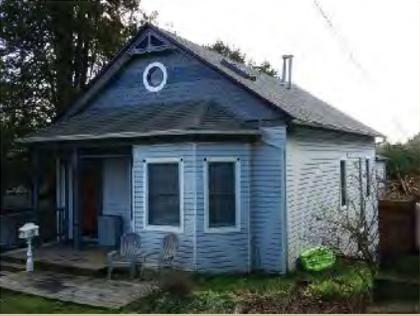
Project ID Survey # Acquisition	Resource Name Address & Assoc. Address Property ID Historic Name	Construction Date Resource Type Primary Style Primary Siding	NRHP Status	Integrity Comments / Notes	Photograph of Resource	Location
SW_1200 88 EASEMENT	364 SW HAMILTON CT PORTLAND R669104630	1894 Building Victorian Era Horizontal Board	Recommended Not Eligible/Non-Contributing	All original windows have been replaced with vinyl sashes. The north facade porch has been infilled and adorned with Craftsman decorative features, further diminishing the historical appearance and integrity of the house. The house is not eligible for listing in the NRHP due to its diminished historical integrity.

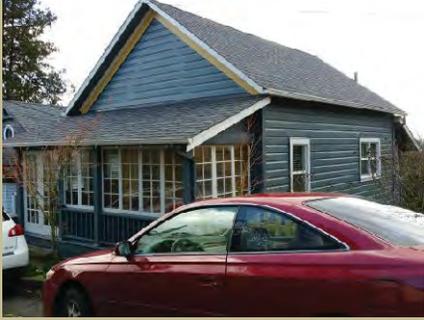
SW_10285 89 PARTIAL	4820 SW BARBUR BLVD PORTLAND R991150550	1962 Building Modern Period Other Stone Other Undefined	Recommended Eligible/Contributing	Embodies distinctive characteristics of its type and period of construction.

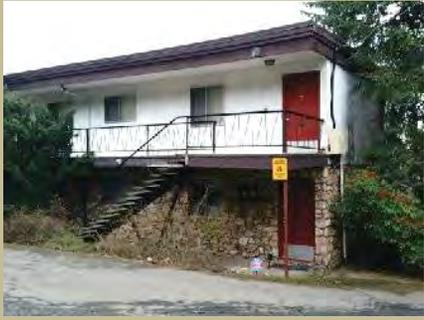
SW_16950 90 PARTIAL	4950 SW BARBUR BLVD PORTLAND R991150270 Rasmussen Village	1941 Building Art Deco Stucco	Recommended Eligible/Contributing	Three historic apartment buildings with an associated historic-period garage and original signs at the SW Barbur Boulevard entry. Three other apartment buildings, possibly modern in construction, are situated east and do not contribute to the property's historical significance.

Rasmussen Village 4950 SW Barbur Blvd., Portland	Historic building or structure	Removal or modification of walls, signs and driveways/circulation (see Attachment B for details)	Adverse effect	Permanent use, greater than <i>de minimis</i>	Complete state-level documentation and compile information about the history of SW Barbur Boulevard (see Attachments B and C for details)
SW Newbury St. Viaduct, Bridge #01983	Historic building or structure	Replacement of the bridge (see Attachment B for details)	Adverse effect	Permanent use, greater than <i>de minimis</i>	Complete federal-level documentation, develop a display to install in the vicinity, and incorporate a historical marker into the new structure (see Attachments B and C for details)
SW Vermont St. Viaduct, Bridge #01984	Historic building or structure	Replacement of the bridge (see Attachment B for details)	Adverse effect	Permanent use, greater than <i>de minimis</i>	Complete federal-level documentation, develop a display to install in the vicinity, and incorporate a historical marker into the new structure (see Attachments B and C for details)

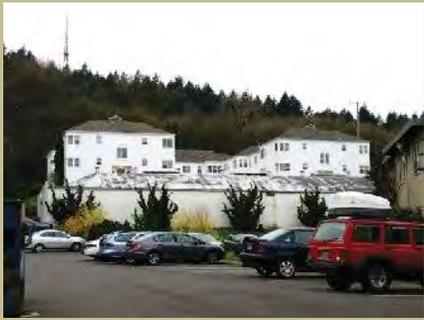
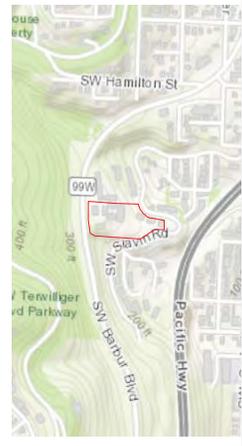
Project ID Survey # Acquisition	Resource Name Address & Assoc. Address Property ID Historic Name	Construction Date Resource Type Primary Style Primary Siding	NRHP Status	Integrity Comments / Notes	Photograph of Resource	Location
SW_5424 91 PARTIAL	5055 SW SLAVIN RD PORTLAND R991150620	1949 Building Vernacular Standard Brick	Recommended Not Eligible/Non-Contributing	This building does not have historically significant associations under Criteria A through D.

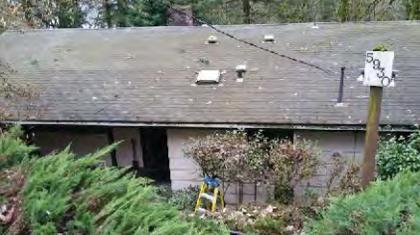
SW_1026 92 NO IMPACT	5930 SW RALSTON DR PORTLAND R300600010	1957 Building Ranch Cedar Shake Shingle	Recommended Not Eligible/Non-Contributing	This building does not have historically significant associations under Criteria A through D.

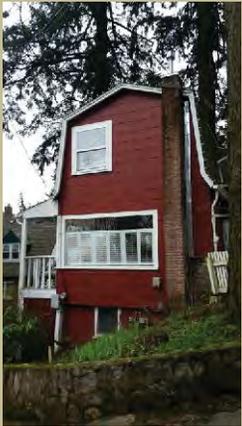
SW_3069 93 NO IMPACT	5870 SW RALSTON DR PORTLAND R649821090	1949 Building Colonial Revival Cement Fiber Siding	Recommended Not Eligible/Non-Contributing	Siding and window modifications diminish the house's historical integrity and its potential to be eligible for listing in the NRHP.

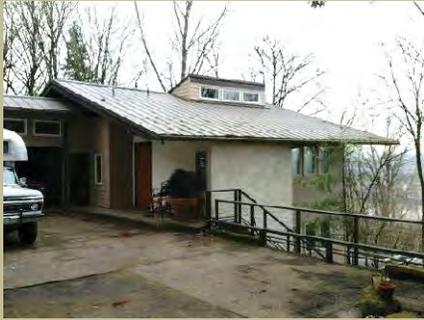
Project ID Survey # Acquisition	Resource Name Address & Assoc. Address Property ID Historic Name	Construction Date Resource Type Primary Style Primary Siding	NRHP Status	Integrity Comments / Notes	Photograph of Resource	Location
SW_10322 94 NO IMPACT	5880 SW RALSTON DR PORTLAND R649631970	1950 Building Modern Period Other Horizontal Board	Recommended Not Eligible/Non-Contributing	Modifications to plan, siding, and windows diminish the house's historical integrity and its potential to be eligible for listing in the NRHP.

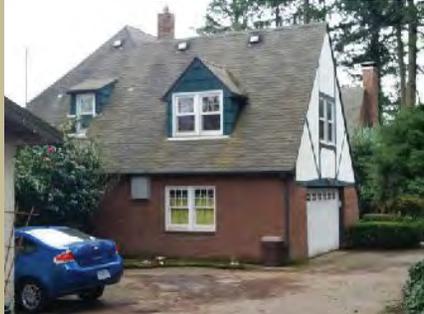
SW_13234 95 PARTIAL	5910 SW RALSTON DR PORTLAND R780207870	1937 Building Tudor Revival Roman Brick	Recommended Eligible/Contributing	Some original windows have been replaced with vinyl sashes of similar configuration. The house embodies distinctive characteristics of its type and period of construction.

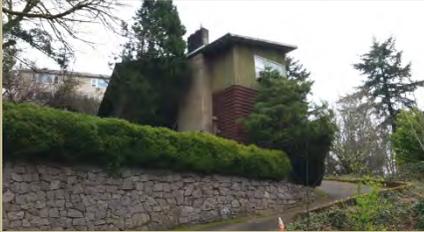
SW_22611 96 NO IMPACT	6660 SW PARKHILL DR PORTLAND R646300920	1952 Building Modern Period Other Horizontal Board	Recommended Not Eligible/Non-Contributing	Likely addition (circa 1970s) observed at the south elevation. This building does not have historically significant associations under Criteria A through D.

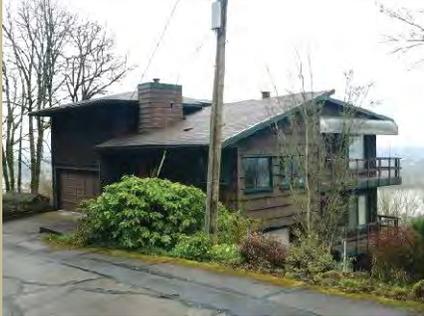
Project ID Survey # Acquisition	Resource Name Address & Assoc. Address Property ID Historic Name	Construction Date Resource Type Primary Style Primary Siding	NRHP Status	Integrity Comments / Notes	Photograph of Resource	Location
SW_668 97 NO IMPACT	6402 SW PARKHILL DR PORTLAND R646300730	1961 Building Split Level Cedar Shake Shingle	Recommended Not Eligible/Non-Contributing	The house has anodized aluminum windows that are not original to the date of construction. This building does not have historically significant associations under Criteria A through D.

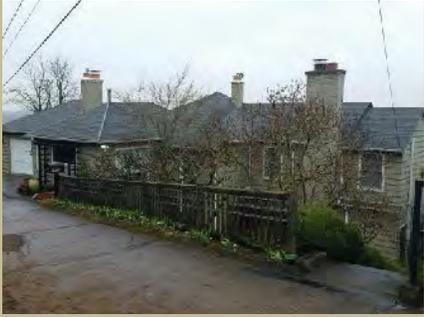
SW_11986 98 NO IMPACT	6438 SW PARKHILL DR PORTLAND R646300820	1940 Building Other / Undefined Horizontal Board	Recommended Not Eligible/Non-Contributing	Windows appear to be modern replacements. This building does not have historically significant associations under Criteria A through D.

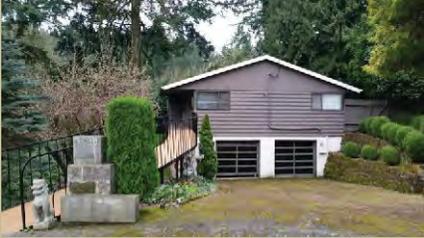
SW_20265 99 NO IMPACT	5933 SW RALSTON DR PORTLAND R300600250	1957 Building Ranch Horizontal Board	Recommended Not Eligible/Non-Contributing	Window modifications diminish the building's historical integrity. This building does not have historically significant associations under Criteria A through D.

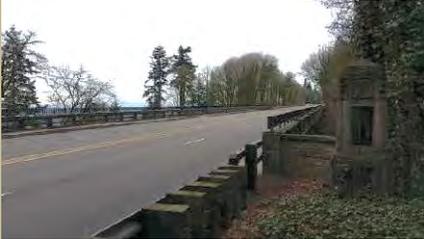
Project ID Survey # Acquisition	Resource Name Address & Assoc. Address Property ID Historic Name	Construction Date Resource Type Primary Style Primary Siding	NRHP Status	Integrity Comments / Notes	Photograph of Resource	Location
Overpass 100 NA	SW Newbury St Viaduct, Hwy 1W Bridge #01983	1934 Structure Not Applicable Not Applicable	Category II Bridge, ODOT Historic Bridge Field Guide (2013); Recommended Eligible/Contributing	Constructed with federal relief funds, this structure has a composite design of timber and concrete.

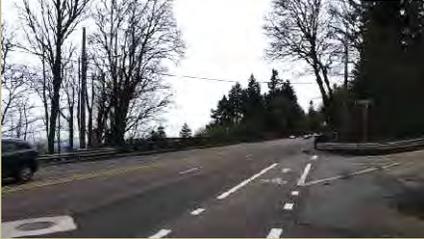
Overpass 101 NA	SW Vermont St Viaduct, Hwy 1W Bridge #01984	1934 Structure Not Applicable Not Applicable	Category II Bridge, ODOT Historic Bridge Field Guide (2013); Recommended Eligible/Contributing	Constructed with federal relief funds, this structure has a composite design of timber and concrete.

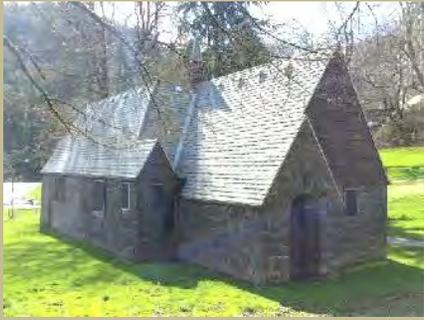
SW_16303 102 PARTIAL	Duniway Park SW 6 TH AVE AND SW SHERIDAN ST PORTLAND	1918 Site Not Applicable Not Applicable	Recommended Eligible/Contributing	Park features a modern recreation field, but retains a historic-period lilac garden and two restroom buildings. It has a significant association with the development of South Portland during the early twentieth century.

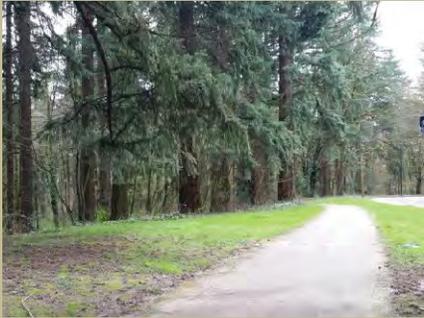
Project ID Survey # Acquisition	Resource Name Address & Assoc. Address Property ID Historic Name	Construction Date Resource Type Primary Style Primary Siding	NRHP Status	Integrity Comments / Notes	Photograph of Resource	Location
SW_16377 103 TCE	George Himes Park 6400 SW Terwilliger Boulevard Fulton Park; George Himes Park	1903 Site Not Applicable Not Applicable	Recommended Eligible/Significant	Park lands were donated in 1903 by Charles Ladd, Henry Pittock, and S.B. Lombard; was originally referred to as Fulton Park, and was later dedicated as George Himes Park in 1935.

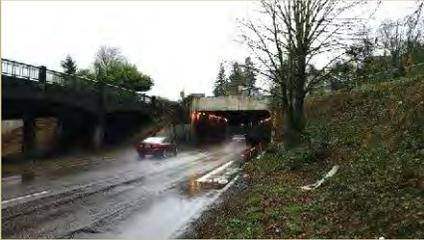
Overpass 104 NA	SW Barbur Blvd over Hwy 1W SB Bridge #05195B	1949 Structure Not Applicable Not Applicable	Recommended Not Eligible/Non-Contributing	Reinforced concrete rigid frame bridge. Not included in Oregon's Historic Bridge Field Guide (2013).

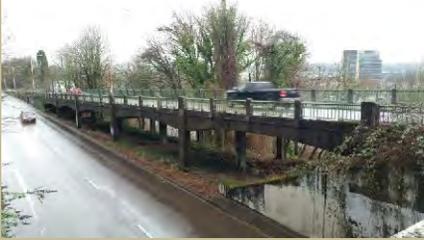
Overpass 105 NA	Harbor Drive Viaduct, Hwy 1W NB Bridge #05195A	1949 Structure Not Applicable Not Applicable	Recommended Not Eligible/Non-Contributing	Reinforced concrete deck girder bridge with filled retaining wall. Not included in Oregon's Historic Bridge Field Guide (2013).

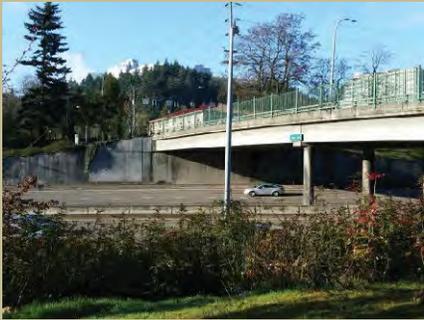
Project ID Survey # Acquisition	Resource Name Address & Assoc. Address Property ID Historic Name	Construction Date Resource Type Primary Style Primary Siding	NRHP Status	Integrity Comments / Notes	Photograph of Resource	Location
Overpass 106 NA	SW 4th Ave over Hwy 61 & Conn #8 Bridge #09155	1964 Structure Not Applicable Not Applicable	Recommended Not Eligible/Non-Contributing	Reinforced concrete box girder. Not included in Oregon's Historic Bridge Field Guide (2013).

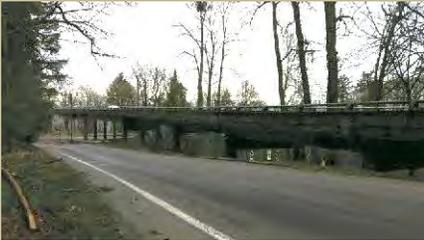
Overpass 107 NA	SW Slavin Rd Conn over Hwy 1W (SW Barbur Blvd) Bridge #08551; City of Portland Bridge #139	1959 Structure Not Applicable Not Applicable	Recommended Not Eligible/Non-Contributing	Bridge with several different construction methods; reinforced concrete deck girder, reinforced concrete box girder, and steel deck girder. Not included in Oregon's Historic Bridge Field Guide (2013).

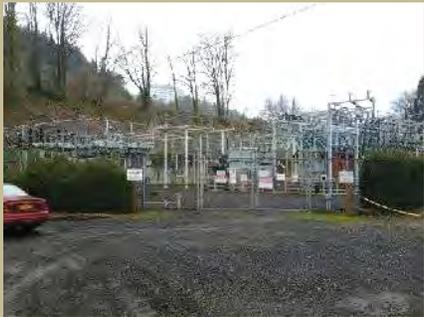
Substation 108 NA	SW Curry Street at SW Water Avenue Portland General Electric Urban Substation	1963 Structure Not Applicable Not Applicable	Recommended Not Eligible/Non-Contributing	This substation was originally constructed with one 3,000 kVA transformer. In 1971, the original transformer was replaced with two 16,800 kVA transformers to meet an increased demand. In 1975, the capacity was increased to its current 54,200 kVA. The substation has no known historical associations of significance under Criteria A through D.

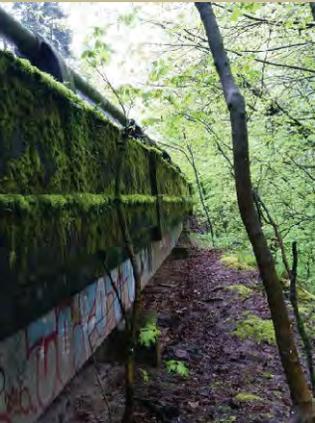
Project ID Survey # Acquisition	Resource Name Address & Assoc. Address Property ID Historic Name	Construction Date Resource Type Primary Style Primary Siding	NRHP Status	Integrity Comments / Notes	Photograph of Resource	Location
Overpass 109 NA	S.W. Capitol Hwy. Semi-Viaduct-M.P. 6.62 at Sloped City of Portland Bridge #140	1959 Structure Not Applicable Not Applicable	Recommended Not Eligible/Non-Contributing	Cast-in-place concrete semi-viaduct situated on the sloped hillside of SW Capitol Highway. Not included in Oregon's Historic Bridge Field Guide (2013); categorized as "not historic" in PBOT's Crossing the Divide Bridge Inventory (2015).

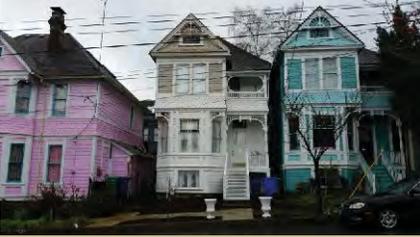
District 110 NA	South Portland Historic District	District	Listed in NRHP (1998)	Listed under Criteria A and C, this district is a good collection of Victorian-era buildings associated with the settlement of South Portland by immigrant groups at the turn of the twentieth century.

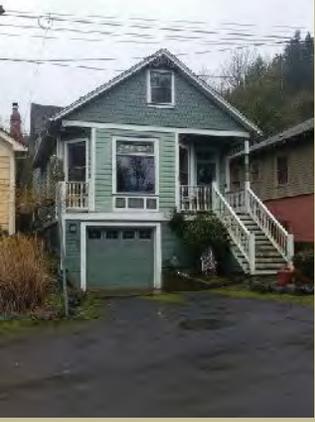
SW_11603 111 NO IMPACT	322 SW MEADE ST PORTLAND R140906790 Murphy, Charles C & Anna, House	1894 Building Queen Anne Horizontal Board	Contributing Resource, South Portland Historic District (Listed in 1998)

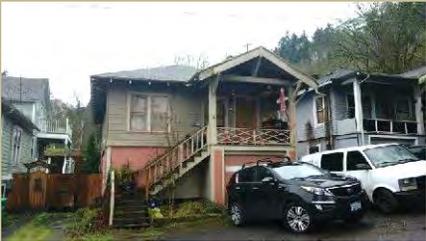
Project ID Survey # Acquisition	Resource Name Address & Assoc. Address Property ID Historic Name	Construction Date Resource Type Primary Style Primary Siding	NRHP Status	Integrity Comments / Notes	Photograph of Resource	Location
SW_9786 112 TCE	330 SW MEADE ST PORTLAND R140906870 Tartarimi, Gaetano & Victoria, House #2	1914 Building Bungalow Shingle	Contributing Resource, South Portland Historic District (Listed in 1998)

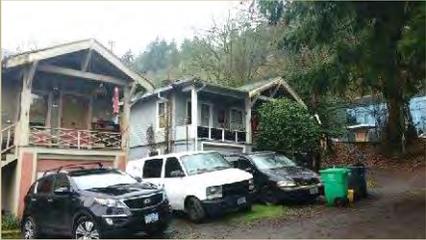
SW_13119 113 FULL	338 SW MEADE ST PORTLAND R140906860 Tartarimi House #1	1914 Building Bungalow Shingle	Contributing Resource, South Portland Historic District (Listed in 1998)

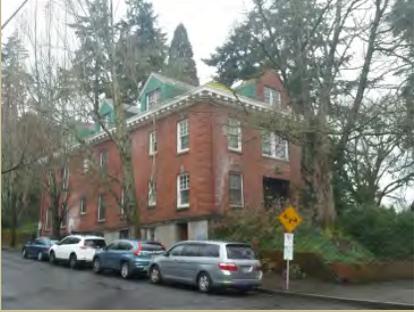
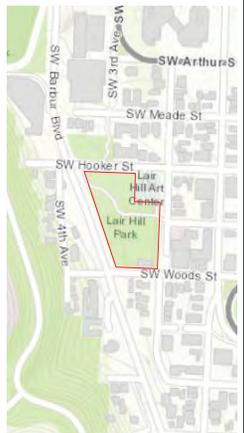
SW_16345 114 PARTIAL	Lair Hill Park 3037 SW 2ND AVE PORTLAND R140906580 Multnomah County Hospital Nurses' Quarters; Lair Hill Park; South	1918 Site	Recommended Eligible/Significant; Contributing Resource, South Portland Historic District	Lair Hill Park was established in 1927. Two historic buildings are within its boundary: the 1918 Multnomah County Hospital Nurses' Quarters and a 1921 South Portland (Carnegie) Library. Within the South Portland Historic District, Lair Hill Park is considered to be part of the Nurses' Quarters, and the Carnegie Library was documented as a separate property.

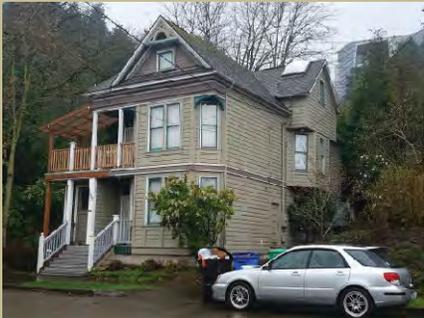
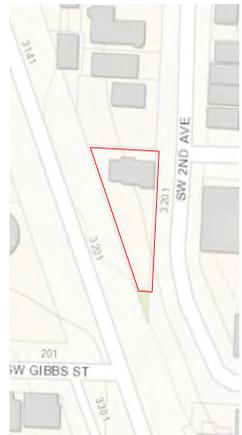
Project ID Survey # Acquisition	Resource Name Address & Assoc. Address Property ID Historic Name	Construction Date Resource Type Primary Style Primary Siding	NRHP Status	Integrity Comments / Notes	Photograph of Resource	Location
SW_14596 115 FULL	3203 SW 2ND AVE PORTLAND R140910570 Oregon Central Railroad Company House	1900 Building Queen Anne Horizontal Board	Not Eligible/Non-Contributing, South Portland Historic District (Listed in 1998)	The house was moved to its current location, and has incurred several other major modifications.

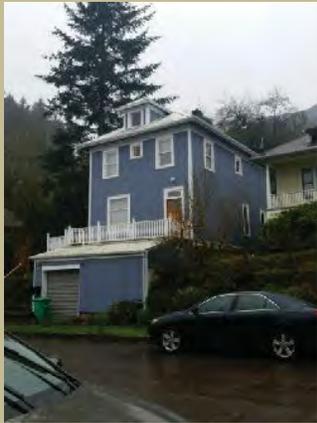
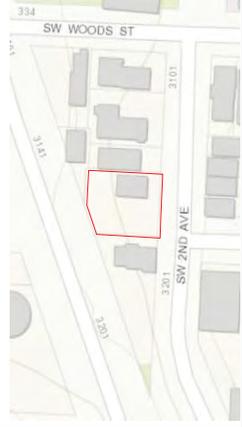
SW_11876 116 PARTIAL	3133 SW 2ND AVE PORTLAND R140910440 Durschmidt, Rudolph, House	1910 Building Foursquare Horizontal Board	Contributing Resource, South Portland Historic District (Listed in 1998);	All original windows have been replaced with vinyl, and non-compatible standing-seam metal has been placed on the roof. The east facade porch overhang, which was in place as late as 1950, has since been removed. The current porch features modern railings, and rests atop a street level garage. The house lacks adequate integrity to contribute to the historic district.

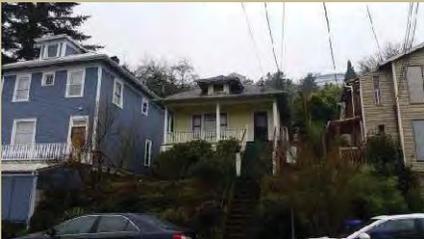
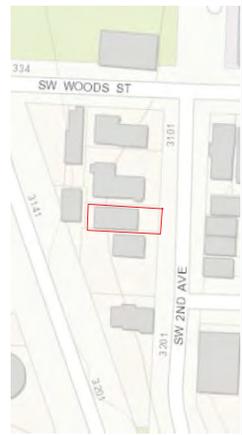
SW_6659 117 TCE	3125 SW 2ND AVE PORTLAND R140910430 King, Ann, House	1906 Building Bungalow Horizontal Board	Contributing Resource, South Portland Historic District (Listed in 1998)

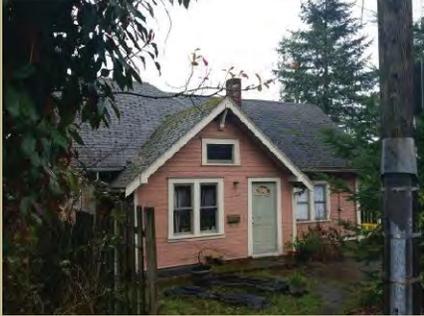
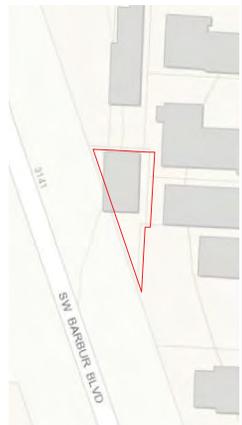
Project ID Survey # Acquisition	Resource Name Address & Assoc. Address Property ID Historic Name	Construction Date Resource Type Primary Style Primary Siding	NRHP Status	Integrity Comments / Notes	Photograph of Resource	Location
SW_22760 118 FULL	3124 SW BARBUR BLVD PORTLAND R140910420 Fiebiger, Victoria, House	1912 Building Craftsman Horizontal Board	Contributing Resource, South Portland Historic District (Listed in 1998)

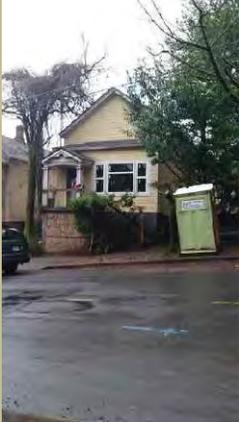
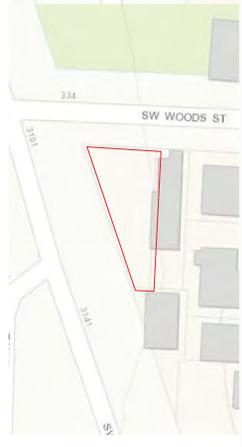
SW_14792 119 FULL	230 SW WOODS ST PORTLAND R140910460 Pulvermacher, R., House	1902 Building Queen Anne Synthetic Wood Siding	Contributing Resource, South Portland Historic District (Listed in 1998)	At the time of survey in 2017, this house was in the process of being remodeled. Original siding has been removed and replaced with synthetic lap boards, and original windows have been replaced with vinyl sashes. These modifications diminish the historical integrity of the house.

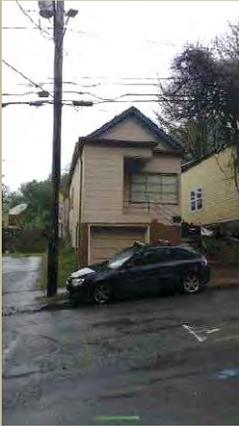
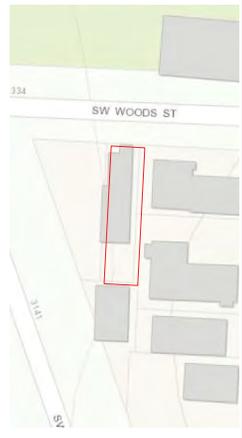
SW_5049 120 PARTIAL	224 SW WOODS ST PORTLAND R140910450 King, William, House	1900 Building Vernacular Cement Fiber Siding	Not Eligible/Non- Contributing, South Portland Historic District (Listed in 1998)	The north facade window appears to have been installed circa 1950; porch modifications and the construction of a concrete block addition to the rear (south) elevation also appear to have been completed at that time.

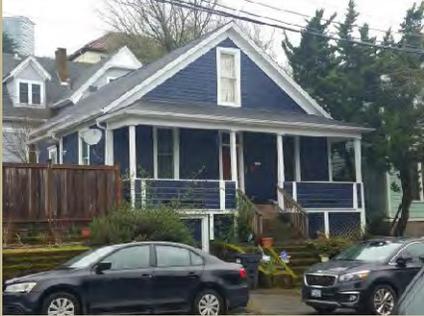
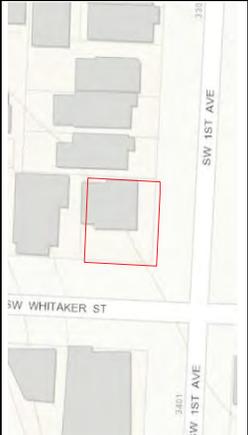
Project ID Survey # Acquisition	Resource Name Address & Assoc. Address Property ID Historic Name	Construction Date Resource Type Primary Style Primary Siding	NRHP Status	Integrity Comments / Notes	Photograph of Resource	Location
SW_21705 121 TCE	3333 SW 1ST AVE PORTLAND R649882610 Boyd, Narcissa and Thomas, House #2 (Building 1 of 2)	1896 Building Victorian Era Horizontal Board	Contributing Resource, South Portland Historic District (Listed in 1998)	Porch and window modifications detract from historical integrity. Tax assessor records document the build date as 1896, while South Portland Historic District nomination reports a build date of 1888.

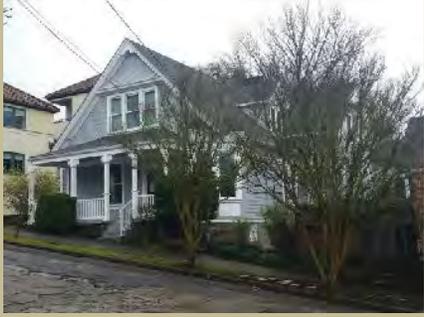
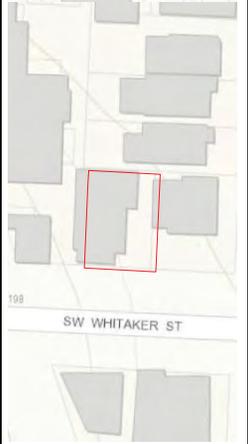
SW_2773 122 TCE	117 SW WHITAKER ST PORTLAND R649882620 Boyd, Narcissa and Thomas, House #2 (Building 2 of 2)	1896 Building Queen Anne Horizontal Board	Contributing Resource, South Portland Historic District (Listed in 1998)

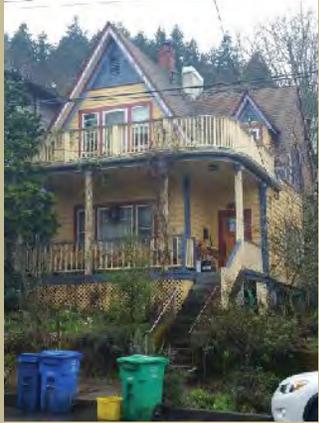
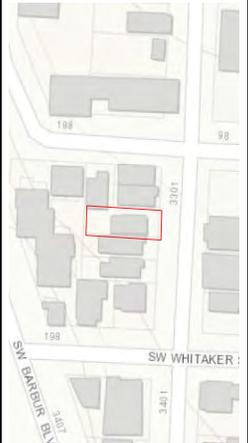
SW_10541 123 NO IMPACT	3311 SW 1ST AVE PORTLAND R140912200 Switzler, Dennie, House	1890 Building Queen Anne Horizontal Board	Contributing Resource, South Portland Historic District (Listed in 1998)

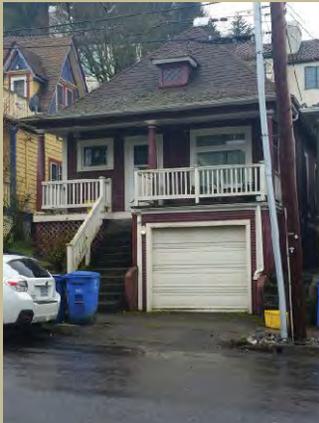
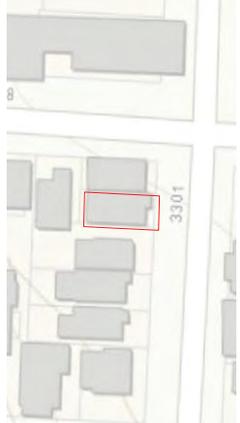
Project ID Survey # Acquisition	Resource Name Address & Assoc. Address Property ID Historic Name	Construction Date Resource Type Primary Style Primary Siding	NRHP Status	Integrity Comments / Notes	Photograph of Resource	Location
SW_10223 124 NO IMPACT	3307 SW 1ST AVE PORTLAND R140912190 Spageli, Fred, House #2	1906 Building Bungalow Horizontal Board	Contributing Resource, South Portland Historic District (Listed in 1998)

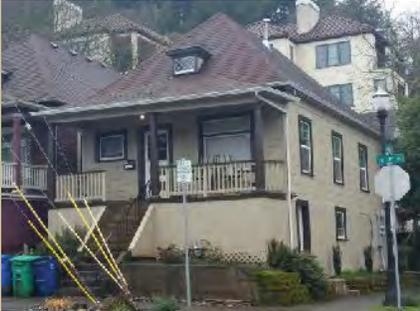
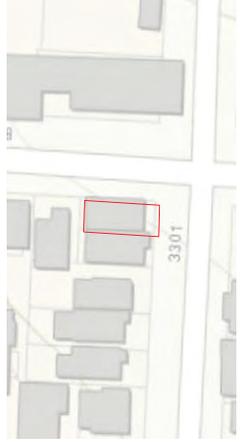
SW_22753 125 NO IMPACT	3303 SW 1ST AVE PORTLAND R140912180 Spageli, Fred, House #1	1906 Building Bungalow Horizontal Board	Contributing Resource, South Portland Historic District (Listed in 1998);	Siding and windows have been modified since the house was last documented in 1998. It now lacks historical integrity.

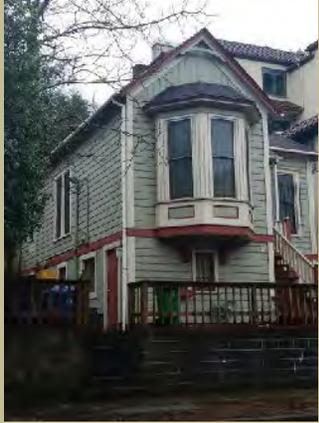
SW_3750 126 TCE	118 SW GIBBS ST PORTLAND R140912170 Dilg, Julius and Anna, House	1900 Building Queen Anne Horizontal Board	Contributing Resource, South Portland Historic District (Listed in 1998)

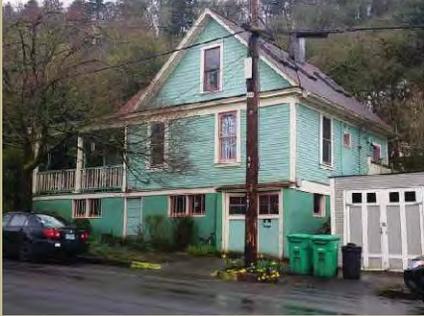
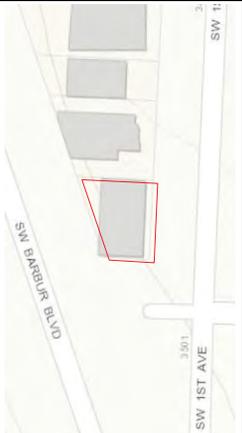
Project ID Survey # Acquisition	Resource Name Address & Assoc. Address Property ID Historic Name	Construction Date Resource Type Primary Style Primary Siding	NRHP Status	Integrity Comments / Notes	Photograph of Resource	Location
SW_10519 127 FULL	105 SW CURRY ST PORTLAND R140912410 Chehak, Seraphim John, House #4	1906 Building Colonial Revival Horizontal Board	Contributing Resource, South Portland Historic District (Listed in 1998)

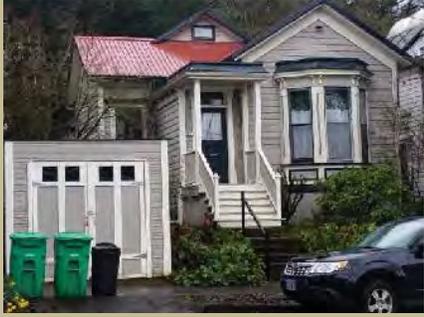
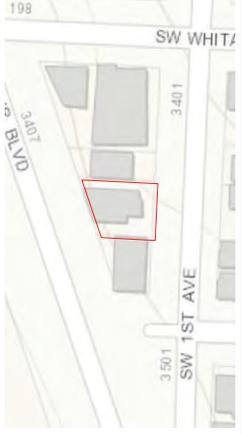
SW_11574 128 FULL	3425 SW 1ST AVE PORTLAND R140912400 Lawton, Philip and Julia, House	1894 Building Italianate Horizontal Board	Contributing Resource, South Portland Historic District (Listed in 1998)

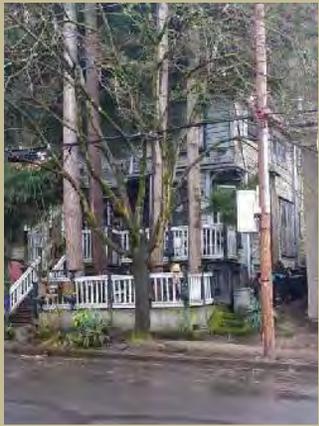
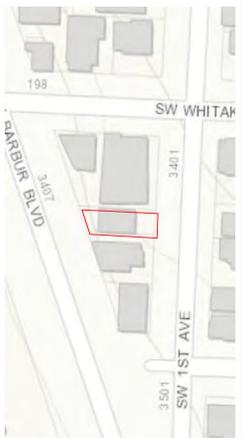
SW_3209 129 PARTIAL	3419 SW 1ST AVE PORTLAND R140912380 Severson, R.W. and Tracy, C.W., House	1892 Building Queen Anne Horizontal Board	Not Eligible/Non- Contributing, South Portland Historic District (Listed in 1998); Recommended Eligible/Contributing	This house is in poor condition but retains an adequate level of integrity to contribute to the historic district. The east facade porch rail is not original, and the South Portland Historic District nomination notes that skylights have been added. However, original windows and siding appear to have been retained.

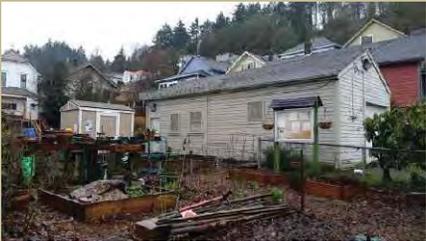
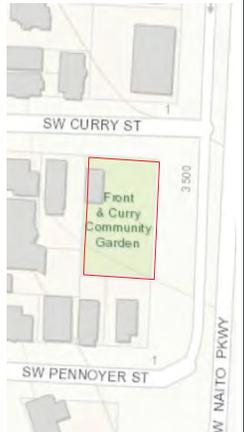
Project ID Survey # Acquisition	Resource Name Address & Assoc. Address Property ID Historic Name	Construction Date Resource Type Primary Style Primary Siding	NRHP Status	Integrity Comments / Notes	Photograph of Resource	Location
SW_16350 130 TCE	Front & Curry Community Gardens 20 SW CURRY ST PORTLAND R140913880	1970 Site Not Applicable Horizontal Board	Not Eligible/Out of Period, South Portland Historic District (Listed in 1998); Recommended Not Eligible/Non-Contributing as an individual resource	This 1970 park encompasses one historic- period garage and one modern shed. The historic- period garage was likely associated with a house that is no longer extant. This small park is used as a community garden. It is not eligible as an individual resource outside of the context of the historic district.

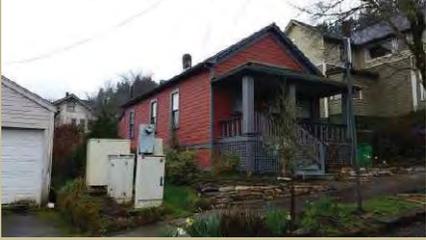
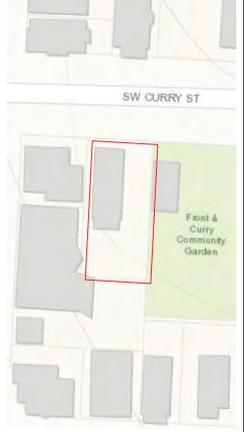
SW_6759 131 NO IMPACT	26 SW CURRY ST PORTLAND R140913950 Thompson, D. P., House #2	1880 Building Victorian Era Horizontal Board	Contributing Resource, South Portland Historic District (Listed in 1998)

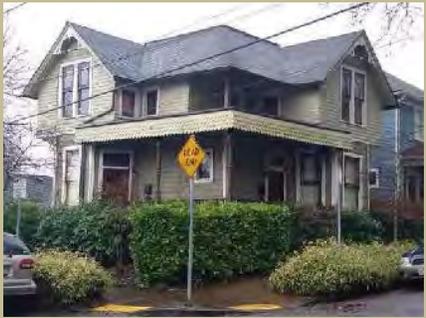
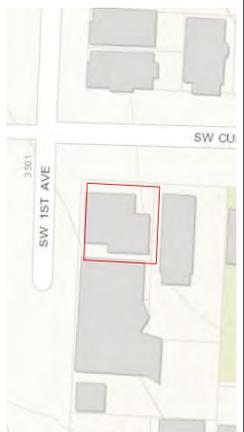
SW_14368 132 NO IMPACT	3504 SW 1ST AVE PORTLAND R140913980 Voos, Frederika, House	1885 Building Queen Anne Horizontal Board	Contributing Resource, South Portland Historic District (Listed in 1998)

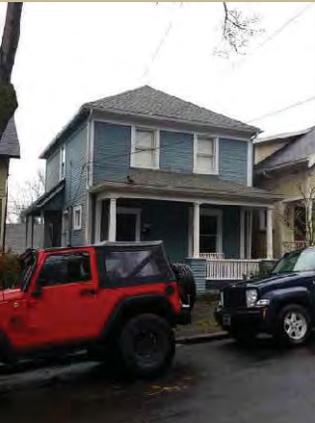
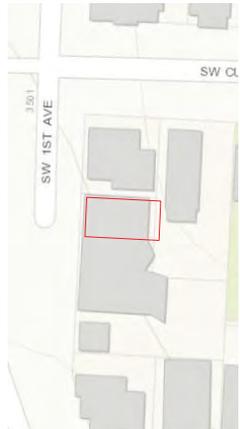
Project ID Survey # Acquisition	Resource Name Address & Assoc. Address Property ID Historic Name	Construction Date Resource Type Primary Style Primary Siding	NRHP Status	Integrity Comments / Notes	Photograph of Resource	Location
SW_13471 133 NO IMPACT	3510 SW 1ST AVE PORTLAND R140913970 O'Leonor, Bridget L., House	1890 Building Foursquare Horizontal Board	Contributing Resource, South Portland Historic District (Listed in 1998)

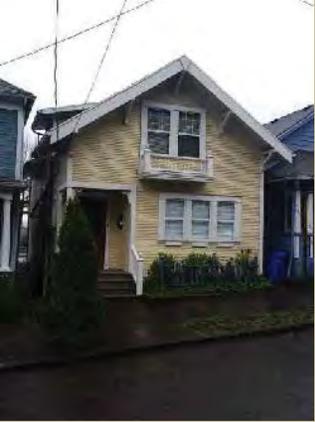
SW_8165 134 PARTIAL	3516 SW 1ST AVE PORTLAND R140913960 Gervutz, S., House	1910 Building Craftsman Horizontal Board	Contributing Resource, South Portland Historic District (Listed in 1998)	Siding is original; windows and most ornamentation are not.

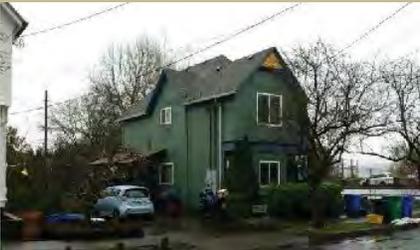
SW_9787 135 TCE	11 SW PENNOYER ST PORTLAND R140913900 Gundoph, Ferdinand, House #1	1884 Building Queen Anne Cedar Rake Shingle	Not Eligible/Non- Contributing, South Portland Historic District (Listed in 1998)

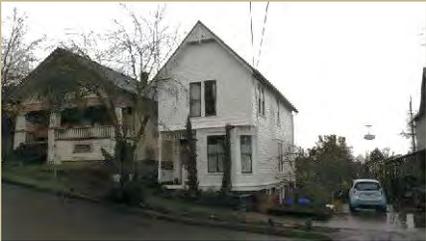
Project ID Survey # Acquisition	Resource Name Address & Assoc. Address Property ID Historic Name	Construction Date Resource Type Primary Style Primary Siding	NRHP Status	Integrity Comments / Notes	Photograph of Resource	Location
SW_22236 136 TCE	19 SW PENNOYER ST PORTLAND R140913910 Gundoph, Ferdinand, House #2	1884 Building Queen Anne Horizontal Board	Contributing Resource, South Portland Historic District (Listed in 1998)

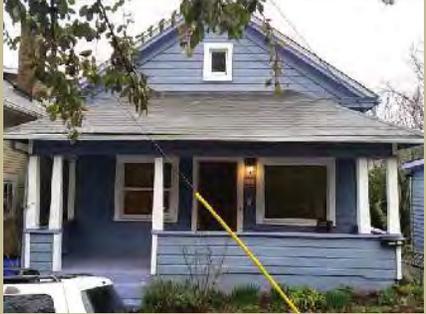
SW_19580 137 FULL	3522-3524 SW 1ST AVE PORTLAND R140913940 Thompson, D. P., House #1	1880 Building Colonial Revival Horizontal Board	Contributing Resource, South Portland Historic District (Listed in 1998)	All original windows have been replaced with vinyl sashes. A detached garage is non-contributing.

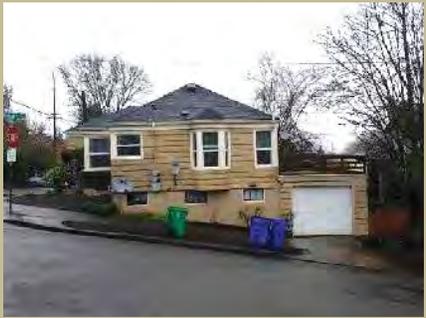
SW_14216 138 FULL	3538 SW BARBUR BLVD PORTLAND R140913920 Schappert, Theo W. and Leora E., House	1942 Building WWII Era Cottage Horizontal Board	Previously Documented as Not Eligible/Out of Period, South Portland Historic District (Listed in 1998); Recommended Not Eligible/Non-Contributing as an individual resource	Basement windows are original wood three light; all others are modern vinyl replacements. The house has no historical associations of significance under Criteria A through D that would qualify it for listing in the NRHP as an individual resource.

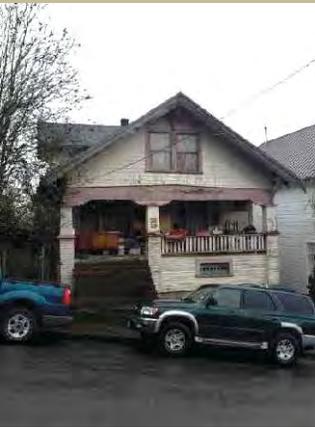
Project ID Survey # Acquisition	Resource Name Address & Assoc. Address Property ID Historic Name	Construction Date Resource Type Primary Style Primary Siding	NRHP Status	Integrity Comments / Notes	Photograph of Resource	Location
SW_13830 139 TCE	23 SW PENNOYER ST PORTLAND R140913930 Sussman, Osias, House	1914 Building Craftsman Horizontal Board	Contributing Resource, South Portland Historic District (Listed in 1998)

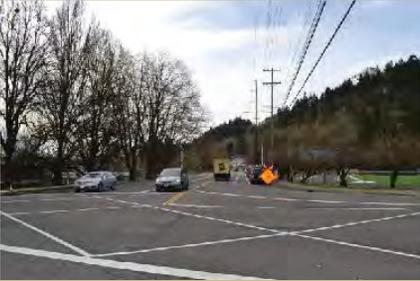
Barbur 140 NA	SW Barbur Boulevard Barbur Boulevard	1936 Structure Not Applicable Not Applicable	Recommended Not Eligible/Non-Contributing	This road resource has been extensively modified since its completion in 1936. Few associated features were identified within the project area; they include stairs at SW 5th and Barbur and a retaining wall between the road's intersections with SW Terwilliger Boulevard and SW Logan Street.

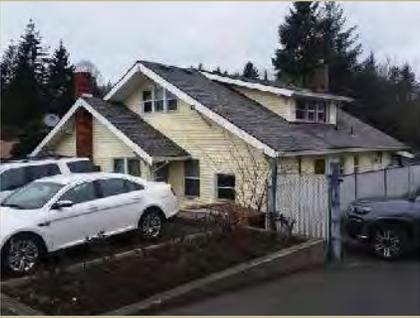
SW_11778 141 NO IMPACT	2524 SW SPRING GARDEN ST PORTLAND R524701570	1919 Building Craftsman Vinyl Siding	Recommended Not Eligible/Non-Contributing	Modifications to windows and siding diminish the house's historical integrity and its potential to be eligible for listing in the NRHP.

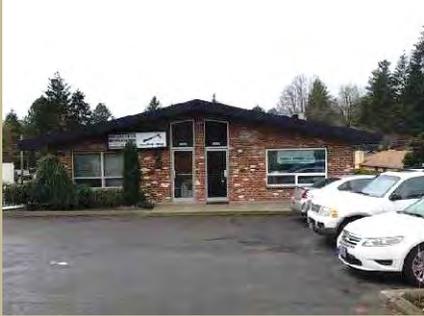
Project ID Survey # Acquisition	Resource Name Address & Assoc. Address Property ID Historic Name	Construction Date Resource Type Primary Style Primary Siding	NRHP Status	Integrity Comments / Notes	Photograph of Resource	Location
SW_253 142 PARTIAL	8565 SW BARBUR BLVD PORTLAND R524701530	1949 Building Other / Undefined Standard Brick	Recommended Not Eligible/Non-Contributing	Modifications to windows and siding diminish the building's historical integrity and its potential to be eligible for listing in the NRHP.

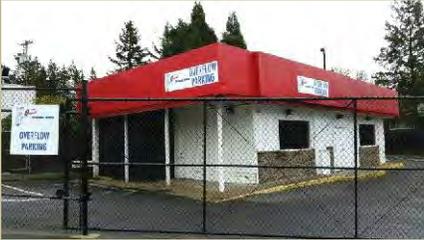
SW_11916 143 FULL	8604 SW BARBUR BLVD PORTLAND R524701500	1959 Building Commercial Vertical Board	Recommended Not Eligible/Non-Contributing	Building may be vacant; surrounding lot used as overflow parking for the adjacent Original Pancake House. The building has no historical associations of significance.

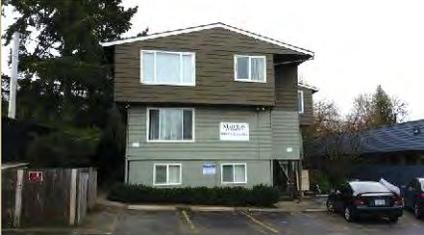
SW_15898 144 PARTIAL	8630 SW BARBUR BLVD PORTLAND R524701600	1967 Building Vernacular Horizontal Board	Recommended Not Eligible/Non-Contributing	Modifications to siding and windows diminish the building's historical integrity and its potential to be eligible for listing in the NRHP.

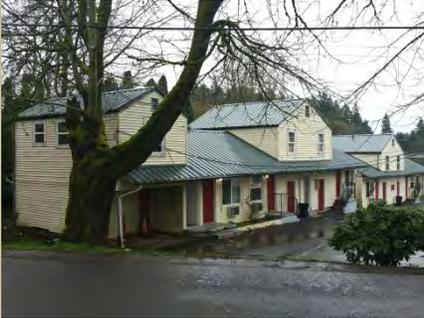
Project ID Survey # Acquisition	Resource Name Address & Assoc. Address Property ID Historic Name	Construction Date Resource Type Primary Style Primary Siding	NRHP Status	Integrity Comments / Notes	Photograph of Resource	Location
SW_15651 145 PARTIAL	Budget Lodge 8715 SW BARBUR BLVD PORTLAND R524701700 Frontier Motel	1945 Building Minimal Traditional Vinyl Siding	City of Portland HRI (1984 - No Rank); Recommended Not Eligible/Non-Contributing	Modifications to siding and windows; original roadside sign has been replaced. The building's diminished integrity limits its potential to be eligible for listing in the NRHP.

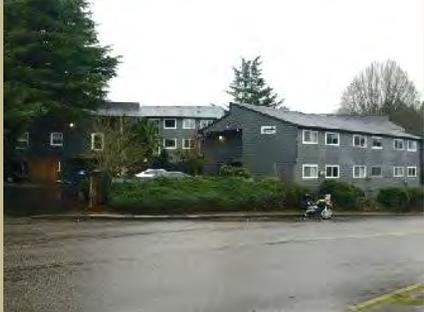
SW_12362 146 NO IMPACT	2720-2722 SW SPRING GARDEN ST PORTLAND R524701850	1943 Building Minimal Traditional Horizontal Board	Recommended Not Eligible/Non-Contributing	Apartment complex consisting of four buildings, several of which appear to have been constructed circa 1970s or later. Only one building, a duplex, appears to have been constructed in 1943. The apartment complex has no historical associations of significance that would qualify it as eligible for listing in the NRHP.

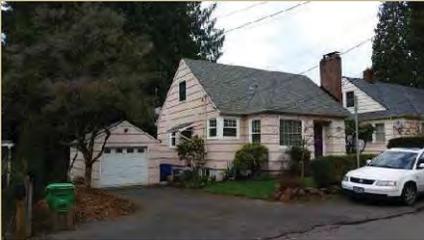
SW_398 147 NO IMPACT	7147 SW 5TH AVE PORTLAND R119103520	1942 Building Minimal Traditional Cedar Shake Shingle	Recommended Not Eligible/Non-Contributing	A detached garage is south of the house. Some original windows have been replaced with vinyl sashes. The building has no historical associations of significance that would qualify it as eligible for listing in the NRHP.

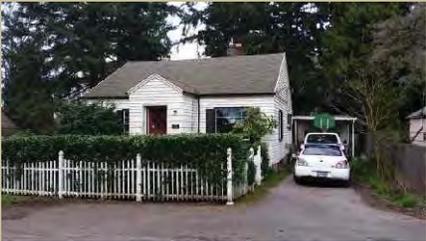
Project ID Survey # Acquisition	Resource Name Address & Assoc. Address Property ID Historic Name	Construction Date Resource Type Primary Style Primary Siding	NRHP Status	Integrity Comments / Notes	Photograph of Resource	Location
SW_19273 148 NO IMPACT	7159 SW 5TH AVE PORTLAND R119103610	1941 Building Minimal Traditional Horizontal Board	Recommended Not Eligible/Non-Contributing	Original windows have been replaced with vinyl sashes. A detached garage is situated northeast. The building has no historical associations of significance that would qualify it as eligible for listing in the NRHP.

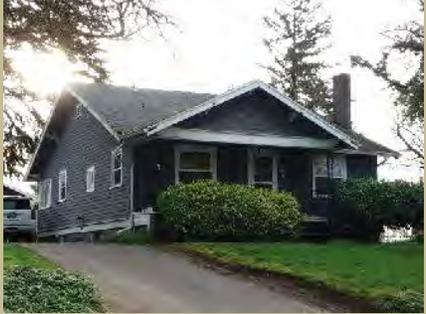
SW_21168 149 NO IMPACT	7152 SW 5TH AVE PORTLAND R300400690	1930 Building Craftsman Horizontal Board	Recommended Not Eligible/Non-Contributing	Porch and window modifications diminish the house's historical integrity and limit its eligibility for listing in the NRHP.

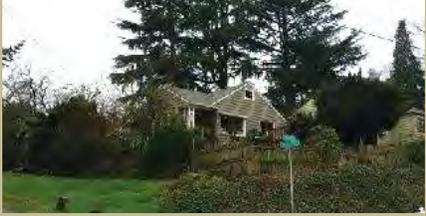
SW_15823 150 NO IMPACT	7159 SW 4TH AVE PORTLAND R300400800	1948 Building Minimal Traditional Horizontal Board	Recommended Not Eligible/Non-Contributing	Not a distinctive example of type, period, or method of construction. The building has no historical associations of significance that would qualify it as eligible for listing in the NRHP.

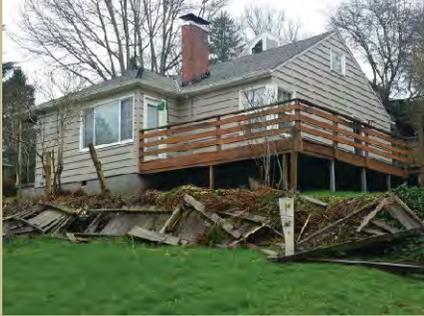
Project ID Survey # Acquisition	Resource Name Address & Assoc. Address Property ID Historic Name	Construction Date Resource Type Primary Style Primary Siding	NRHP Status	Integrity Comments / Notes	Photograph of Resource	Location
SW_16785 151 NO IMPACT	7158 SW 4TH AVE PORTLAND R300400810	1948 Building Minimal Traditional Horizontal Board	Recommended Not Eligible/Non-Contributing	Modifications to siding and windows; plan appears to have been modified after construction. The house's diminished historical integrity limits its potential to be eligible for listing in the NRHP.

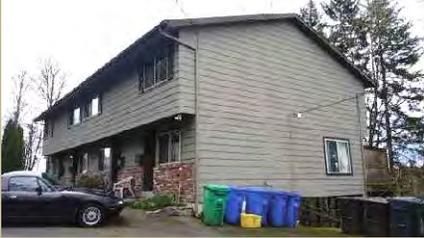
SW_532 152 NO IMPACT	940-946 SW CALDEW DR PORTLAND R119102990	1967 Building Neo-Colonial Horizontal Board	Recommended Not Eligible/Non-Contributing	The building has no historical associations of significance that would qualify it as eligible for listing in the NRHP.

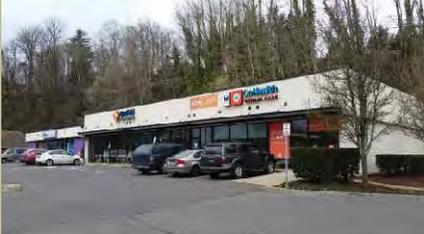
SW_18098 153 NO IMPACT	7461-7463 SW BARBUR BLVD PORTLAND R119103070	1970 Building Commercial Concrete Block	Recommended Not Eligible/Non-Contributing	The building has no historical associations of significance that would qualify it as eligible for listing in the NRHP.

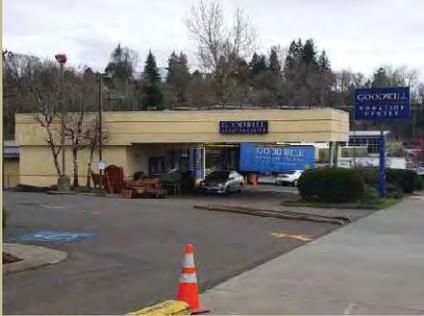
Project ID Survey # Acquisition	Resource Name Address & Assoc. Address Property ID Historic Name	Construction Date Resource Type Primary Style Primary Siding	NRHP Status	Integrity Comments / Notes	Photograph of Resource	Location
SW_9493 154 TCE	Goodwill Donation Center 7635 SW BARBUR BLVD PORTLAND R133902830	1954 Building Modern Period Other Stucco	Recommended Not Eligible/Non-Contributing	The building has no historical associations of significance that would qualify it as eligible for listing in the NRHP.

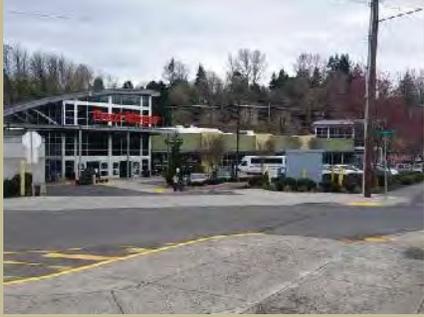
SW_6350 155 PARTIAL	Burlingame Fred Meyer 7529-7601 SW BARBUR BLVD PORTLAND R991210680	1951 Building Commercial Concrete Block	Recommended Not Eligible/Non-Contributing	Store was extensively remodeled in 2013, and no longer retains historical integrity. The store's original neon sign at SW Barbur Boulevard has been maintained, and was documented as a separate resource for the SW Corridor project. The building is recommended to be not eligible for listing in the NRHP due to its lack of historical integrity.

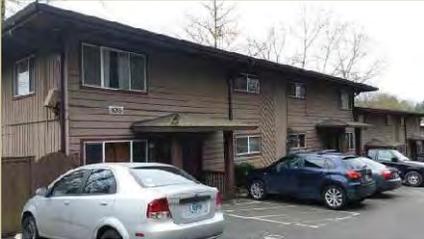
SW_878 156 NO IMPACT	Burlingame View Condominiums 1015 SW BERTHA BLVD PORTLAND R119480010	1961 Building Undefined Horizontal Board	Recommended Not Eligible/Non-Contributing	Apartments recently converted to condominiums. There are four separate buildings at this location, all of which are similarly constructed and finished. The complex has no historical associations of significance that would qualify it as eligible for listing in the NRHP.

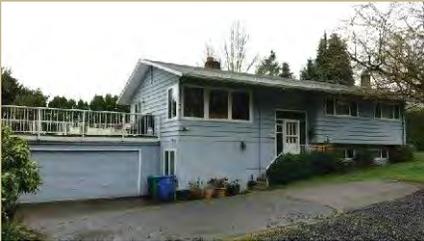
Project ID Survey # Acquisition	Resource Name Address & Assoc. Address Property ID Historic Name	Construction Date Resource Type Primary Style Primary Siding	NRHP Status	Integrity Comments / Notes	Photograph of Resource	Location
SW_1251 157 NO IMPACT	324 SW NEVADA CT PORTLAND R300401310	1960 Building Split Entry Horizontal Board	Recommended Not Eligible/Non-Contributing	Modifications to cladding and windows diminish the building's historical integrity and its potential to be eligible for listing in the NRHP.

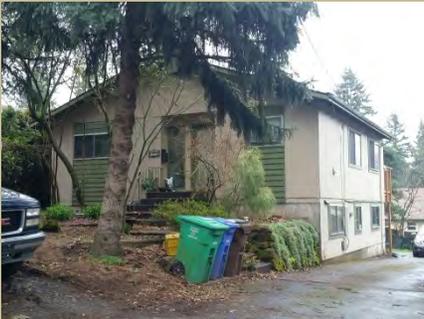
SW_17590 158 NO IMPACT	7222 SW 4TH AVE PORTLAND R300401300	1967 Building Vernacular Wood Sheet	Recommended Not Eligible/Non-Contributing	This building has good historical integrity but it is not a distinctive example of a type, period, or method of construction. The building has no historical associations of significance that would qualify it as eligible for listing in the NRHP.

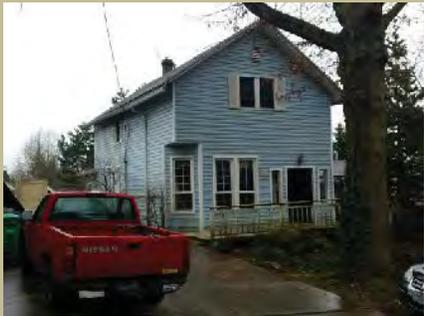
SW_1252 159 NO IMPACT	7228 SW 4TH AVE PORTLAND R300401290	1890 Building Victorian Era Vinyl Siding	Recommended Not Eligible/Non-Contributing	Modifications to windows and siding diminish the building's historical integrity and its potential to be eligible for listing in the NRHP.

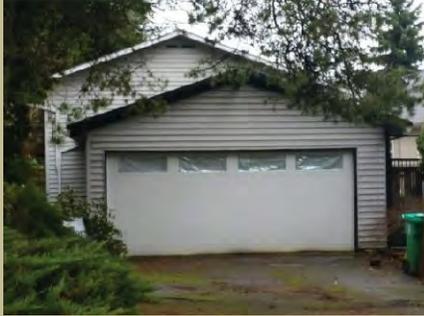
Project ID Survey # Acquisition	Resource Name Address & Assoc. Address Property ID Historic Name	Construction Date Resource Type Primary Style Primary Siding	NRHP Status	Integrity Comments / Notes	Photograph of Resource	Location
SW_3964 160 NO IMPACT	7306 SW 4TH AVE PORTLAND R300401270	1964 Building Vernacular Vinyl Siding	Recommended Not Eligible/Non-Contributing	The building has no historical associations of significance that would qualify it as eligible for listing in the NRHP.

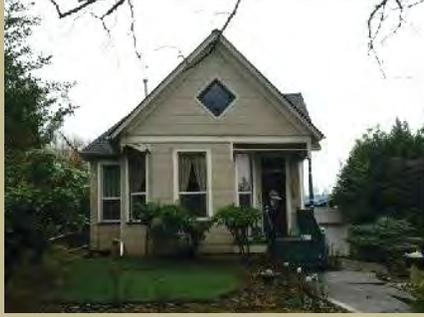
SW_21217 161 NO IMPACT	7312 SW 4TH AVE PORTLAND R300401260	1890 Building Queen Anne Cement Fiber Siding	Recommended Not Eligible/Non-Contributing	Modifications to siding and windows diminish the historical integrity of the building and its potential to be eligible for listing in the NRHP.

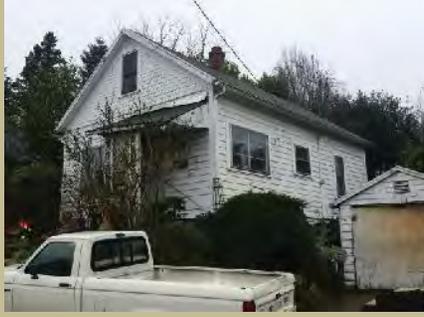
SW_12423 162 FULL	7331 SW BARBUR BLVD PORTLAND R300401250	1890 Building Queen Anne Horizontal Board	Recommended Not Eligible/Non-Contributing	Modifications to windows and the south facade porch diminish the historical integrity of the house and its potential to be eligible for listing in the NRHP. A detached garage is situated to the east.

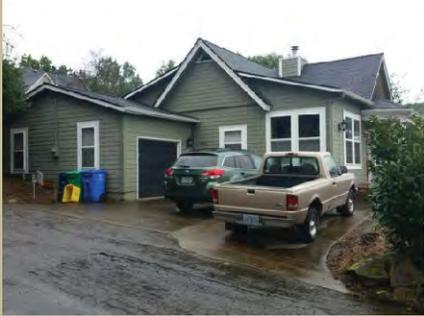
Project ID Survey # Acquisition	Resource Name Address & Assoc. Address Property ID Historic Name	Construction Date Resource Type Primary Style Primary Siding	NRHP Status	Integrity Comments / Notes	Photograph of Resource	Location
SW_20626 163 FULL	7318 SW 4TH AVE PORTLAND R300401240	1890 Building Vernacular Horizontal Board	Recommended Not Eligible/Non-Contributing	Modifications to plan, cladding, and fenestration diminish the historical integrity of the house and its potential to be eligible for listing in the NRHP.

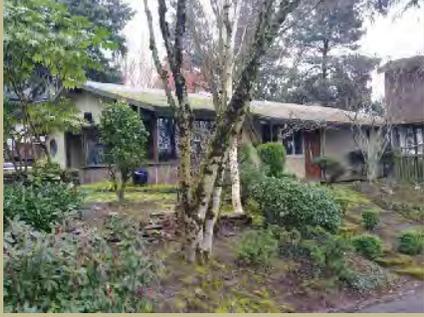
SW_3809 164 FULL	7341 SW BARBUR BLVD PORTLAND R300401520	1970 Building Ranch Vertical Board	Recommended Not Eligible/Non-Contributing	Siding and window modifications diminish the historical integrity of the house and its potential to be eligible for listing in the NRHP.

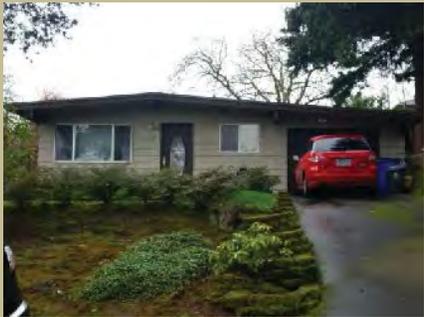
SW_3810 165 NO IMPACT	7323 SW 4TH AVE PORTLAND R300401510	1970 Building Modern Period Other Horizontal Board	Recommended Not Eligible/Non-Contributing	Original windows have been replaced with vinyl sashes, diminishing the historical integrity of the house and its potential to be eligible for listing in the NRHP.

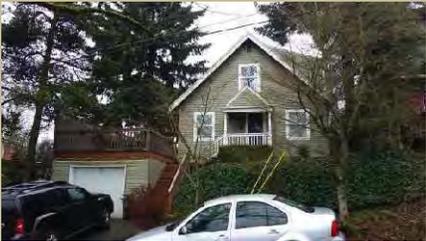
Project ID Survey # Acquisition	Resource Name Address & Assoc. Address Property ID Historic Name	Construction Date Resource Type Primary Style Primary Siding	NRHP Status	Integrity Comments / Notes	Photograph of Resource	Location
SW_12810 166 NO IMPACT	7311 SW 4TH AVE PORTLAND R300401500	1922 Building Vernacular Horizontal Board	Recommended Not Eligible/Non-Contributing	The windows and siding of the house are modern, and a large dormer has been added to the north elevation. The house's diminished historical integrity limits its potential to be eligible for listing in the NRHP. A detached garage is situated southeast of the house at street level.
