**Section 106 and 4(f) Public Documents
Supplemental Information: Potential Impacts and Mitigation
for Historic Properties and Public Parks
SW Corridor Light Rail Project
Draft – December 15th, 2020**

This technical memo details the potential SW Corridor Light Rail Project impacts to protected historic properties and parks resources, as well as the proposed mitigations. This memo is intended for public review and comment.

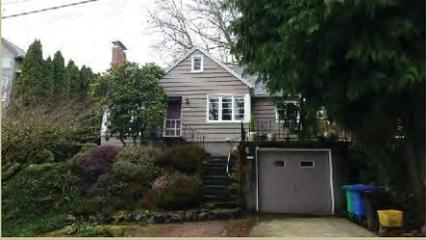
SW_18837 167 NO IMPACT	7225 SW 4TH AVE PORTLAND R300401480	1941 Building Minimal Traditional Horizontal Board	Recommended Eligible/Contributing	Good integrity. Distinctive example of a Tudor- inspired Minimal Traditional House. A street- level garage appears to be original.

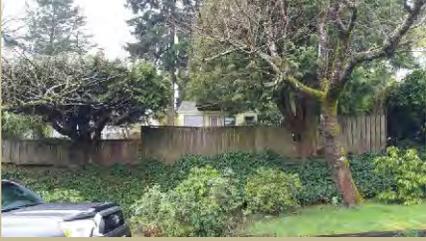
SW_9583 168 NO IMPACT	7207 SW 4TH AVE PORTLAND R300401460	1948 Building Minimal Traditional Horizontal Board	Recommended Not Eligible/Non-Contributing	The east facade porch is a modern addition to the house, which has no historical associations of significance under Criteria A through D.

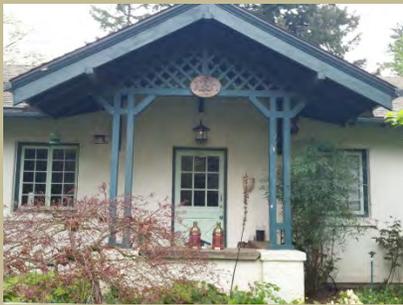
Project ID Survey # Acquisition	Resource Name Address & Assoc. Address Property ID Historic Name	Construction Date Resource Type Primary Style Primary Siding	NRHP Status	Integrity Comments / Notes	Photograph of Resource	Location
SW_1078 169 NO IMPACT	7204 SW 5TH AVE PORTLAND R300401450	1922 Building Bungalow Stucco	Recommended Not Eligible/Non-Contributing	East facade porch appears to be of modern construction and diminishes the historical appearance and integrity of the house. The house has no historical associations of significance under Criteria A through D.

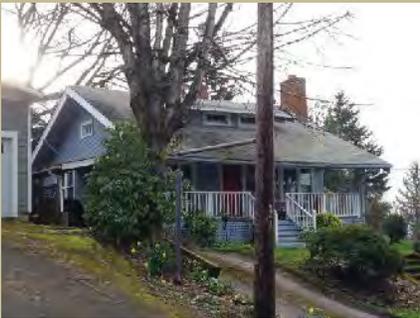
SW_11695 170 NO IMPACT	7224 SW 5TH AVE PORTLAND R300401420	1919 Building Craftsman Horizontal Board	Recommended Not Eligible/Non-Contributing	Vinyl windows and porch modifications diminish the house's historical integrity and its potential to be eligible for listing in the NRHP.

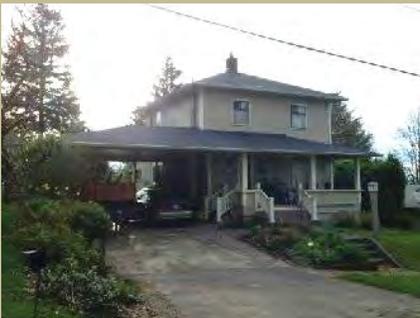
SW_16939 171 NO IMPACT	7312 SW 5TH AVE PORTLAND R300401400	1900 Building Foursquare Cement Fiber Siding	Recommended Not Eligible/Non-Contributing	Large carport addition to north elevation; window and siding modifications were also observed. This diminished historical integrity limits the house's potential to be eligible for listing in the NRHP.

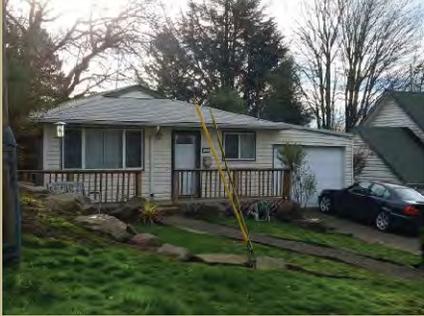
Project ID Survey # Acquisition	Resource Name Address & Assoc. Address Property ID Historic Name	Construction Date Resource Type Primary Style Primary Siding	NRHP Status	Integrity Comments / Notes	Photograph of Resource	Location
SW_7875 172 NO IMPACT	7320 SW 5TH AVE PORTLAND R300401390	1970 Building Vernacular Vinyl Siding	Recommended Not Eligible/Non-Contributing	Original siding and windows have been replaced with vinyl, diminishing the house's historical integrity and its potential to be eligible for listing in the NRHP.

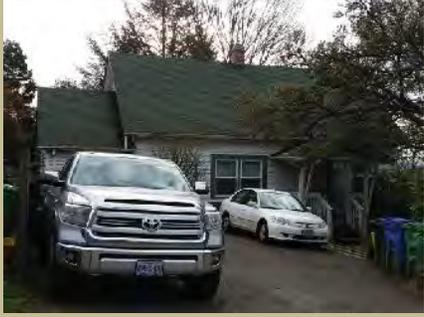
SW_1546 173 FULL	7326 SW 5TH AVE PORTLAND R300401380	1890 Building Vernacular Vinyl Siding	Recommended Not Eligible/Non-Contributing	Modifications to the siding and windows diminish the house's historical integrity and its potential to be eligible for listing in the NRHP. West-facing entry may represent a historic-period change to the house's original plan.

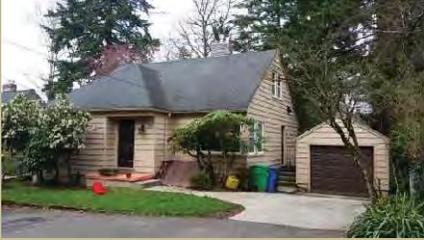
SW_6507 174 NO IMPACT	7207 SW 5TH AVE PORTLAND R119103620	1943 Building Minimal Traditional Horizontal Board	Recommended Not Eligible/Non-Contributing	Most all original windows have been replaced with vinyl sashes, diminishing the house's historical integrity and its potential to be eligible for listing in the NRHP. A detached garage is situated north of the house.

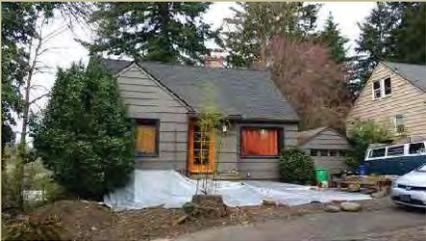
Project ID Survey # Acquisition	Resource Name Address & Assoc. Address Property ID Historic Name	Construction Date Resource Type Primary Style Primary Siding	NRHP Status	Integrity Comments / Notes	Photograph of Resource	Location
SW_1614 175 NO IMPACT	7227 SW 5TH AVE PORTLAND R119103490	1943 Building Minimal Traditional Cedar Shake Shingle	Recommended Not Eligible/Non-Contributing	This house is not a distinctive example of a type, period, or method of construction, and it has no historical associations of significance under Criteria A through D. A detached garage is situated north of the house.

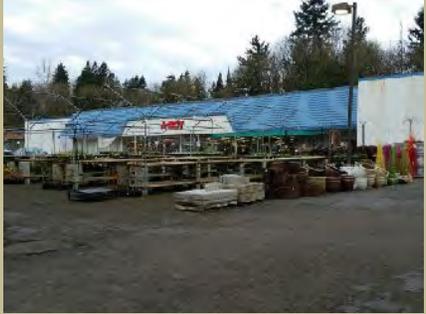
SW_20889 176 PARTIAL	7365-7375 SW BARBUR BLVD PORTLAND R119103430	1963 Building Modern Commercial Concrete Block	Recommended Not Eligible/Non-Contributing	The building does not have a historical association of significance under Criteria A through D.

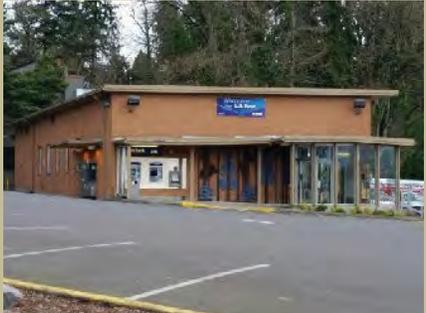
SW_13715 177 PARTIAL	7300 SW TERWILLIGER BLVD PORTLAND R119103250	1963 Building Modern Commercial Standard Brick	Recommended Not Eligible/Non-Contributing	Good integrity. However, this building is not a distinctive example of a type, period, or method of construction, nor does it have a historical association of significance under Criteria A through D.

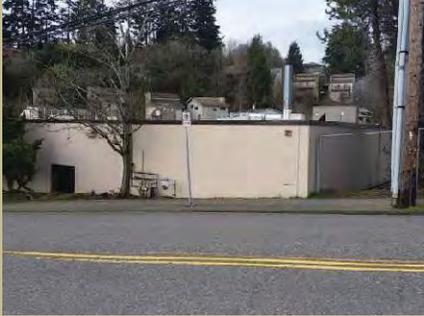
Project ID Survey # Acquisition	Resource Name Address & Assoc. Address Property ID Historic Name	Construction Date Resource Type Primary Style Primary Siding	NRHP Status	Integrity Comments / Notes	Photograph of Resource	Location
SW_13325 178 PARTIAL	1325-1341 SW CUSTER DR PORTLAND R991212060	1963 Building Modern Commercial Concrete Panels	Recommended Not Eligible/Non-Contributing	The building does not have a historical association of significance under Criteria A through D.

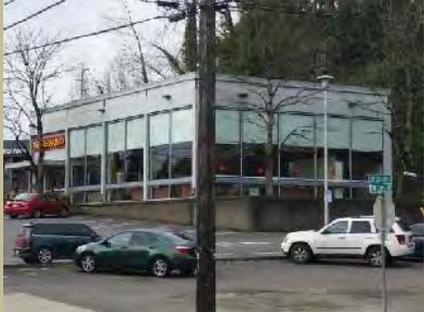
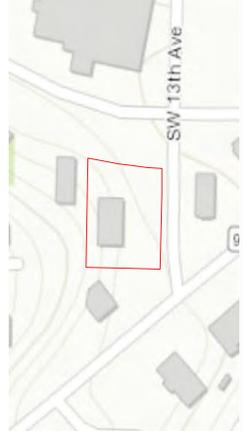
SW_6012 179 NO IMPACT	Wells Fargo 7615 SW 13TH AVE PORTLAND R133902920	1964 Building Modern Commercial Concrete Other / Undefined	Recommended Not Eligible/Non-Contributing	The building does not have a historical association of significance under Criteria A through D.

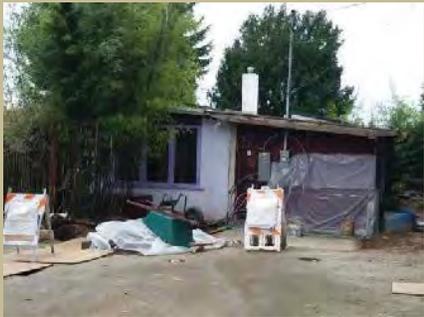
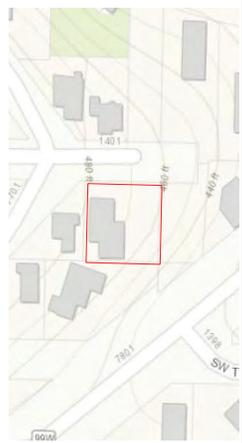
SW_21186 180 NO IMPACT	1400 SW CANBY ST PORTLAND R133902590	1950 Building Other / Undefined Wood Sheet	Recommended Not Eligible/Non-Contributing	Building was being remodeled at the time of survey, and does not have a historical association of significance under Criteria A through D.

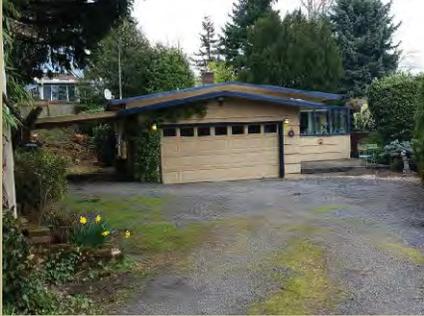
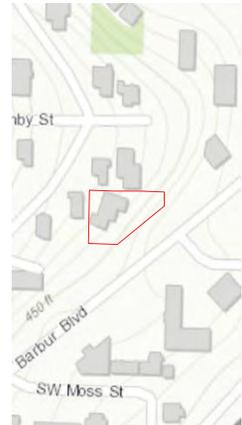
Project ID Survey # Acquisition	Resource Name Address & Assoc. Address Property ID Historic Name	Construction Date Resource Type Primary Style Primary Siding	NRHP Status	Integrity Comments / Notes	Photograph of Resource	Location
SW_401 181 NO IMPACT	1423 SW TROY ST PORTLAND R133902760	1949 Building Vernacular Cedar Shake Shingle	Recommended Not Eligible/Non-Contributing	The building does not have a historical association of significance under Criteria A through D.

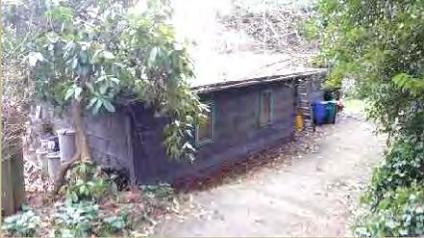
SW_13839 182 NO IMPACT	7726 SW 17TH DR PORTLAND R133902770	1948 Building Ranch Cedar Shake Shingle	Recommended Not Eligible/Non-Contributing	The building does not have a historical association of significance under Criteria A through D. One associated outbuilding was observed on the parcel.

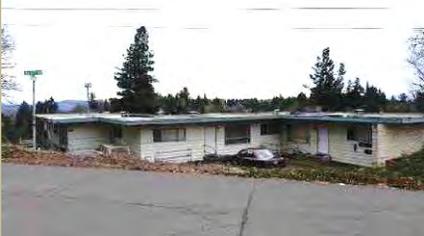
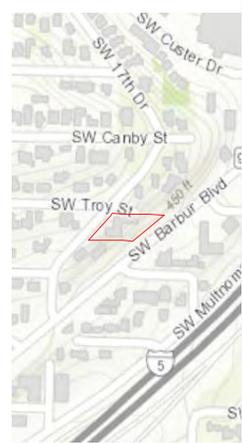
SW_13281 183 NO IMPACT	7802 SW 17TH DR PORTLAND R133902310	1963 Building Modern Period Other Horizontal Board	Recommended Not Eligible/Non-Contributing	Some original windows and doors have been replaced. The building is in poor condition, but retains fair historical integrity. The building does not have a historical association of significance under Criteria A through D.

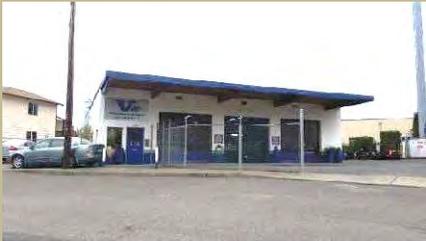
Project ID Survey # Acquisition	Resource Name Address & Assoc. Address Property ID Historic Name	Construction Date Resource Type Primary Style Primary Siding	NRHP Status	Integrity Comments / Notes	Photograph of Resource	Location
SW_15736 184 FULL	1330 SW TROY ST PORTLAND R133902400	1968 Building Modern Commercial Concrete Block	Recommended Not Eligible/Non-Contributing	The building does not have a historical association of significance under Criteria A through D.

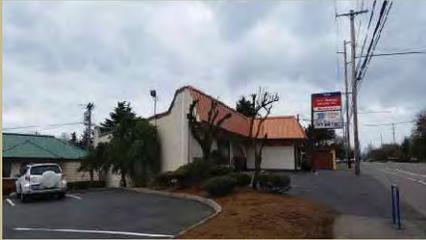
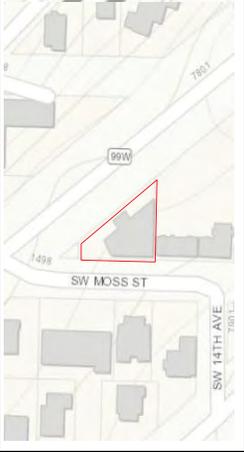
SW_9848 185 FULL	7850 SW BARBUR BLVD PORTLAND R133902480	1951 Building Commercial Vertical Board	Recommended Not Eligible/Non-Contributing	The building does not have a historical association of significance under Criteria A through D.

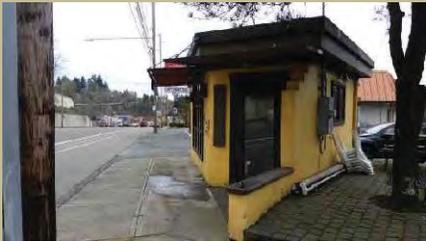
SW_9849 186 FULL	7900 SW BARBUR BLVD PORTLAND R133902500	1952 Building Commercial Stucco	Recommended Not Eligible/Non-Contributing	The building does not have a historical association of significance under Criteria A through D.

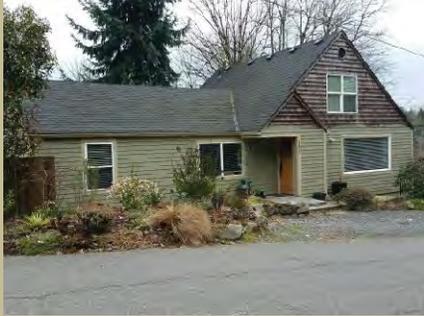
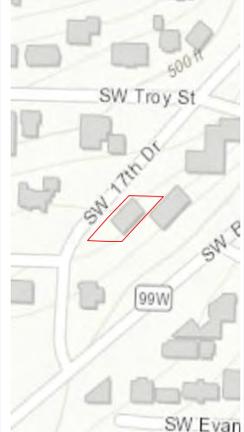
Project ID Survey # Acquisition	Resource Name Address & Assoc. Address Property ID Historic Name	Construction Date Resource Type Primary Style Primary Siding	NRHP Status	Integrity Comments / Notes	Photograph of Resource	Location
SW_1673 187 NO IMPACT	7830 SW 17TH DR PORTLAND R133902540	1945 Building Tudor Revival Vinyl Siding	Recommended Not Eligible/Non-Contributing	Modifications to plan, cladding, and windows diminish the house's historical integrity and its potential to be eligible for listing in the NRHP.

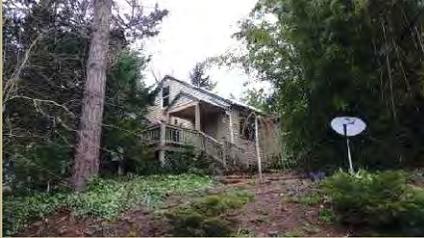
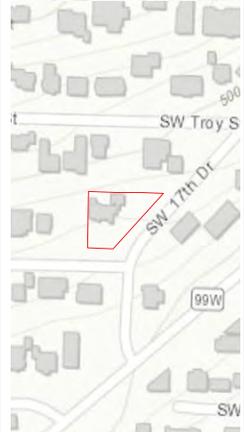
SW_1269 188 NO IMPACT	1703 SW MOSS ST PORTLAND R133901820	1932 Building Vernacular Horizontal Board	Recommended Not Eligible/Non-Contributing	Most all original windows have been replaced with vinyl sashes, diminishing the house's historical integrity and its potential to be eligible for listing in the NRHP. A detached garage is situated north of the house.

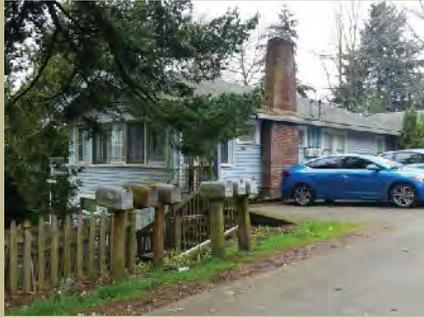
SW_4140 189 NO IMPACT	1718 SW MOSS ST PORTLAND R133902000	1920 Building Craftsman Horizontal Board	Recommended Not Eligible/Non-Contributing	Some original windows replaced; converted for multi-family use. Not a distinctive example of a type, period, or method of construction, nor does it have significant historical associations under Criteria A through D.

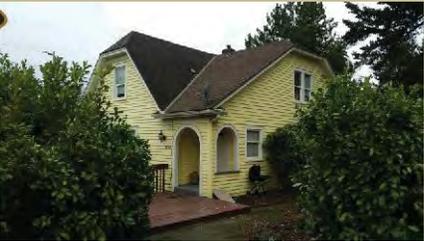
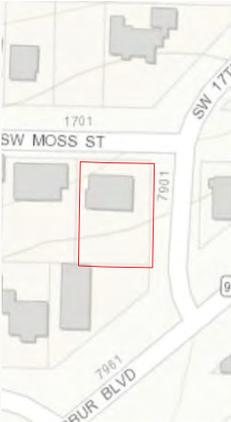
Project ID Survey # Acquisition	Resource Name Address & Assoc. Address Property ID Historic Name	Construction Date Resource Type Primary Style Primary Siding	NRHP Status	Integrity Comments / Notes	Photograph of Resource	Location
SW_12645 190 PARTIAL	1704 SW MOSS ST PORTLAND R133902020	1926 Building Tudor Revival Horizontal Board	Recommended Not Eligible/Non-Contributing	Most all original windows have been replaced with vinyl sashes, diminishing the house's historical integrity and its potential to be eligible for listing in the NRHP. The house has been converted for multi-family use, and has no historical associations of significance under Criteria A through C.

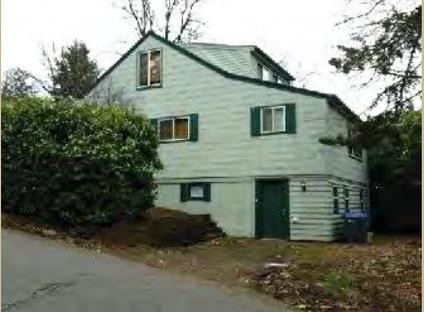
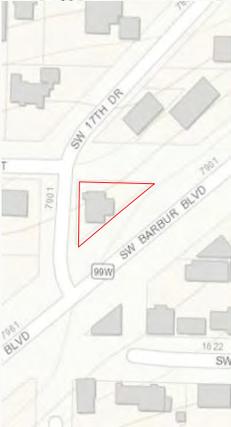
SW_12341 191 FULL	7910 SW 17TH AVE PORTLAND R133902120	1921 Building Tudor Revival Horizontal Board	Recommended Not Eligible/Non-Contributing	Original windows have been replaced with vinyl and aluminum sashes, diminishing the house's historical integrity and its potential to be eligible for listing in the NRHP.

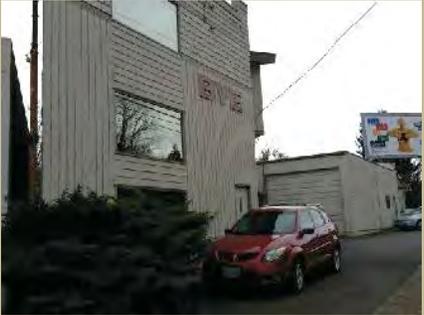
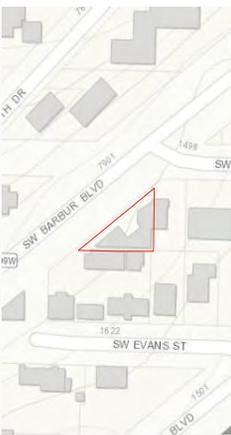
SW_2758 192 FULL	7914 SW BARBUR BLVD PORTLAND R133902140	1952 Building Other / Undefined Vertical Board	Recommended Not Eligible/Non-Contributing	Three-part commercial building; northeast section is two stories and features crenellation, central section has a false front, and southwest section has a flat roof. The building appears to have been modified circa 1970s. It has no historical associations of significance under Criteria A through D.

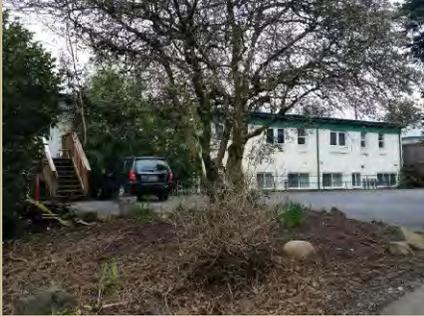
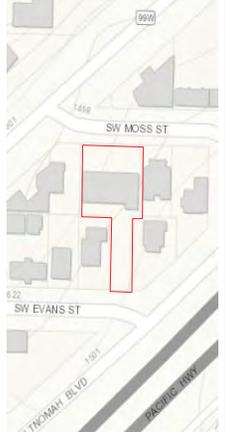
Project ID Survey # Acquisition	Resource Name Address & Assoc. Address Property ID Historic Name	Construction Date Resource Type Primary Style Primary Siding	NRHP Status	Integrity Comments / Notes	Photograph of Resource	Location
SW_8132 193 PARTIAL	1430 SW MOSS ST PORTLAND R133902170	1941 Building Vernacular Standard Brick	Recommended Not Eligible/Non-Contributing	All original windows have been replaced with vinyl sashes of various configurations, diminishing the building's historical integrity and its potential to be eligible for listing in the NRHP.

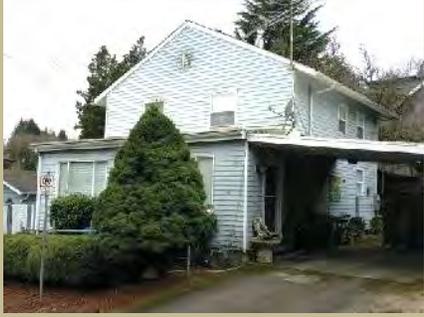
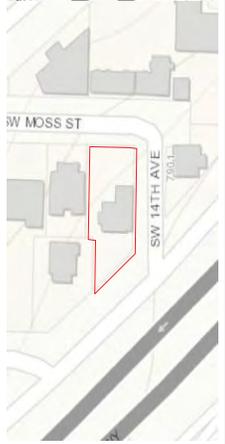
SW_4393 194 NO IMPACT	7917 SW 14TH AVE PORTLAND R133902210	1908 Building Vernacular Vinyl Siding	Recommended Not Eligible/Non-Contributing	Vinyl siding, vinyl windows, and porch modifications diminish the house's historical integrity and its potential to be eligible for listing in the NRHP.

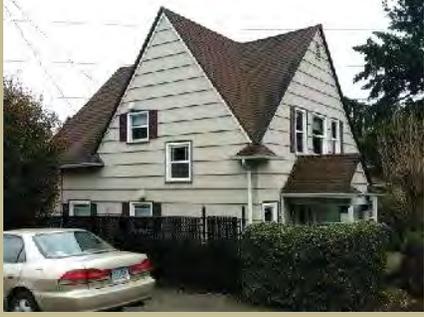
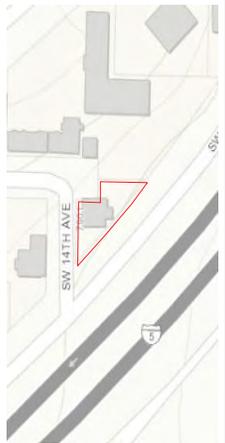
SW_8363 195 NO IMPACT	7904 SW 14TH AVE PORTLAND R133902220	1926 Building Tudor Revival Cedar Rake Shingle	Recommended Not Eligible/Non-Contributing	All original windows have been replaced with vinyl sashes, diminishing the house's historical integrity and its potential to be eligible for listing in the NRHP.

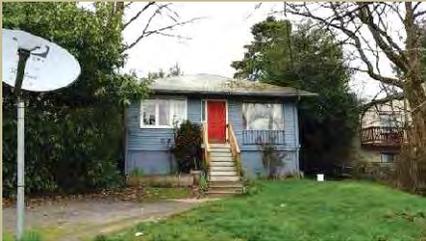
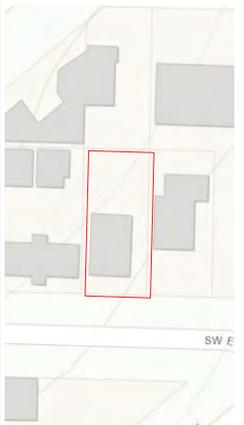
Project ID Survey # Acquisition	Resource Name Address & Assoc. Address Property ID Historic Name	Construction Date Resource Type Primary Style Primary Siding	NRHP Status	Integrity Comments / Notes	Photograph of Resource	Location
SW_4000 196 NO IMPACT	1513 SW EVANS ST PORTLAND R133902260	1915 Building Vernacular Horizontal Board	Recommended Not Eligible/Non-Contributing	Modifications to windows and siding, in addition to possible porch modifications diminish the house's historical integrity and its potential to be eligible for listing in the NRHP.

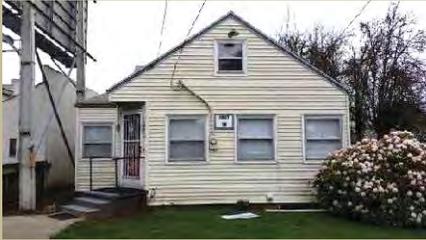
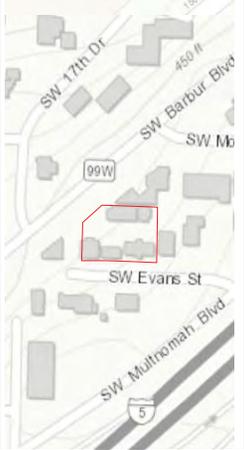
SW_1175 197 PARTIAL	7934 SW BARBUR BLVD PORTLAND R133902270	1942 Building Minimal Traditional Vinyl Siding	Recommended Not Eligible/Non-Contributing	Several homes and one duplex that represent a mixture of historic and modern construction episodes. Currently used as rental housing. The complex has no historical associations of significance under Criteria A through D.

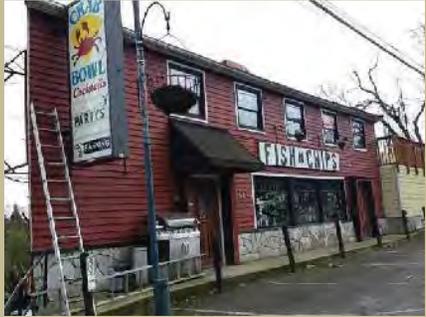
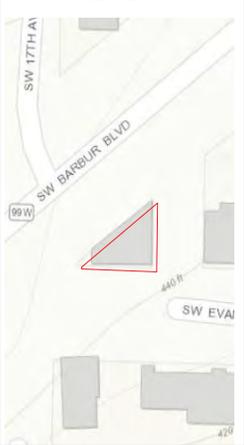
SW_13968 198 FULL	7958 SW BARBUR BLVD PORTLAND R133902300	1937 Building Commercial Horizontal Board	Recommended Not Eligible/Non-Contributing	Modifications to plan, windows, and siding diminish the building's historical integrity and its potential to be eligible for listing in the NRHP.

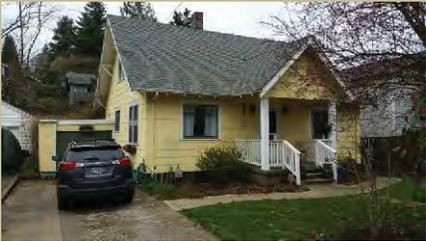
Project ID Survey # Acquisition	Resource Name Address & Assoc. Address Property ID Historic Name	Construction Date Resource Type Primary Style Primary Siding	NRHP Status	Integrity Comments / Notes	Photograph of Resource	Location
SW_18515 199 PARTIAL	1727 SW EVANS ST PORTLAND R133902050	1928 Building Craftsman Cement Fiber Siding	Recommended Not Eligible/Non-Contributing	Not a distinctive example of a type, period, or method of construction, nor does the house have significant historical associations under Criteria A through D.

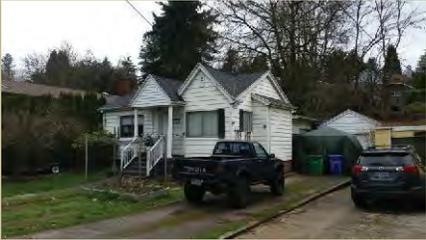
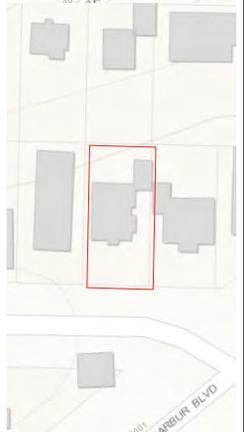
SW_18304 200 PARTIAL	1739 SW EVANS ST PORTLAND R133902060	1928 Building Minimal Traditional Aluminum	Recommended Not Eligible/Non-Contributing	The building does not have significant historical associations under Criteria A through D. A detached garage is situated east of the house.

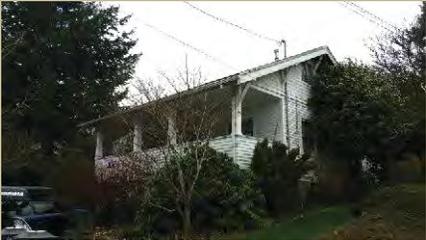
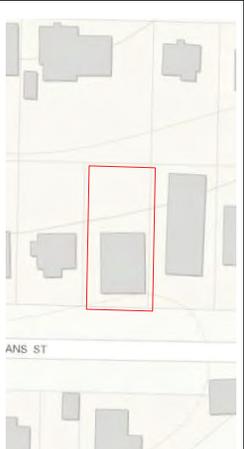
SW_5397 201 TCE	1801 SW EVANS ST PORTLAND R133902080	1922 Building Craftsman Horizontal Board	Recommended Eligible/Contributing	One aluminum window was observed in the upper half story of the east elevation; otherwise, the house retains its historical appearance. Within its local context the house is a good example of its type and period of construction.

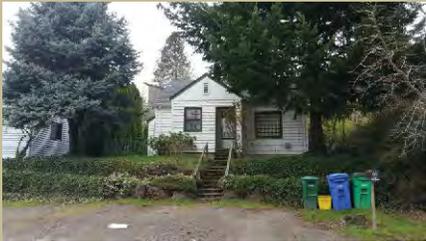
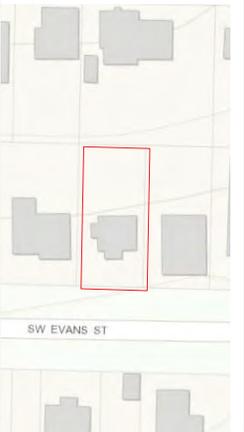
Project ID Survey # Acquisition	Resource Name Address & Assoc. Address Property ID Historic Name	Construction Date Resource Type Primary Style Primary Siding	NRHP Status	Integrity Comments / Notes	Photograph of Resource	Location
SW_5279 202 NO IMPACT	1825 SW EVANS ST PORTLAND R133902090	1940 Building Minimal Traditional Horizontal Board	Recommended Not Eligible/Non-Contributing	Not a distinctive example of a type, period, or method of construction, nor does the house have significant historical associations under Criteria A through D.

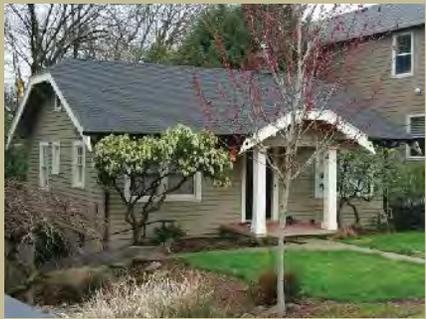
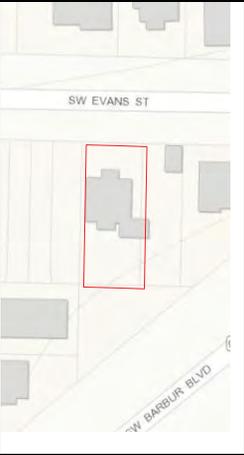
SW_17608 203 PARTIAL	1824 SW EVANS ST PORTLAND R133904040	1926 Building Craftsman Horizontal Board	Recommended Not Eligible/Non-Contributing	Siding appears to be a modern replacement; bargeboard also looks modern. This house has fair historical integrity, but it is not a distinctive example of its type, period, or method of construction, nor does the house have significant historical associations under Criteria A through D.

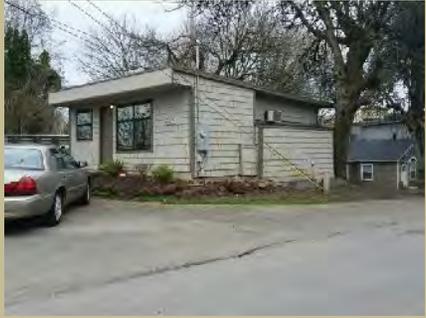
SW_9040 204 FULL	8005 SW BARBUR BLVD PORTLAND R133904010	1951 Building Vernacular Shingle	Recommended Not Eligible/Non-Contributing	Fenestration has been modified. The building has no historical associations of significance under Criteria A through D. A modern shed was also observed on this land parcel.

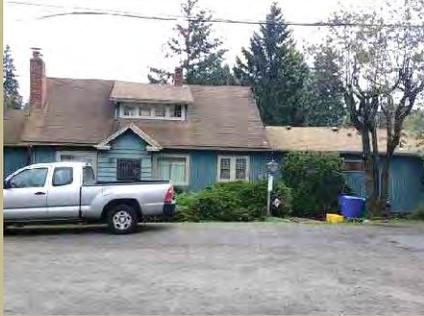
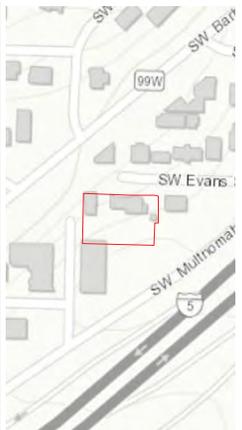
Project ID Survey # Acquisition	Resource Name Address & Assoc. Address Property ID Historic Name	Construction Date Resource Type Primary Style Primary Siding	NRHP Status	Integrity Comments / Notes	Photograph of Resource	Location
SW_2987 205 TCE	1624 SW EVANS ST PORTLAND R133903850	1928 Building Colonial Revival Vertical Board	Recommended Not Eligible/Non-Contributing	Modifications to plan and siding diminish the house's historical integrity and its potential to be eligible for listing in the NRHP.

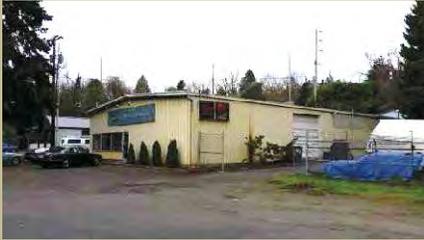
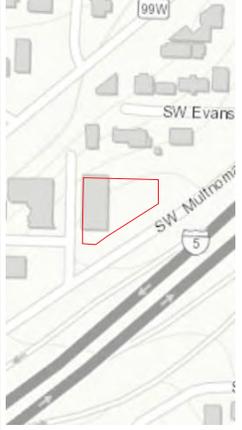
SW_2988 206 TCE	1641 SW MULTNOMAH BLVD PORTLAND R133903890	1970 Building Modern Period Other Metal Other / Undefined	Recommended Not Eligible/Non-Contributing	Not distinctive of a type, period, or method of construction, nor does the building have significant historical associations under Criteria A through D.

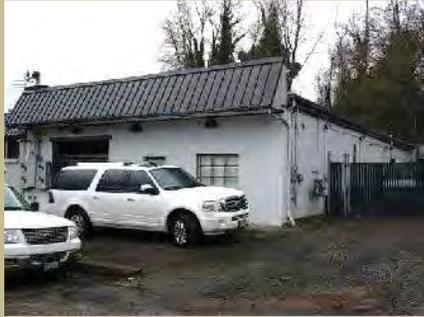
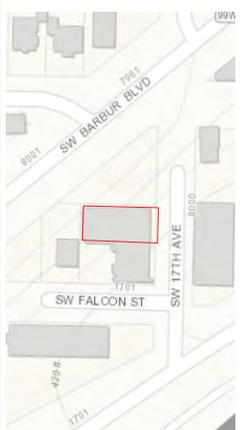
SW_21431 207 PARTIAL	8029 SW 17TH AVE PORTLAND R133904190	1955 Building Utilitarian Concrete Block	Recommended Not Eligible/Non-Contributing	Fenestration has been modified. Was likely constructed in association with building to immediate south (8037 SW 17th Avenue). The building has no significant historical associations under Criteria A through D.

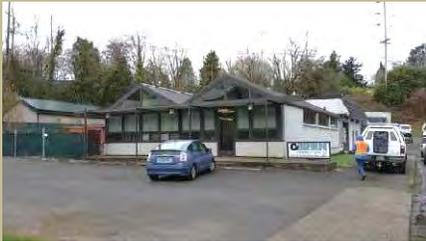
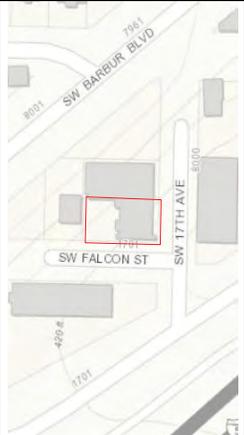
Project ID Survey # Acquisition	Resource Name Address & Assoc. Address Property ID Historic Name	Construction Date Resource Type Primary Style Primary Siding	NRHP Status	Integrity Comments / Notes	Photograph of Resource	Location
SW_21432 208 PARTIAL	8037 SW 17TH AVE PORTLAND R133904200	1955 Building Commercial Concrete Block	Recommended Not Eligible/Non-Contributing	Modifications to fenestration. Was likely constructed in association with adjacent building to north (8029 SW 17th Avenue). The building has no historical associations of significance under Criteria A through D.

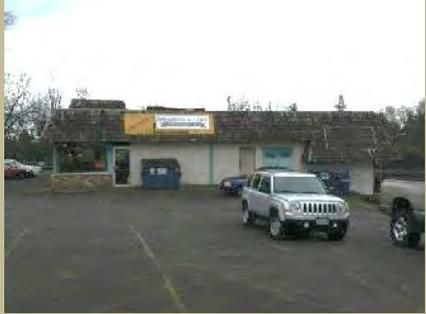
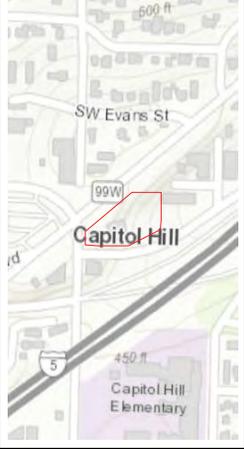
SW_6672 209 PARTIAL	Golden Touch Family Restaurant 8124 SW BARBUR BLVD PORTLAND R133904340	1970 Building Modern Commercial Stucco	Recommended Not Eligible/Non-Contributing	Not a distinctive example of a type, period, or method of construction, nor does the building have significant historical associations under Criteria A through D.

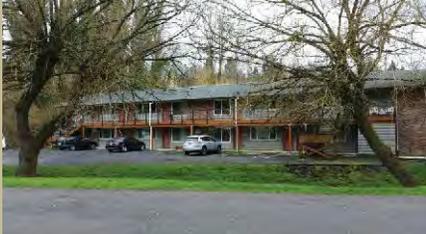
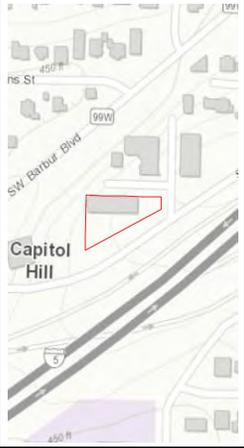
SW_56 210 NO IMPACT	1725 SW MULTNOMAH BLVD PORTLAND R133904210	1968 Building Vernacular Horizontal Board	Recommended Not Eligible/Non-Contributing	All original windows have been replaced with vinyl sliding sashes; stairs and balcony are modern. The building's diminished historical integrity limits its potential to be eligible for listing in the NRHP.

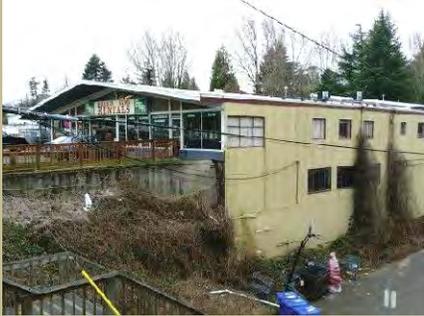
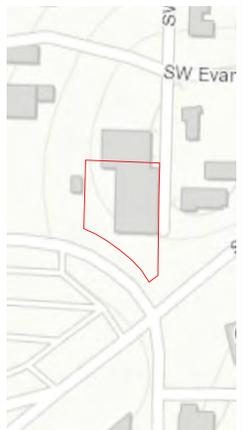
Project ID Survey # Acquisition	Resource Name Address & Assoc. Address Property ID Historic Name	Construction Date Resource Type Primary Style Primary Siding	NRHP Status	Integrity Comments / Notes	Photograph of Resource	Location
SW_5352 211 PARTIAL	8201-8205 SW BARBUR BLVD PORTLAND R991210910	1959 Building Modern Commercial Brick Other / Undefined	Recommended Not Eligible/Non-Contributing	Large addition to north elevation that extends onto a neighboring tax parcel (R330154). The building has no historical associations of significance under Criteria A through D.

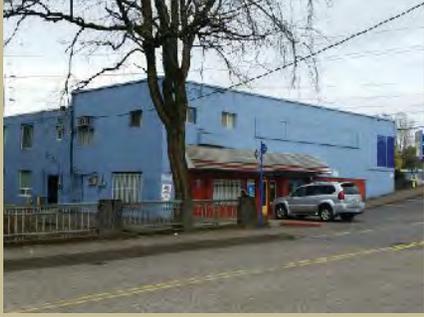
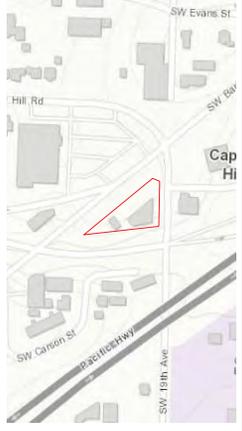
SW_20293 212 FULL	8200-8224 SW BARBUR BLVD PORTLAND R991210340	1951 Building Commercial Poured Concrete	Recommended Not Eligible/Non-Contributing	"Edwards 1953" imprint was observed on the second story at the southeast corner of the building. A secondary building constructed of concrete block is located to the west; it is currently operated as a small restaurant. The building has no historical associations of significance under Criteria A through D.

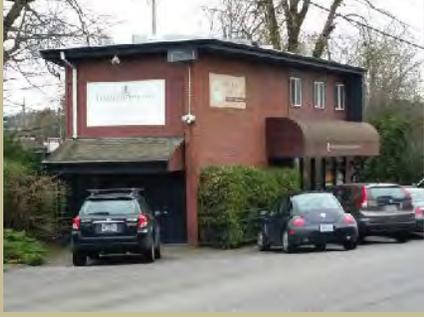
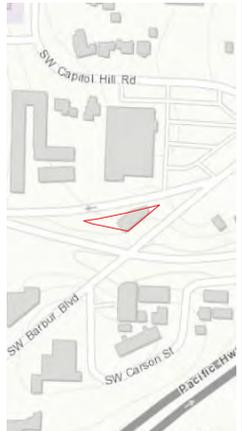
SW_7405 213 FULL	8283 SW BARBUR BLVD PORTLAND R991211080	1951 Building Commercial Vertical Board	Recommended Not Eligible/Non-Contributing	The building has no historical associations of significance under Criteria A through D.

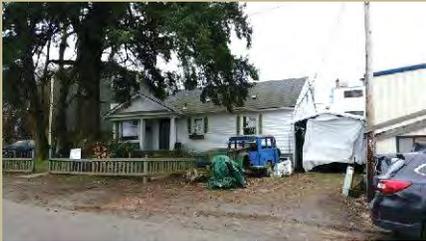
Project ID Survey # Acquisition	Resource Name Address & Assoc. Address Property ID Historic Name	Construction Date Resource Type Primary Style Primary Siding	NRHP Status	Integrity Comments / Notes	Photograph of Resource	Location
SW_22202 214 NO IMPACT	8321 SW 20TH AVE PORTLAND R012801600	1926 Building Colonial Revival Horizontal Board	Recommended Not Eligible/Non-Contributing	The north portion of the house appears to have been constructed as an addition, circa 1940. At least one outbuilding is situated west of the house but was not visible at the time of survey; modern temporary shelters are situated along the driveway north and west of the house. Integrity of setting has been diminished. The building has no historical associations of significance under Criteria A through D.

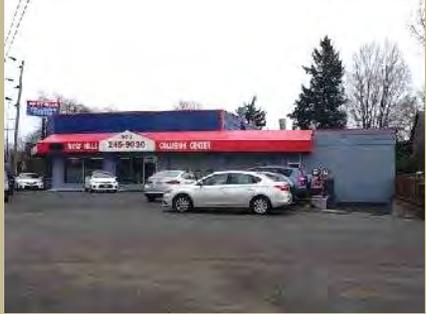
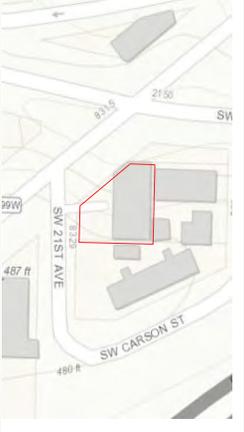
SW_162 215 FULL	8300 SW BARBUR BLVD PORTLAND R012801630	1947 Building Commercial Poured Concrete	Recommended Not Eligible/Non-Contributing	Abstract column motifs frame windows and doors; most original windows have been replaced. The building has no significant historical associations under Criteria A through D.

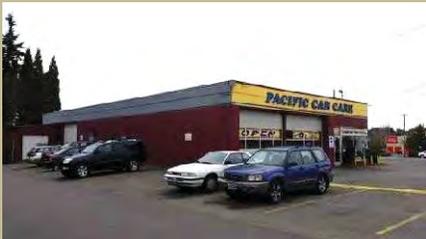
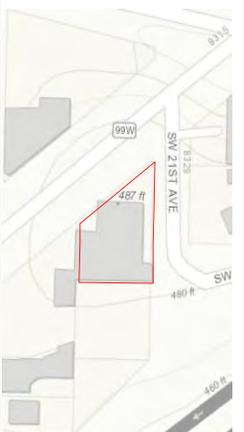
SW_165 216 FULL	8350 SW BARBUR BLVD PORTLAND R012801280	1939 Building Commercial Stucco	Recommended Not Eligible/Non-Contributing	Modifications to fenestration diminish the building's historical integrity and its potential to be eligible for listing in the NRHP.

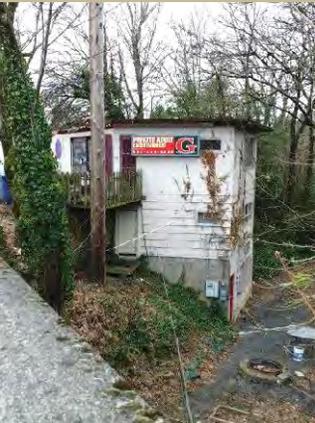
Project ID Survey # Acquisition	Resource Name Address & Assoc. Address Property ID Historic Name	Construction Date Resource Type Primary Style Primary Siding	NRHP Status	Integrity Comments / Notes	Photograph of Resource	Location
SW_3748 217 FULL	8315 SW BARBUR BLVD PORTLAND R012801460	1952 Building Modern Commercial Vertical Board	Recommended Not Eligible/Non-Contributing	Not a distinctive example of a type, period, or method of construction, nor does it have significant historical associations under Criteria A through D.

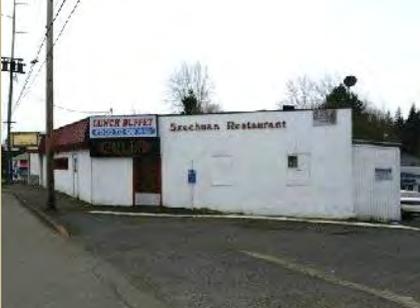
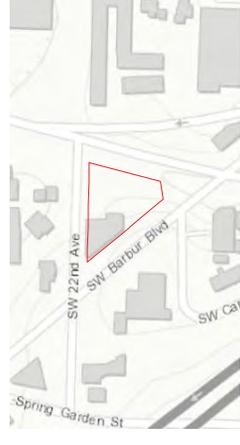
SW_15317 218 FULL	8343 SW BARBUR BLVD PORTLAND R012801320	1935 Building Other/Undefined Vertical Board	Recommended Not Eligible/Non-Contributing	Modifications to fenestration and cladding diminish the building's historical integrity and its potential to be eligible for listing in the NRHP. The building is constructed of poured concrete.

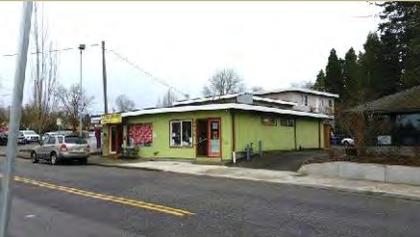
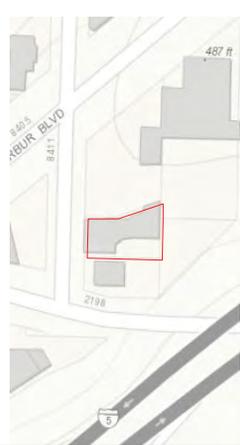
SW_13970 219 NO IMPACT	8424 SW 22ND AVE PORTLAND R012801430	1947 Building Vernacular Vertical Board	Recommended Not Eligible/Non-Contributing	Building appears to have been expanded and remodeled circa 1965. It has no historical associations of significance that would qualify it as eligible for listing in the NRHP under Criteria A through D.

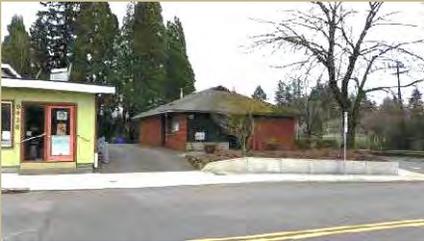
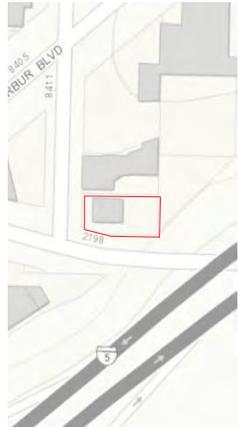
Project ID Survey # Acquisition	Resource Name Address & Assoc. Address Property ID Historic Name	Construction Date Resource Type Primary Style Primary Siding	NRHP Status	Integrity Comments / Notes	Photograph of Resource	Location
SW_22979 220 NO IMPACT	8430 SW 22ND AVE PORTLAND R012801440	1949 Building Modern Commercial Roman Brick	Recommended Not Eligible/Non-Contributing	Modifications to plan, siding, and fenestration diminish the building's historical integrity and its potential to be eligible for listing in the NRHP.

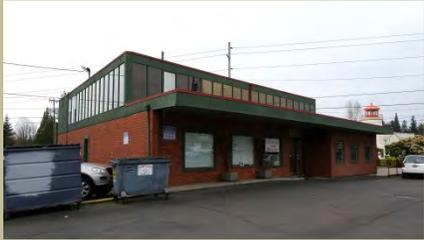
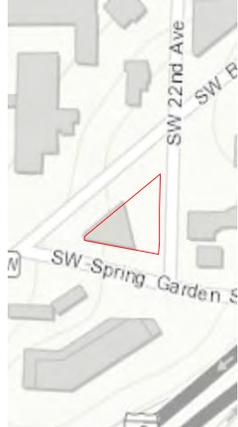
SW_9672 221 FULL	8414 SW BARBUR BLVD PORTLAND R012801010 Multnomah Bank	1951 Building Modern Commercial Vertical Board	City of Portland HRI (1984 - No Rank); Recommended Not Eligible/Non-Contributing	Modifications to windows and siding diminish the building's historical integrity and its potential to be eligible for listing in the NRHP.

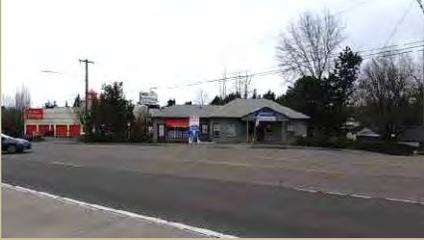
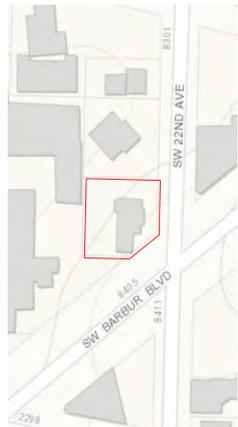
SW_18270 222 FULL	8405 SW 22ND AVE PORTLAND R012801080	1922 Building Vernacular Vertical Board	Recommended Not Eligible/Non-Contributing	Appears to be a former residence that was later expanded and modified for commercial use. It has no historical associations of significance that would qualify it as eligible for listing in the NRHP under Criteria A through D.

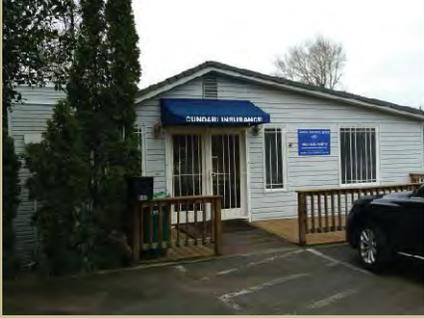
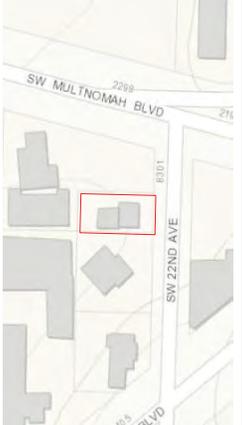
Project ID Survey # Acquisition	Resource Name Address & Assoc. Address Property ID Historic Name	Construction Date Resource Type Primary Style Primary Siding	NRHP Status	Integrity Comments / Notes	Photograph of Resource	Location
SW_4268 223 NO IMPACT	8309 SW 22ND AVE PORTLAND R012801120	1950 Building Vernacular Vinyl Siding	Recommended Not Eligible/Non-Contributing	Modifications to plan, cladding, and windows diminish the building's integrity and its potential to be eligible for listing in the NRHP.

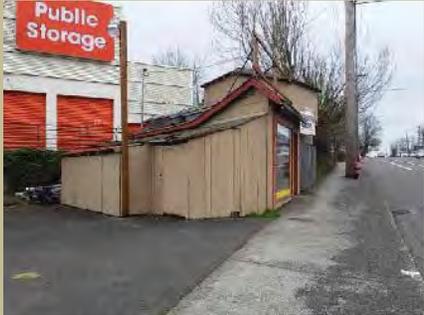
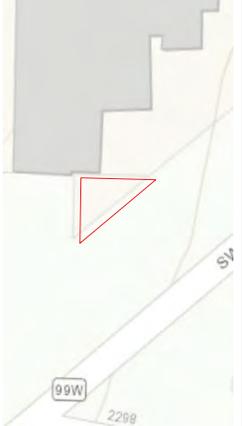
SW_4828 224 FULL	8449 SW BARBUR BLVD PORTLAND R012801200	1945 Building Vernacular Vertical Board	Recommended Not Eligible/Non-Contributing	Modifications to the plan and siding diminish the building's integrity and its potential to be eligible for listing in the NRHP

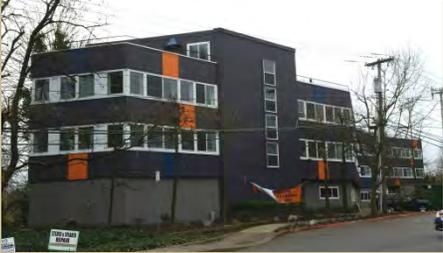
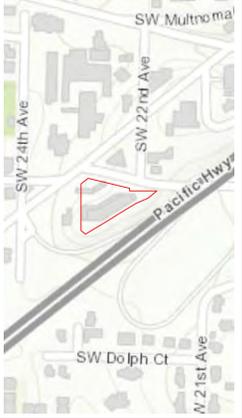
SW_20960 225 PARTIAL	2222 SW SPRING GARDEN ST PORTLAND R012800390 Spring Garden Apartments	1967 Building Modern Period Other Concrete Panels	Recommended Not Eligible/Non-Contributing	Vinyl windows diminish historical appearance and integrity. The building has no historical associations of significance under Criteria A through D.

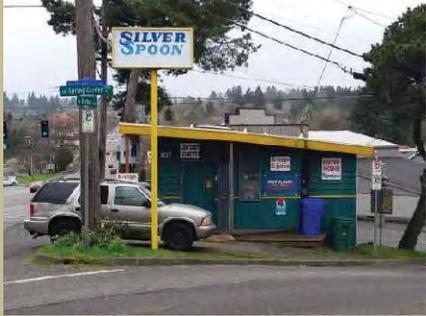
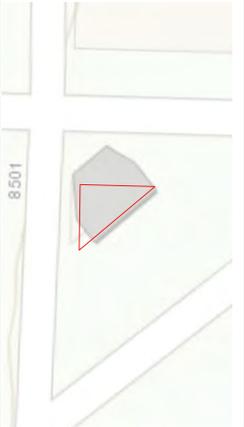
Project ID Survey # Acquisition	Resource Name Address & Assoc. Address Property ID Historic Name	Construction Date Resource Type Primary Style Primary Siding	NRHP Status	Integrity Comments / Notes	Photograph of Resource	Location
SW_12821 226 FULL	8521 SW BARBUR BLVD PORTLAND R012800530	1935 Building Modern Commercial Horizontal Board	Recommended Not Eligible/Non-Contributing	Modifications to siding and windows diminish the building's integrity and its potential to be eligible for listing in the NRHP

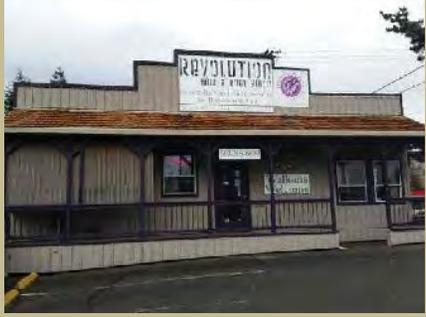
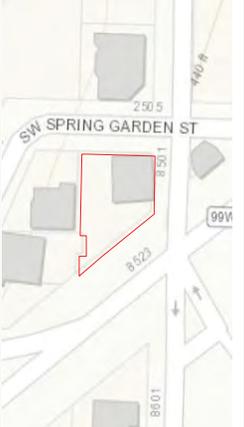
SW_4507 227 PARTIAL	8525 SW BARBUR BLVD PORTLAND R012800630	1941 Building Other / Undefined Vertical Board	Recommended Not Eligible/Non-Contributing	Modifications to plan, windows, and siding diminish the building's integrity and its potential to be eligible for listing in the NRHP

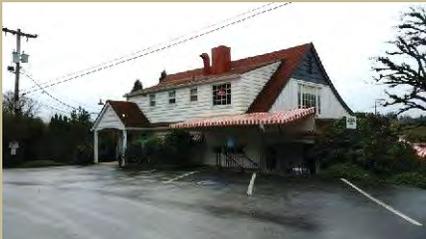
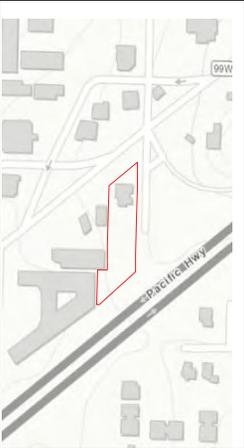
SW_15228 228 PARTIAL	Original Pancake House 8601 SW 24TH AVE PORTLAND R799501000 Pancake House	1942 Building Tudor Revival Horizontal Board	Recommended Eligible/Contributing	An addition was observed on the north elevation and several original windows have been replaced. However, this building is associated with a significant local restaurant, the Original Pancake House, which has operated from this location since 1953.

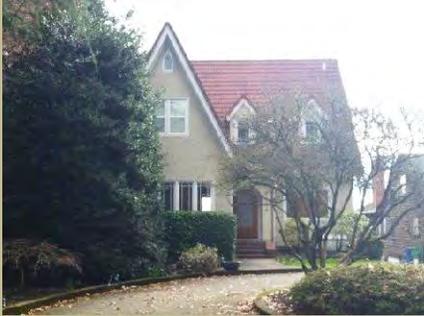
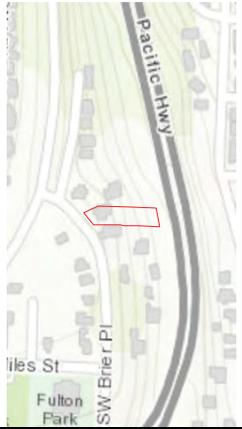
Project ID Survey # Acquisition	Resource Name Address & Assoc. Address Property ID Historic Name	Construction Date Resource Type Primary Style Primary Siding	NRHP Status	Integrity Comments / Notes	Photograph of Resource	Location
SW_6674 229 NO IMPACT	7114 SW BRIER PL PORTLAND R178200490	Circa 1930 Building Tudor Revival Stucco	Recommended Eligible/Contributing	Large addition to the rear (east) elevation is not visible from public right of way. Some original windows have been replaced with vinyl sashes; however, the house retains distinctive characteristics of its type and period of construction.

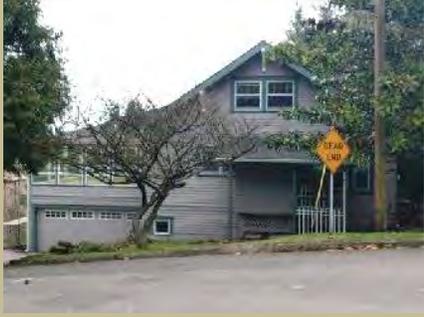
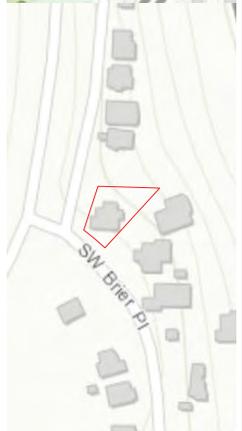
SW_8327 230 NO IMPACT	7100 SW BRIER PL PORTLAND R178200640	1924 Building Craftsman Horizontal Board	Recommended Not Eligible/Non-Contributing	Garage and sunroom addition at north elevation; siding does not appear to be original to construction, and some original windows have been replaced. The house's diminished integrity limits its potential to be eligible for listing in the NRHP.

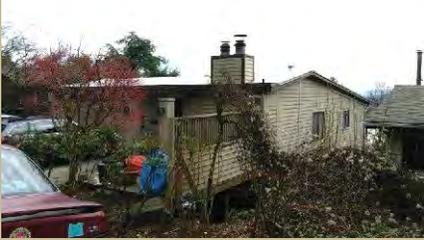
SW_16973 231 NO IMPACT	7032 SW BRIER PL PORTLAND R780206650	1968 Building Vernacular Horizontal Board	Recommended Not Eligible/Non-Contributing	The building has no associations of historical significance under Criteria A through D.

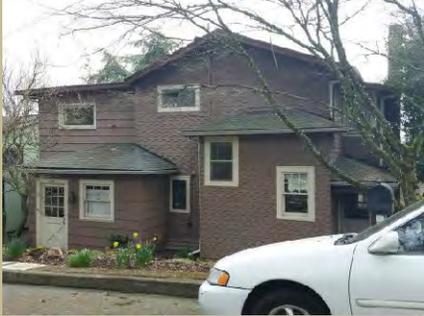
Project ID Survey # Acquisition	Resource Name Address & Assoc. Address Property ID Historic Name	Construction Date Resource Type Primary Style Primary Siding	NRHP Status	Integrity Comments / Notes	Photograph of Resource	Location
SW_21826 232 TCE	7010 SW BRIER PL PORTLAND R780206660	1890 Building Vernacular Shingle	Recommended Not Eligible/Non-Contributing	Modifications to plan, windows, and siding diminish the building's integrity and its potential to be eligible for listing in the NRHP.

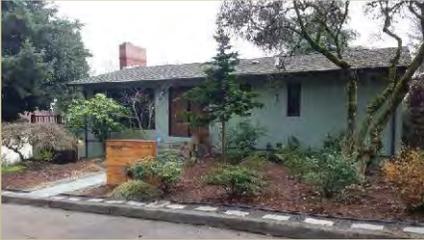
SW_14513 233 TCE	7006 SW BRIER PL PORTLAND R780206670	1964 Building Ranch Stucco	Recommended Not Eligible/Non-Contributing	The building has no historical associations of significance under Criteria A through D.

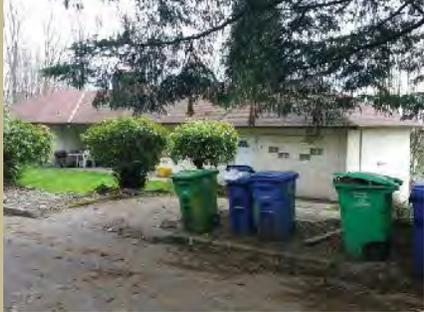
SW_3940 234 PARTIAL	6930 SW BRIER PL PORTLAND R780206450	1949 Building Ranch Concrete Block	Recommended Not Eligible/Non-Contributing	Garage door opening now enclosed with concrete block. The building has no historical associations of significance under Criteria A through D.

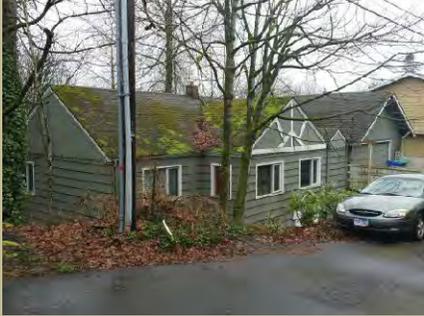
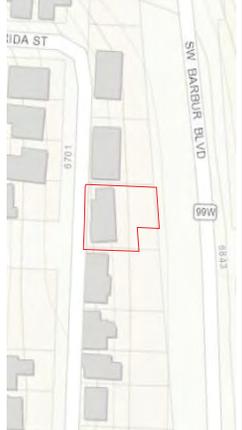
Project ID Survey # Acquisition	Resource Name Address & Assoc. Address Property ID Historic Name	Construction Date Resource Type Primary Style Primary Siding	NRHP Status	Integrity Comments / Notes	Photograph of Resource	Location
SW_1081 235 NO IMPACT	6834 SW 2ND AVE PORTLAND R780207050	1912 Building Vernacular Cedar Shake Shingle	Recommended Not Eligible/Non-Contributing	Modifications to the plan, siding, and windows diminish the building's integrity and its potential to be eligible for listing in the NRHP.

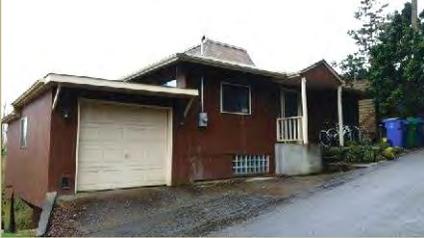
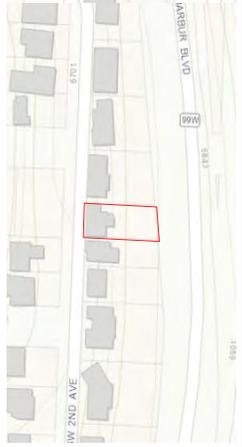
SW_8049 236 NO IMPACT	6920 SW 2ND AVE PORTLAND R780207020	1950 Building Vernacular Vertical Board	Recommended Not Eligible/Non-Contributing	Modifications to siding and windows; roof likely modified circa 1970s. The building's diminished historical integrity limits its potential to be eligible for listing in the NRHP.

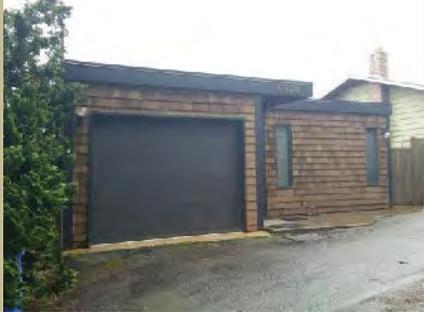
SW_18826 237 EASEMENT	6924 SW 2ND AVE PORTLAND R780207000	1970 Building Modern Period Other Shingle	Recommended Not Eligible/Non-Contributing	The building has no historical associations of significance under Criteria A through D.

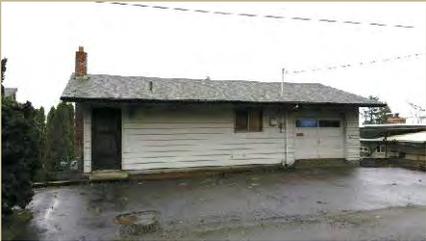
Project ID Survey # Acquisition	Resource Name Address & Assoc. Address Property ID Historic Name	Construction Date Resource Type Primary Style Primary Siding	NRHP Status	Integrity Comments / Notes	Photograph of Resource	Location
SW_1503 238 EASEMENT	6926 SW 2ND AVE PORTLAND R780206980	1957 Building Ranch Horizontal Board	Recommended Not Eligible/Non-Contributing	The building has no historical associations of significance under Criteria A through D.

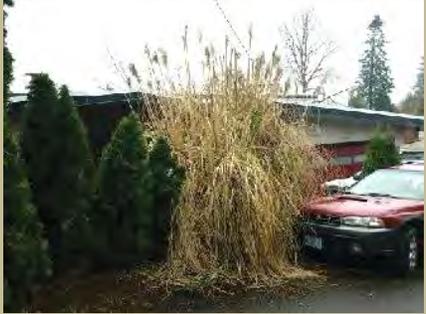
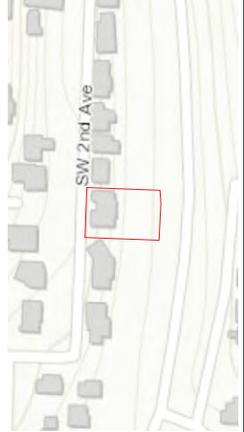
SW_11585 239 PARTIAL	7000 SW 2ND AVE PORTLAND R780206940	1957 Building Modern Period Other Cedar Shake Shingle	Recommended Not Eligible/Non-Contributing	Some original wood windows have been replaced. The building has no historical associations of significance under Criteria A through D.

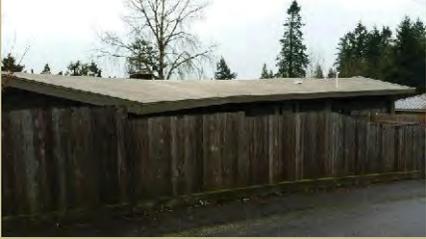
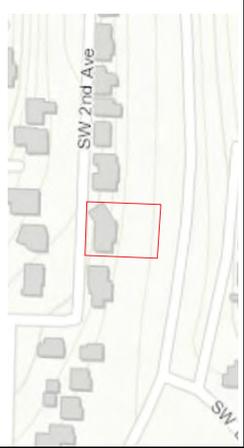
SW_12450 240 PARTIAL	7030 SW 2ND AVE PORTLAND R780206900	1955 Building Ranch Vertical Board	Recommended Not Eligible/Non-Contributing	Window and siding modifications diminish the building's historical integrity and its potential to be eligible for listing in the NRHP.
