**Section 106 and 4(f) Public Documents
Supplemental Information: Potential Impacts and Mitigation
for Historic Properties and Public Parks
SW Corridor Light Rail Project
Draft – December 15th, 2020**

This technical memo details the potential SW Corridor Light Rail Project impacts to protected historic properties and parks resources, as well as the proposed mitigations. This memo is intended for public review and comment.

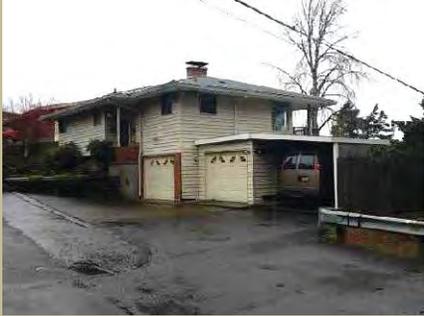
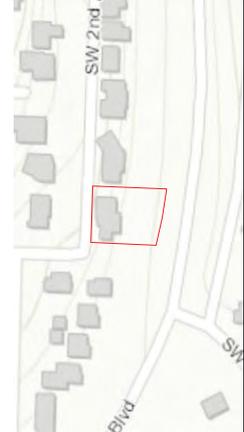
Project ID Survey # Acquisition	Resource Name Address & Assoc. Address Property ID Historic Name	Construction Date Resource Type Primary Style Primary Siding	NRHP Status	Integrity Comments / Notes	Photograph of Resource	Location
SW_4838 241 FULL	7040 SW 2ND AVE PORTLAND R780206870	1964 Building Ranch Vinyl Siding	Recommended Not Eligible/Non-Contributing	The building has no historical associations of significance under Criteria A through D.

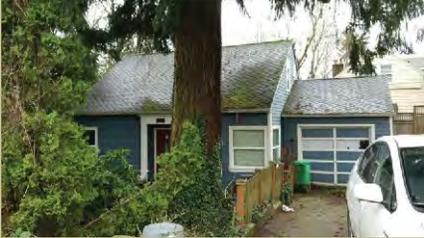
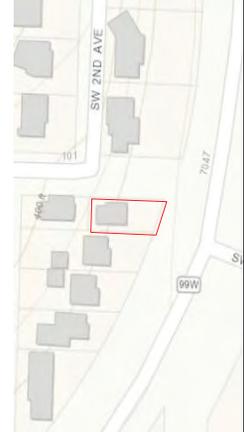
SW_12802 242 FULL	110 SW NEVADA ST PORTLAND R300401000	1941 Building Cape Cod Horizontal Board	Recommended Not Eligible/Non-Contributing	Vinyl windows have replaced original wood windows. The building has no historical associations of significance under Criteria A through D.

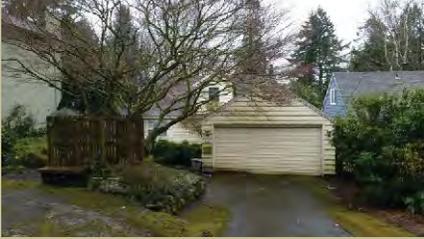
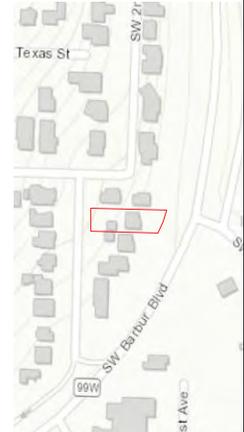
SW_10259 243 FULL	7116 SW 2ND AVE PORTLAND R300400990	1941 Building Minimal Traditional Horizontal Board	Recommended Not Eligible/Non-Contributing	The building has no historical associations of significance under Criteria A through D. There is a detached garage west of house.

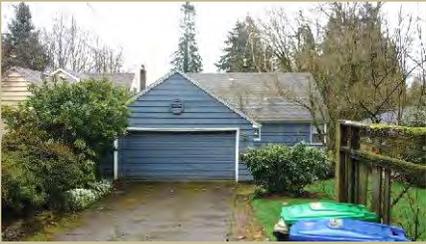
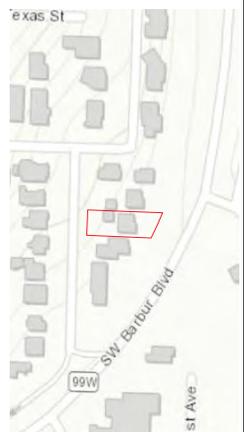
Project ID Survey # Acquisition	Resource Name Address & Assoc. Address Property ID Historic Name	Construction Date Resource Type Primary Style Primary Siding	NRHP Status	Integrity Comments / Notes	Photograph of Resource	Location
SW_20902 244 FULL	7134 SW 2ND AVE PORTLAND R300400970	1941 Building Minimal Traditional Horizontal Board	Recommended Not Eligible/Non-Contributing	The building has no historical associations of significance under Criteria A through D. A detached garage is west of the house.

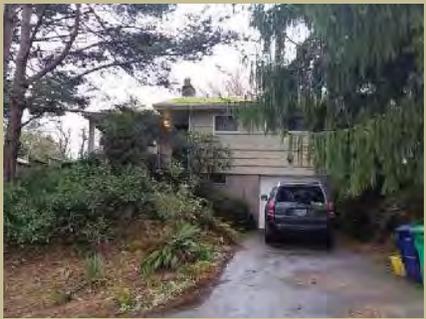
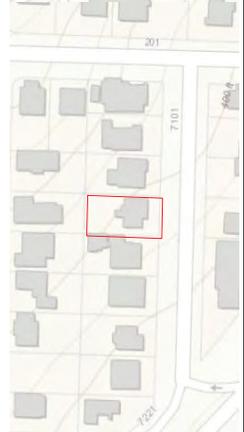
SW_9110 245 NO IMPACT	7145 SW 2ND AVE PORTLAND R300401190	1957 Building Ranch Cedar Shake Shingle	Recommended Not Eligible/Non-Contributing	The building has no historical associations of significance under Criteria A through D.

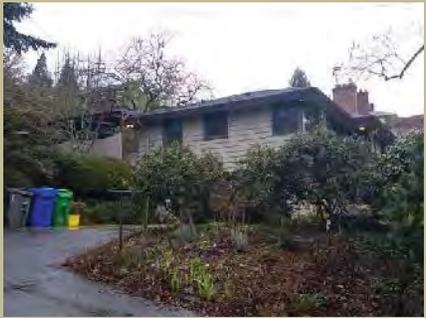
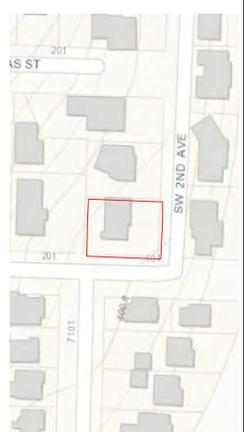
SW_10314 246 NO IMPACT	7037 SW 2ND AVE PORTLAND R780207770	1953 Building Ranch Horizontal Board	Recommended Eligible/Contributing	Some possible window replacements. House is a good example of mid-century ranch in this immediate area.

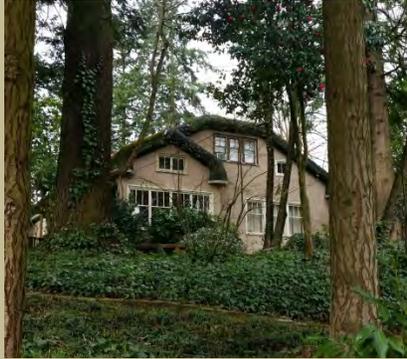
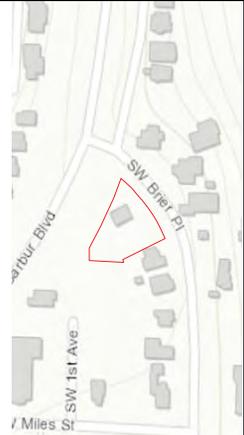
Project ID Survey # Acquisition	Resource Name Address & Assoc. Address Property ID Historic Name	Construction Date Resource Type Primary Style Primary Siding	NRHP Status	Integrity Comments / Notes	Photograph of Resource	Location
SW_12156 247 NO IMPACT	7115 SW BRIER PL PORTLAND R178200010	1926 Building English Cottage Stucco	Recommended Eligible/Contributing	Rolled eaves, original windows, street level garage.

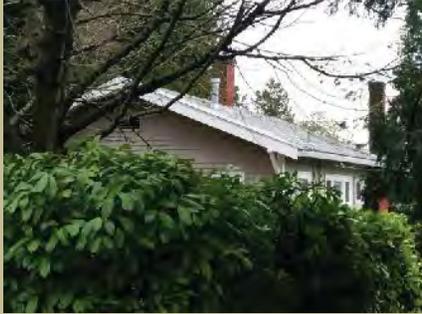
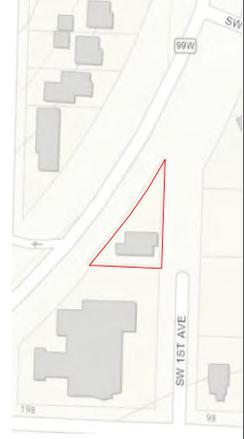
SW_2672 248 FULL	7225 SW 1ST AVE PORTLAND R178202100	1916 Building Craftsman Horizontal Board	Recommended Not Eligible/Non-Contributing	Modifications to siding and fenestration diminish the house's historical integrity and its potential to be eligible for listing in the NRHP.

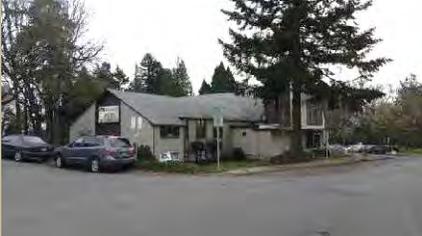
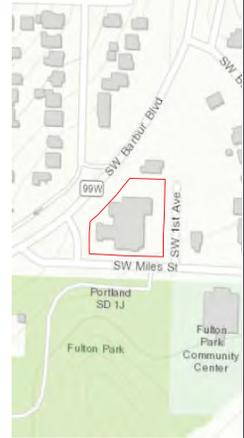
SW_2673 249 PARTIAL	PDX Church 125 SW MILES ST PORTLAND R300401530	1948 Building Vernacular Horizontal Board	Recommended Not Eligible/Non-Contributing	Modifications to siding and south facade entry diminish the building's historical integrity and its potential to be eligible for listing in the NRHP.

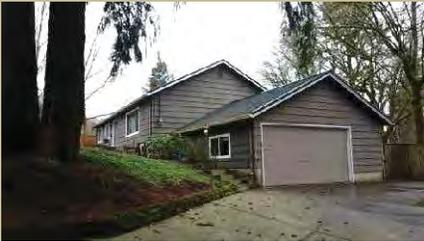
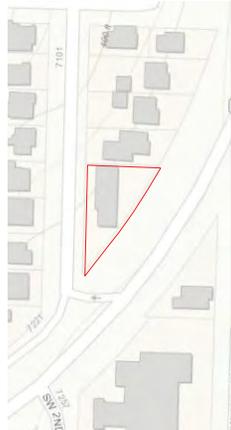
Project ID Survey # Acquisition	Resource Name Address & Assoc. Address Property ID Historic Name	Construction Date Resource Type Primary Style Primary Siding	NRHP Status	Integrity Comments / Notes	Photograph of Resource	Location
SW_17208 250 FULL	7208 SW 2ND AVE PORTLAND R300400930	1924 Building Vernacular Cedar Shake Shingle	Recommended Not Eligible/Non-Contributing	Modifications to siding, plan, and fenestration diminish the house's historical integrity and its potential to be eligible for listing in the NRHP.

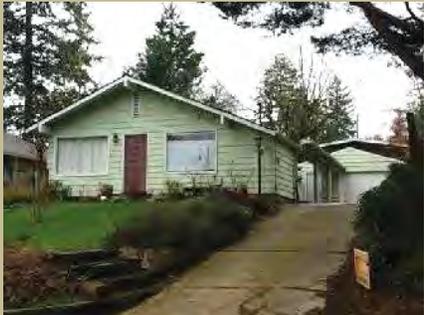
SW_4462 251 NO IMPACT	7207 SW 2ND AVE PORTLAND R300401200	1954 Building Vernacular Horizontal Board	Recommended Not Eligible/Non-Contributing	This building has no historical associations of significance to qualify it as eligible for listing in the NRHP under Criteria A through D.

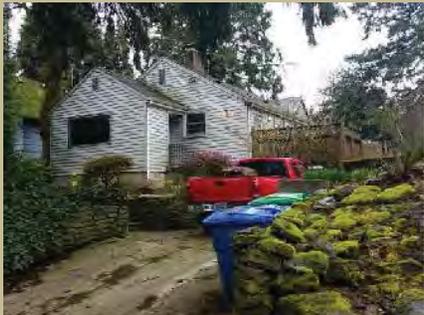
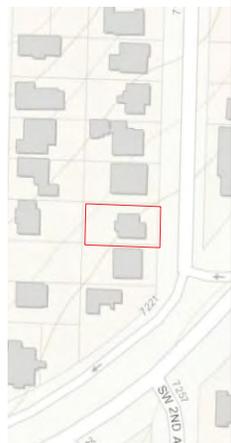
SW_8205 252 EASEMENT	7231 SW 2ND AVE PORTLAND R300401220	1940 Building Minimal Traditional Vinyl Siding	Recommended Not Eligible/ Non-Contributing	This building has no historical associations of significance to qualify it as eligible for listing in the NRHP under Criteria A through D.

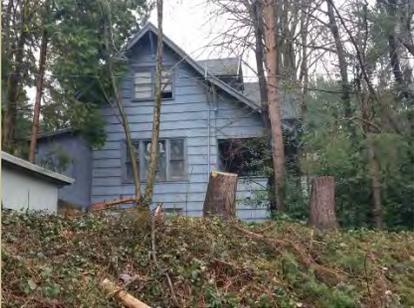
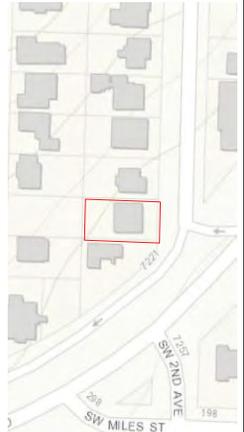
Project ID Survey # Acquisition	Resource Name Address & Assoc. Address Property ID Historic Name	Construction Date Resource Type Primary Style Primary Siding	NRHP Status	Integrity Comments / Notes	Photograph of Resource	Location
SW_8725 253 FULL	7235 SW 2ND AVE PORTLAND R300401230	1910 Building Craftsman Cedar Shake Shingle	Recommended Not Eligible/Non-Contributing	Historic-period modifications to windows and siding diminish the historical integrity of the house. This building has no historical associations of significance that would qualify it as eligible for listing in the NRHP under Criteria A through D.

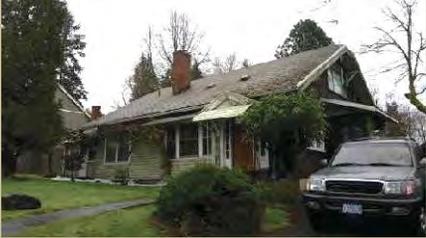
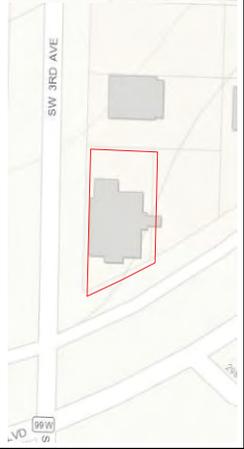
SW_22623 254 FULL	7316 SW 3RD AVE PORTLAND R300401050	1925 Building Craftsman Horizontal Board	Recommended Not Eligible/Non-Contributing	Modifications to plan and windows; siding may not be original. The house's diminished historical integrity limits its eligibility for listing in the NRHP.

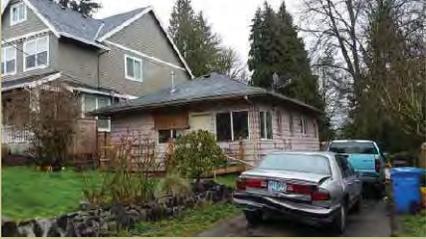
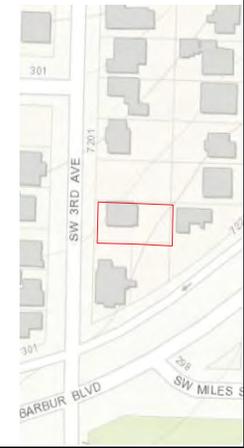
SW_17791 255 NO IMPACT	7224 SW 3RD AVE PORTLAND R300401030	1908 Building Vernacular Horizontal Board	Recommended Not Eligible/Non-Contributing	Modifications to siding and windows diminish the house's historical integrity and its potential to be eligible for listing in the NRHP.

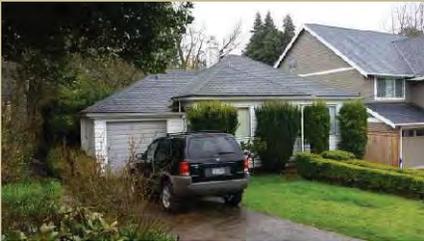
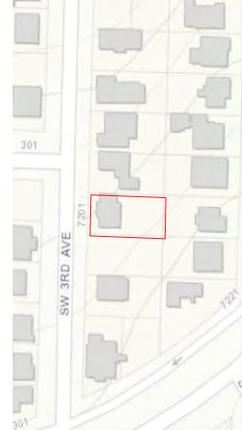
Project ID Survey # Acquisition	Resource Name Address & Assoc. Address Property ID Historic Name	Construction Date Resource Type Primary Style Primary Siding	NRHP Status	Integrity Comments / Notes	Photograph of Resource	Location
SW_8726 256 NO IMPACT	7206 SW 3RD AVE PORTLAND R300401090	1941 Building WWII Era Cottage Horizontal Board	Recommended Not Eligible/Non-Contributing	This building has no historical associations of significance that would qualify it as eligible for listing in the NRHP under Criteria A through D.

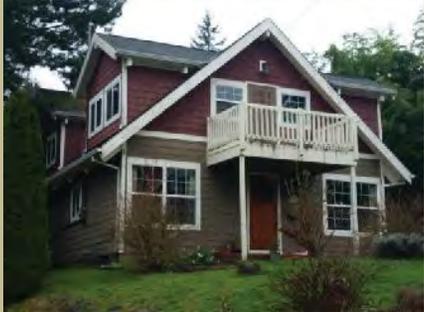
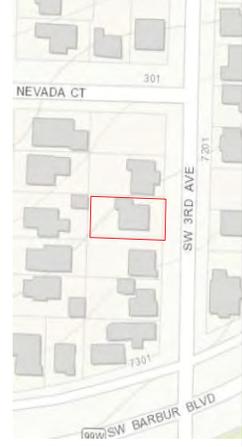
SW_2454 257 NO IMPACT	7239 SW 3RD AVE PORTLAND R300401340	1967 Building Vernacular Horizontal Board	Recommended Not Eligible/Non-Contributing	Modifications to cladding and windows; plan likely modified as well. The house's diminished historical integrity limits its eligibility for listing in the NRHP.

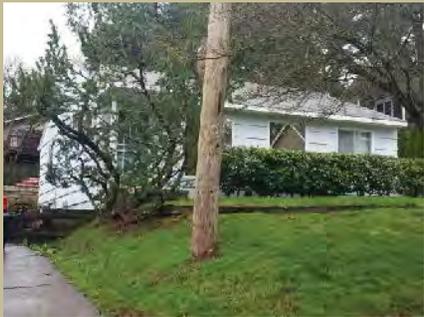
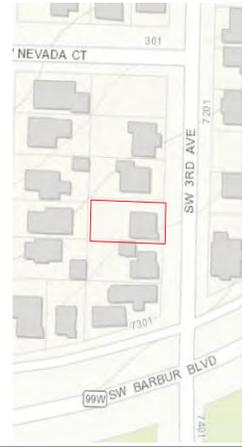
SW_14657 258 FULL	7305 SW 3RD AVE PORTLAND R300401350	1952 Building Minimal Traditional Cedar Shake Shingle	Recommended Not Eligible/Non-Contributing	This building has no historical associations of significance that would qualify it as eligible for listing in the NRHP under Criteria A through D.

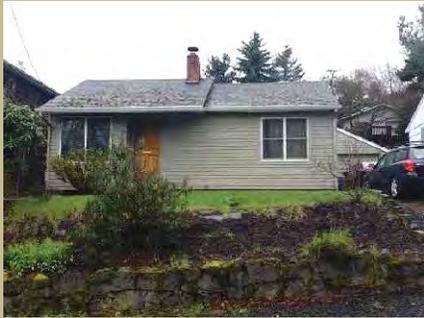
SW_15569 260 FULL	7321 SW BARBUR BLVD PORTLAND R300401370	1920 Building Vernacular Shingle	Recommended Not Eligible/Non-Contributing	Extensive modifications to plan, cladding, and windows diminish the house's historical integrity and its potential to be eligible for listing in the NRHP.

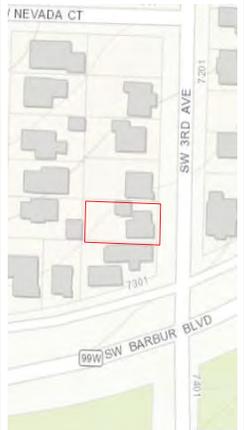
Project ID Survey # Acquisition	Resource Name Address & Assoc. Address Property ID Historic Name	Construction Date Resource Type Primary Style Primary Siding	NRHP Status	Integrity Comments / Notes	Photograph of Resource	Location
SW_6267 259 FULL	7311 SW 3RD AVE PORTLAND R300401360	1950 Building Minimal Traditional Horizontal Board	Recommended Not Eligible/Non-Contributing	Siding and window modifications diminish the house's historical integrity and its potential to be eligible for listing in the NRHP. A detached garage is situated northwest of the house.

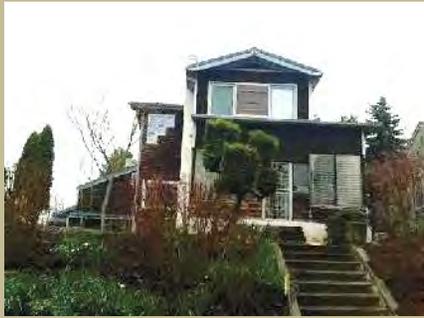
SW_2011 261 NO IMPACT	7420 SW 3RD AVE PORTLAND R300402360	1890 Building Queen Anne Horizontal Board	Recommended Not Eligible/Non-Contributing	Modifications to fenestration and roof diminish the house's historical integrity and its potential to be eligible for listing in the NRHP. The house has no known historical associations of significance.

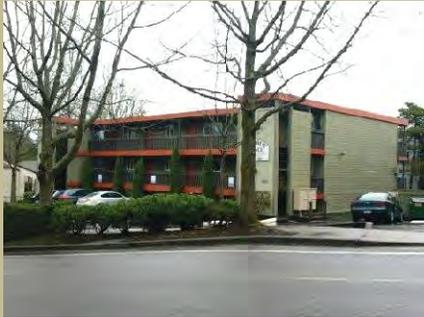
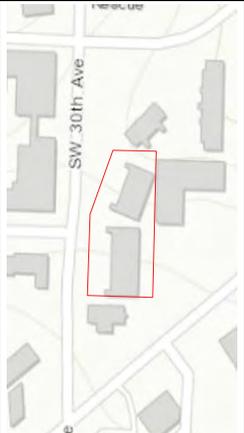
Project ID Survey # Acquisition	Resource Name Address & Assoc. Address Property ID Historic Name	Construction Date Resource Type Primary Style Primary Siding	NRHP Status	Integrity Comments / Notes	Photograph of Resource	Location
SW_15372 262 NO IMPACT	Barbur Place Apartments 8924-8934 SW 30TH AVE PORTLAND R524703620	1969 Building Modern Period Other Horizontal Board	Recommended Not Eligible/Non-Contributing	Not a distinctive example of a type, period, or method of construction, and has no historical associations of significance under Criteria A through D.

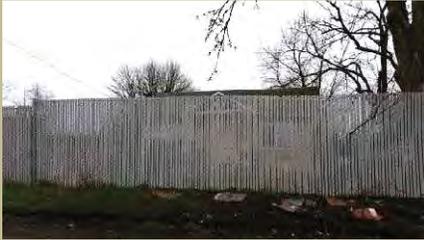
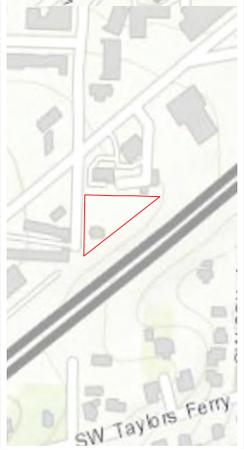
SW_19238 263 PARTIAL	9104 SW 30TH AVE PORTLAND R013901660	1924 Building Craftsman Horizontal Board	Recommended Not Eligible/Non-Contributing	Setting is diminished, windows have been replaced. A perimeter fence prevented the collection of clear photographs. The building has diminished integrity and no known historical associations of significance under Criteria A through D.

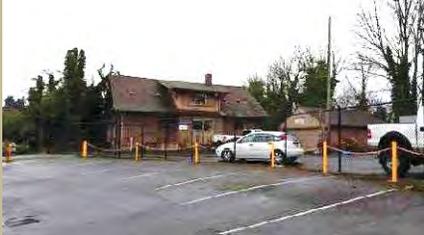
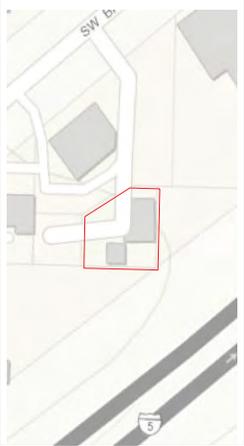
SW_10786 264 NO IMPACT	8946 SW BARBUR BLVD PORTLAND R013901520	1923 Building Craftsman Vertical Board	Recommended Not Eligible/Non-Contributing	The siding and windows have been modified, and the house is now used as a commercial office space. The building's diminished historical integrity limits its potential to be eligible for listing in the NRHP. A detached garage is situated to the southwest.

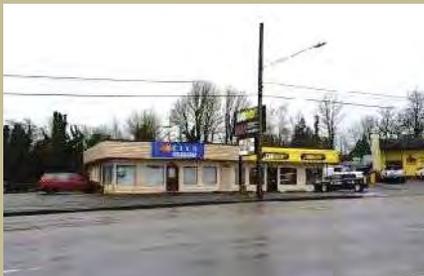
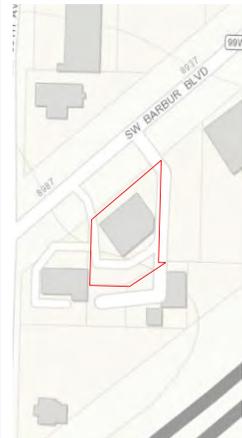
Project ID Survey # Acquisition	Resource Name Address & Assoc. Address Property ID Historic Name	Construction Date Resource Type Primary Style Primary Siding	NRHP Status	Integrity Comments / Notes	Photograph of Resource	Location
SW_8978 265 FULL	8948-8952 SW BARBUR BLVD PORTLAND R524703960	1951 Building Commercial Vinyl Siding	Recommended Not Eligible/Non-Contributing	Extensive modifications to siding and fenestration diminish the building's historical integrity and its potential to be eligible for listing in the NRHP.

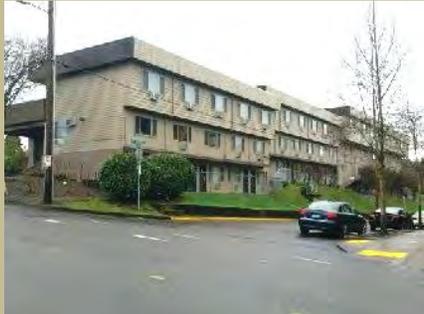
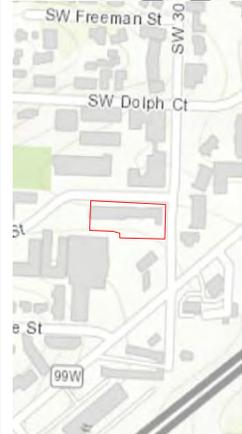
SW_1180 267 PARTIAL	9045 SW BARBUR BLVD PORTLAND R539000580	1957 Building Commercial Stucco	Recommended Not Eligible/Non-Contributing	Modifications to siding and fenestration diminish the building's historical integrity and its potential to be eligible for listing in the NRHP.

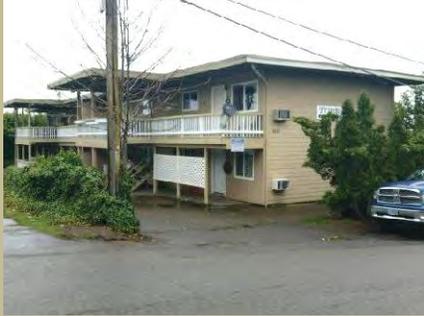
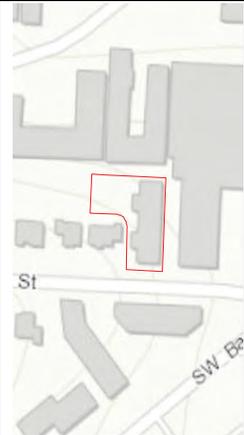
Project ID Survey # Acquisition	Resource Name Address & Assoc. Address Property ID Historic Name	Construction Date Resource Type Primary Style Primary Siding	NRHP Status	Integrity Comments / Notes	Photograph of Resource	Location
SW_2813 268 PARTIAL	Primrose Apartments 3137-3139 SW PRIMROSE ST PORTLAND R383800020	1963 Building Modern Period Other Horizontal Board	Recommended Not Eligible/Non-Contributing	Modifications to siding and windows diminish the building's historical integrity and its potential to be eligible for listing in the NRHP.

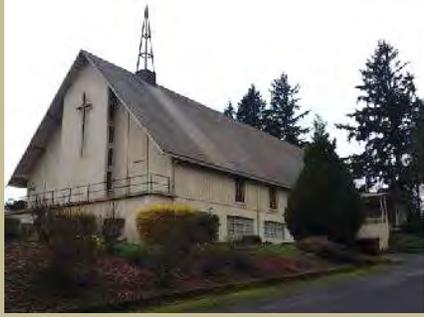
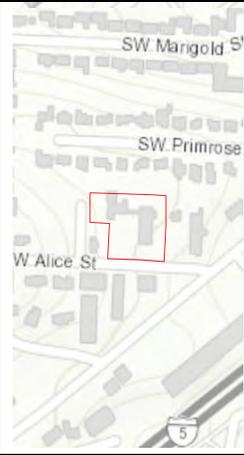
SW_7068 269 TCE	Good Shepherd Lutheran Church and Little Lambs Preschool 3405 SW ALICE ST PORTLAND R892300840 Good Shepherd Lutheran Church	1959 Building Modern Period Other Vertical Board	Recommended Eligible/Contributing	These two buildings have the same address but are situated on two separate land parcels. Both parcels are included in the resource boundary. The property is a good example of the work of architect Kurt P. Schuette of Church, Newberry, Roehr and Schuette.

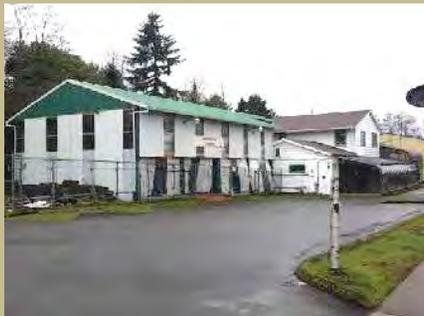
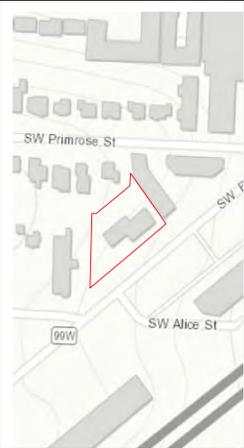
SW_3783 270 PARTIAL	9155 SW BARBUR BLVD PORTLAND R892300720	1970 Building Colonial Revival Aluminum	Recommended Not Eligible/Non-Contributing	Modifications to plan and siding diminish the building's historical integrity and its potential to be eligible for listing in the NRHP.

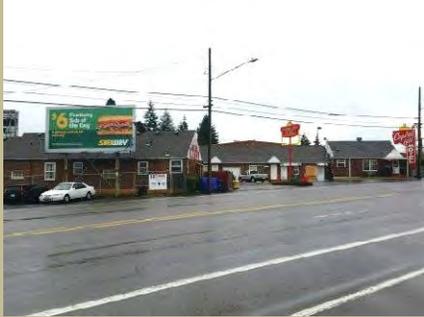
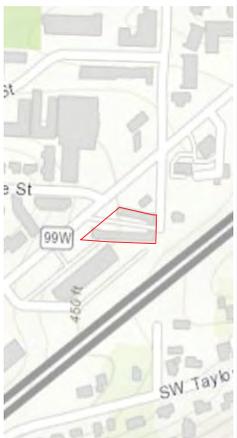
Project ID Survey # Acquisition	Resource Name Address & Assoc. Address Property ID Historic Name	Construction Date Resource Type Primary Style Primary Siding	NRHP Status	Integrity Comments / Notes	Photograph of Resource	Location
SW_15652 271 FULL	9110 SW BARBUR BLVD PORTLAND R991290810 Capitol Hill Motel	1940 Building Minimal Traditional Standard Brick	Previously Recorded as Eligible/Contributing (1998); Recommended Eligible/Contributing	This motel is a good example of roadside architecture along SW Barbur Boulevard. Most all original windows have been replaced with vinyl sashes, original doors have been replaced, and vinyl siding has replaced wood lap siding. Two neon signs advertise the property on SW Barbur Boulevard.

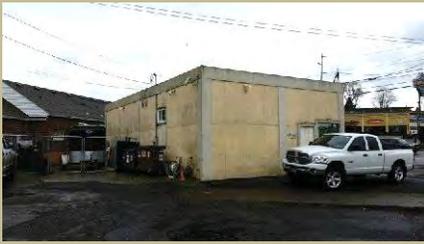
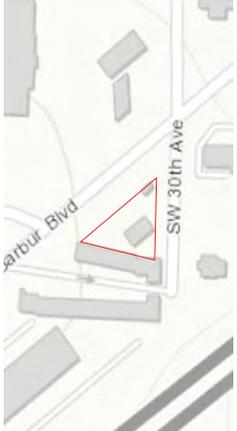
SW_11099 272 FULL	9050 SW BARBUR BLVD PORTLAND R991290710	1955 Building Commercial Stucco	Recommended Not Eligible/Non-Contributing	Modifications to windows and cladding diminish the building's historical integrity and its potential to be eligible for listing in the NRHP.

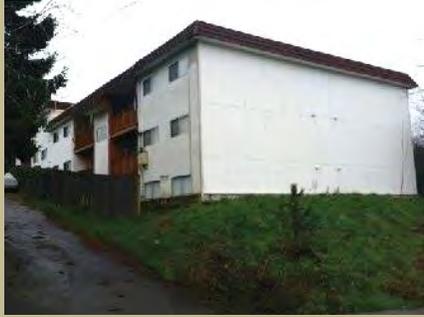
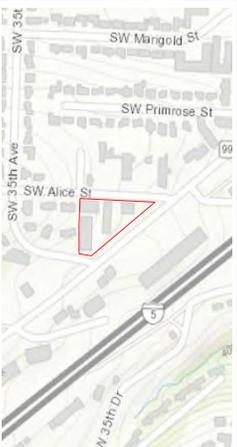
SW_5170 273 PARTIAL	Crestwood Terrace 3410-3440 SW ALICE ST PORTLAND R892301420	1970 Building Other / Undefined Stucco	Recommended Not Eligible/Non-Contributing	This building has no historical associations of significance that would qualify it as eligible for listing in the NRHP under Criteria A through D.

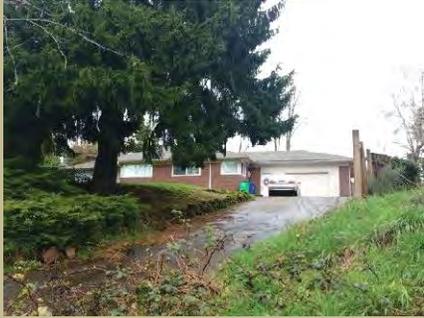
Project ID Survey # Acquisition	Resource Name Address & Assoc. Address Property ID Historic Name	Construction Date Resource Type Primary Style Primary Siding	NRHP Status	Integrity Comments / Notes	Photograph of Resource	Location
SW_2373 274 NO IMPACT	9386 SW 35TH AVE PORTLAND R892301330	1949 Building Ranch Roman Brick	Recommended Not Eligible/Non-Contributing	Modifications to windows and attached garage diminish the building's historical integrity and its potential to be eligible for listing in the NRHP.

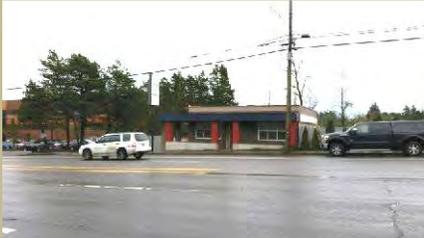
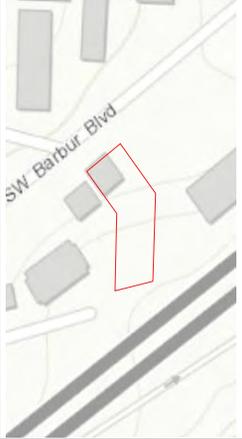
SW_20041 275 FULL	9400 SW BARBUR BLVD PORTLAND R892301230	1946 Building Commercial Roman Brick	Recommended Not Eligible/Non-Contributing	Modifications to cladding and windows diminish the building's historical integrity and its potential to be eligible for listing in the NRHP.

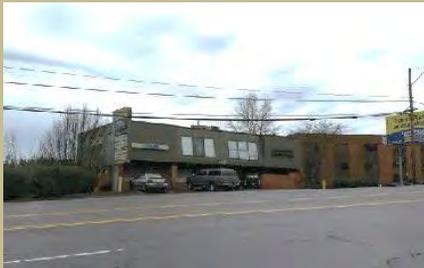
SW_15155 276 FULL	9442 SW BARBUR BLVD PORTLAND R991291020	1957 Building Commercial Standard Brick	Recommended Not Eligible/Non-Contributing	Upper story appears to have been modified circa 1975. The building has no historical associations of significance that would qualify it as eligible for listing in the NRHP under Criteria A through D.

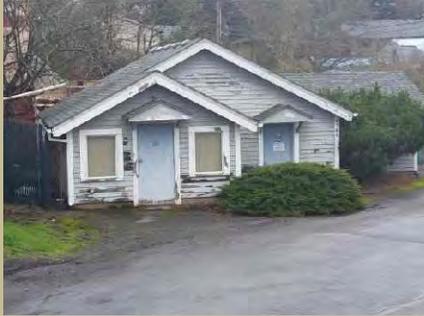
Project ID Survey # Acquisition	Resource Name Address & Assoc. Address Property ID Historic Name	Construction Date Resource Type Primary Style Primary Siding	NRHP Status	Integrity Comments / Notes	Photograph of Resource	Location
SW_16472 277 NO IMPACT	9748 SW BARBUR BLVD PORTLAND R894213520	1940 Building Minimal Traditional Horizontal Board	Recommended Not Eligible/Non-Contributing	Good integrity but not a distinctive example of a type, period, or method of construction. The building has no historical associations of significance that would qualify it as eligible for listing in the NRHP under Criteria A through D.

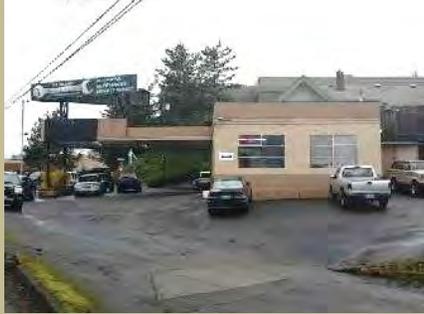
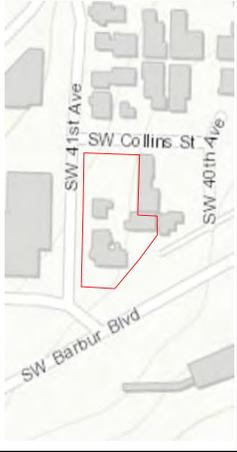
SW_6950 278 PARTIAL	Master Wrench 9803 SW BARBUR BLVD PORTLAND R894213460	Circa 1940 Building Commercial Metal Sheet	Recommended Eligible/Contributing	The circa 1940 service station is a good example of its type and period of construction, and is representative of mid-century roadside architecture of SW Barbur Boulevard. The other three buildings on this parcel do not contribute to the eligibility of the service station.

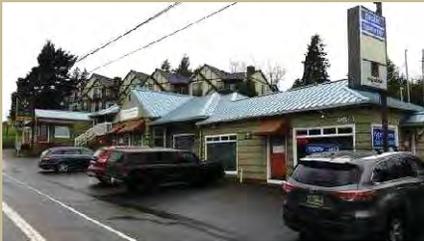
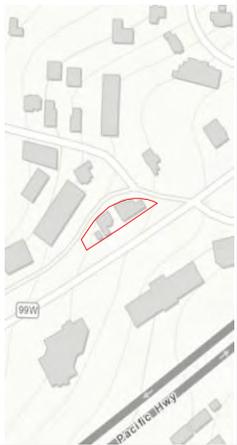
SW_1183 279 FULL	9513-9521 SW BARBUR BLVD PORTLAND R991292230	1941 Building Minimal Traditional Cedar Rake Shingle	Recommended Not Eligible/Non-Contributing	Modifications to the fenestration diminish the building's historical integrity and its potential to meet minimum eligibility qualifications for listing in the NRHP.

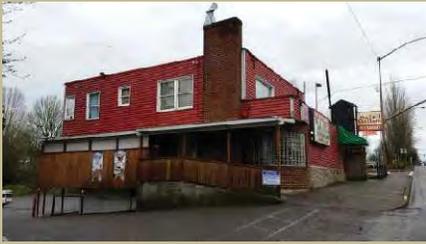
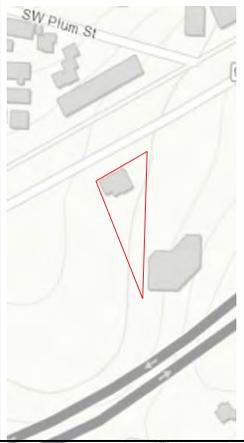
Project ID Survey # Acquisition	Resource Name Address & Assoc. Address Property ID Historic Name	Construction Date Resource Type Primary Style Primary Siding	NRHP Status	Integrity Comments / Notes	Photograph of Resource	Location
SW_12301 280 FULL	9656 SW BARBUR BLVD PORTLAND R991290170	1940 Building Vernacular Horizontal Board	Recommended Not Eligible/Non-Contributing	This building has no historical associations of significance under Criteria A through D. Modifications to the fenestration diminish the building's historical integrity.

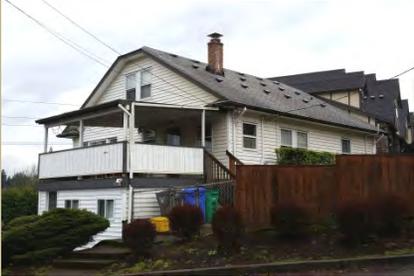
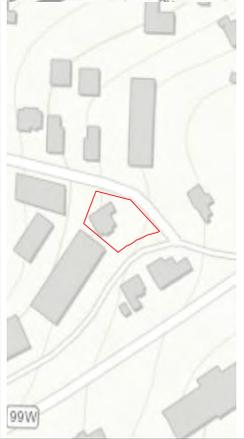
SW_9487 281 NO IMPACT	3540 SW BAIRD ST PORTLAND R233400030	1926 Building Colonial Revival Vinyl Siding	Recommended Not Eligible/Non-Contributing	Modifications to plan and siding diminish the house's historical integrity and its potential to be eligible for listing in the NRHP.

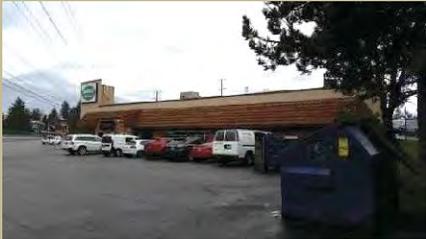
SW_12102 282 PARTIAL	9845 SW BARBUR BLVD PORTLAND R406400270	1936 Building Commercial Stucco	Recommended Not Eligible/Non-Contributing	Building appears to have been modified during the modern era to have a Mediterranean Revival appearance. This building has no historical associations of significance under Criteria A through D.

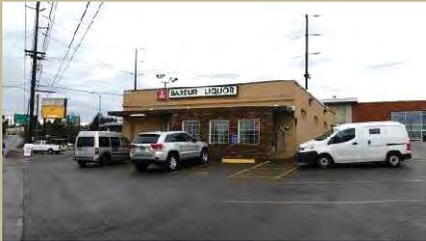
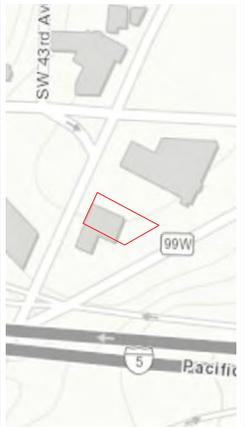
Project ID Survey # Acquisition	Resource Name Address & Assoc. Address Property ID Historic Name	Construction Date Resource Type Primary Style Primary Siding	NRHP Status	Integrity Comments / Notes	Photograph of Resource	Location
SW_12103 283 PARTIAL	9875 SW BARBUR BLVD PORTLAND R406400300	1961 Building Commercial Stucco	Recommended Not Eligible/Non-Contributing	This building has no historical associations of significance under Criteria A through D.

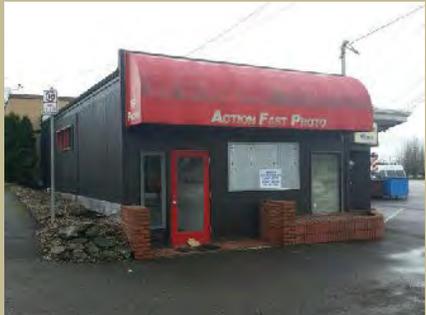
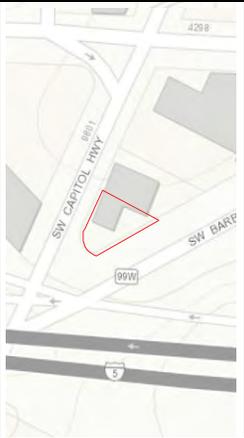
SW_19628 284 PARTIAL	9889 SW BARBUR BLVD PORTLAND R406400070	1947 Building Commercial Vertical Board	Recommended Not Eligible/Non-Contributing	Modifications to windows and siding diminish the building's historical integrity and its potential to meet minimum qualifications for listing in the NRHP.

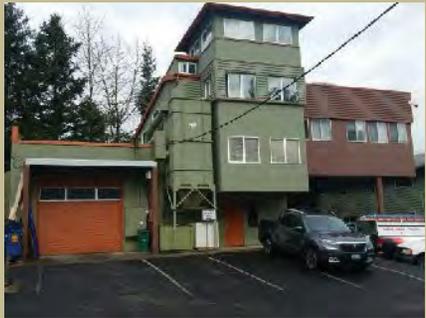
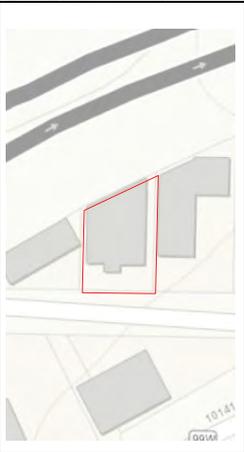
SW_1521 285 NO IMPACT	4647 SW HUBER ST PORTLAND R991300550	1961 Building Split Level Vertical Board	Recommended Not Eligible/Non-Contributing	Modifications to siding and windows diminish the building's historical integrity and its potential to meet minimum qualifications for listing in the NRHP.

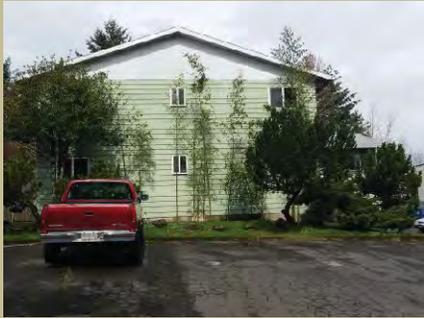
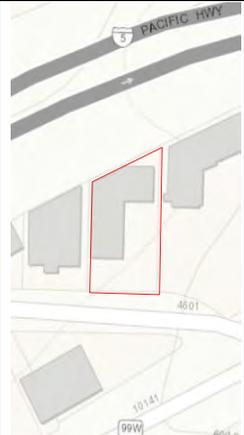
Project ID Survey # Acquisition	Resource Name Address & Assoc. Address Property ID Historic Name	Construction Date Resource Type Primary Style Primary Siding	NRHP Status	Integrity Comments / Notes	Photograph of Resource	Location
SW_14124 286 EASEMENT	4633 SW HUBER ST PORTLAND R991302050	1969 Building Other / Undefined Horizontal Board	Recommended Not Eligible/Non-Contributing	All original windows replaced with vinyl sliding sashes. This building has no historical associations of significance under Criteria A through D.

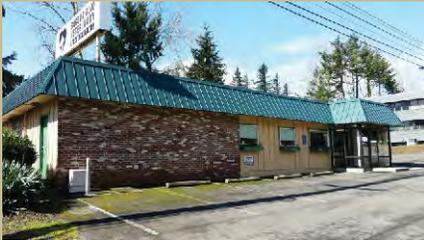
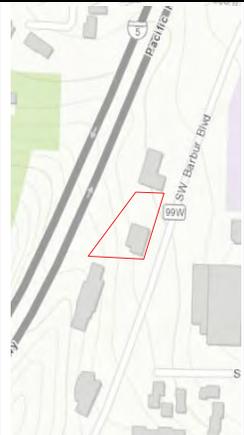
SW_22568 287 PARTIAL	10629 SW BARBUR BLVD PORTLAND R991300380	1947 Building Vernacular Standard Brick	Recommended Not Eligible/Non-Contributing	Modifications to windows, siding, and roof diminish the building's historical integrity and its potential to meet minimum qualifications for listing in the NRHP.

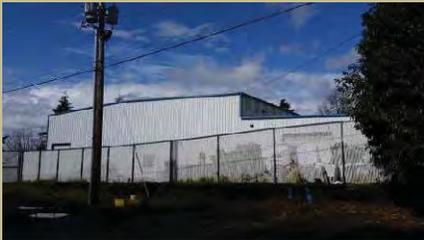
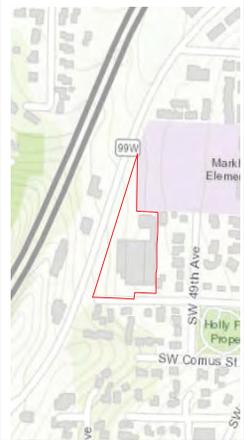
SW_12477 288 EASEMENT	10626-10630 SW BARBUR BLVD PORTLAND R991300650	1955 Building Utilitarian Metal Other / Undefined	Recommended Not Eligible/Non-Contributing	Modern siding and windows diminish the building's historical integrity and its potential to meet minimum qualifications for listing in the NRHP.

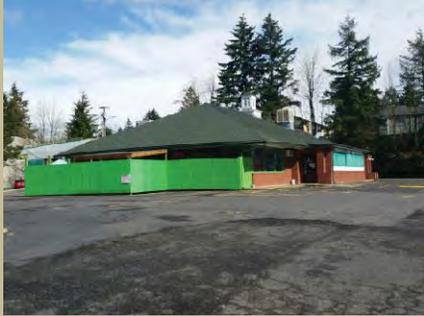
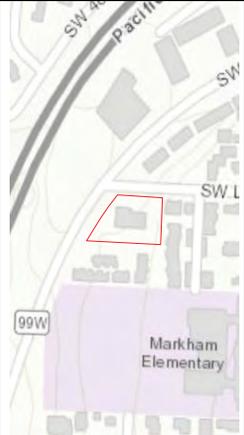
Project ID Survey # Acquisition	Resource Name Address & Assoc. Address Property ID Historic Name	Construction Date Resource Type Primary Style Primary Siding	NRHP Status	Integrity Comments / Notes	Photograph of Resource	Location
SW_3227 289 NO IMPACT	Happy Fortune 10420 SW BARBUR BLVD PORTLAND R991300810 Boulevard Coffee Shop Restaurant	1950 Building Commercial Standard Brick	Recommended Not Eligible/Non-Contributing	Building may have significant associations with mid-century commercial development along SW Barbur Boulevard, but modifications to its plan, fenestration, and siding diminish its historical appearance and integrity. The original Boulevard Coffee Shop sign is no longer extant.

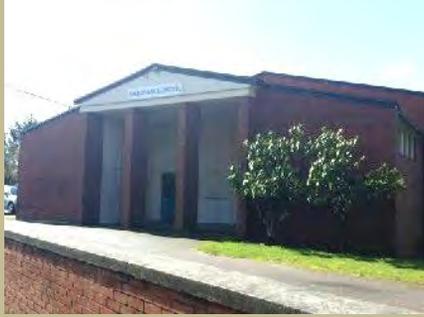
SW_18254 290 EASEMENT	Edwin Markham Elementary School 10531 SW CAPITOL HWY PORTLAND R991300200 Markham School	1951 Building Neo-Colonial Standard Brick	Previously Recorded as Eligible/Significant (2009 - Portland Public Schools Historic Building Assessment); Recommended Eligible/Significant	Designed by Richard Sundeleaf, this building is eligible for listing in the NRHP under Criteria A and C

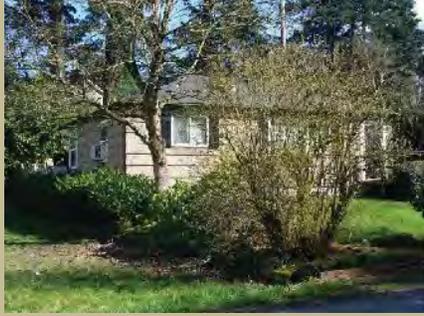
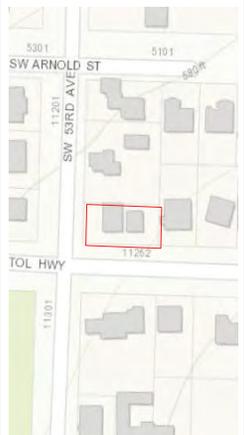
SW_20458 291 TCE	11261 SW CAPITOL HWY PORTLAND R894607780	1949 Building Vernacular Cedar Shake Shingle	Recommended Not Eligible/Non-Contributing	Modifications to siding and windows diminish the building's historical integrity and its potential to meet minimum qualifications for listing in the NRHP.

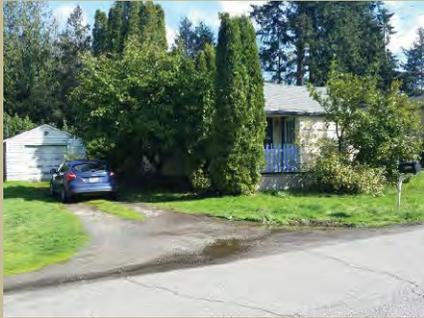
SW_12705 293 TCE	11204 SW 53RD AVE PORTLAND R894607750	1948 Building Minimal Traditional Shingle	Recommended Not Eligible/Non-Contributing	Modifications to plan, cladding, and siding diminish the building's historical integrity and its potential to meet minimum qualifications for listing in the NRHP

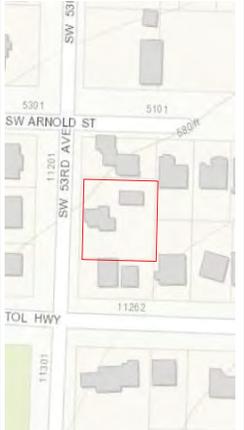
Project ID Survey # Acquisition	Resource Name Address & Assoc. Address Property ID Historic Name	Construction Date Resource Type Primary Style Primary Siding	NRHP Status	Integrity Comments / Notes	Photograph of Resource	Location
SW_9715 292 TCE	11224 SW 53RD AVE PORTLAND R894607760	1944 Building Minimal Traditional Cedar Shake Shingle	Recommended Not Eligible/Non-Contributing	Modifications to plan and cladding diminish the building's historical integrity and its potential to meet minimum qualifications for listing in the NRHP. A detached garage is situated northeast of the house.

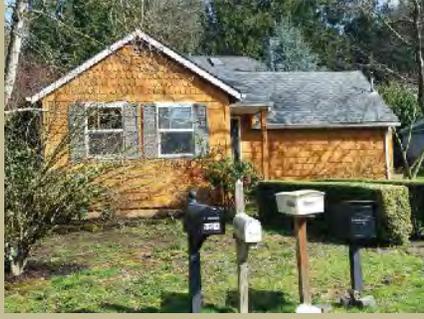
SW_17414 294 TCE	11138 SW 53RD AVE PORTLAND R894607210	1935 Building Minimal Traditional Horizontal Board	Recommended Not Eligible/Non-Contributing	Modifications to windows; not a distinctive example of a type, period, or method of construction. This building has no historical associations of significance under Criteria A through D.

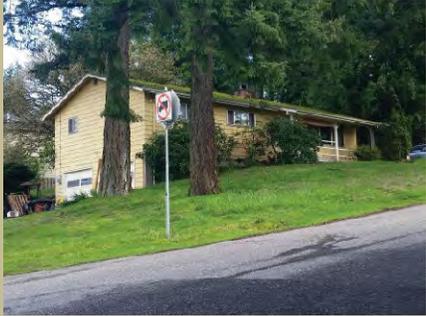
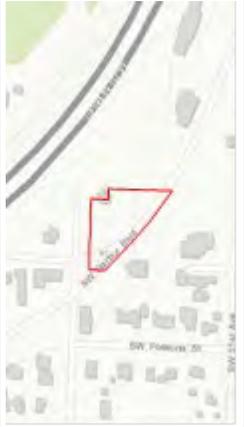
Project ID Survey # Acquisition	Resource Name Address & Assoc. Address Property ID Historic Name	Construction Date Resource Type Primary Style Primary Siding	NRHP Status	Integrity Comments / Notes	Photograph of Resource	Location
SW_16222 295 TCE	11106 SW 53RD AVE PORTLAND R894607190	1961 Building Ranch Horizontal Board	Recommended Not Eligible/Non-Contributing	Not a distinctive example of a type, period, or method of construction; this house has no historical associations of significance under Criterion A through D.

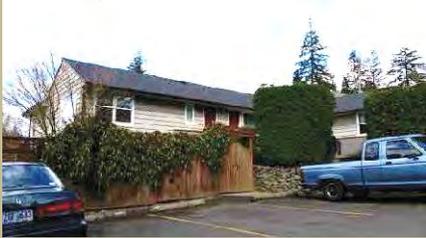
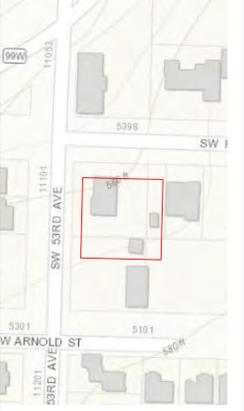
SW_17516 296 NO IMPACT	5203-5227 SW POMONA ST PORTLAND R894604160	1954 Building Minimal Traditional Horizontal Board	Recommended Not Eligible/Non-Contributing	Modifications to siding and windows diminish the building's historical integrity and its potential to meet minimum qualifications for listing in the NRHP.

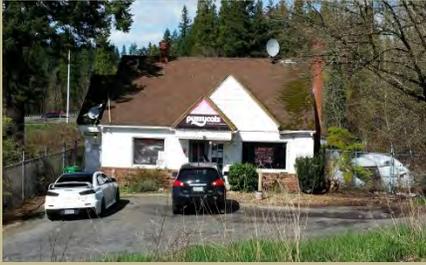
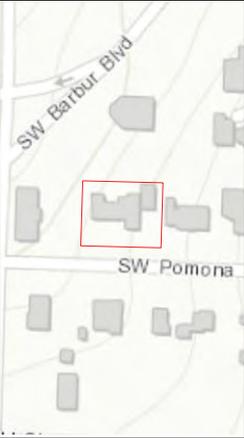
SW_12618 297 FULL	10813 SW BARBUR BLVD PORTLAND R894603430	1947 Building Tudor Revival Stucco	Recommended Not Eligible/Non-Contributing	Modifications to fenestration and setting diminish the building's historical integrity and its potential to meet minimum qualifications for listing in the NRHP.

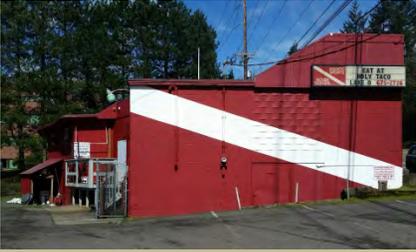
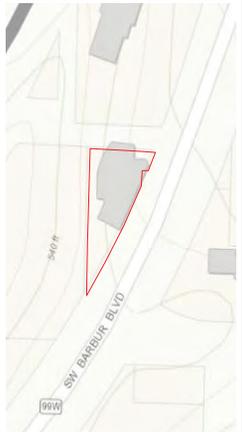
Project ID Survey # Acquisition	Resource Name Address & Assoc. Address Property ID Historic Name	Construction Date Resource Type Primary Style Primary Siding	NRHP Status	Integrity Comments / Notes	Photograph of Resource	Location
SW_16582 298 FULL	10803 SW BARBUR BLVD PORTLAND R894600290	1956 Building Modern Commercial Concrete Block	Recommended Not Eligible/Non-Contributing	Window modifications; not a distinctive example of a type, period, or method of construction. This building has no historical associations of significance under Criteria A through D.

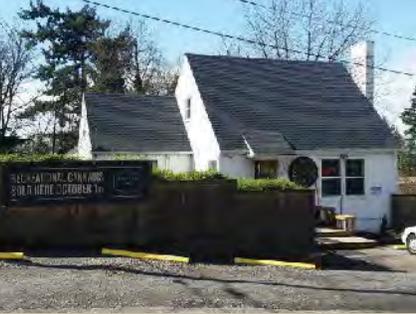
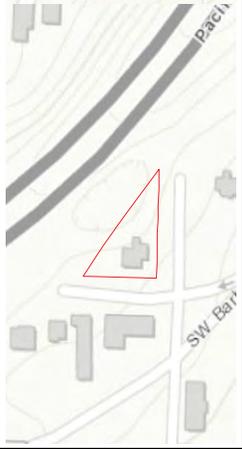
SW_2756 299 FULL	10931 SW 53RD AVE PORTLAND R894603710	1940 Building Cape Cod Vertical Board	Recommended Not Eligible/Non-Contributing	Modifications to siding and windows diminish the building's historical integrity and its potential to meet minimum qualifications for listing in the NRHP. The attached garage has been converted and enclosed.

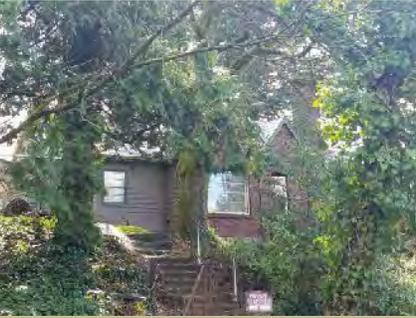
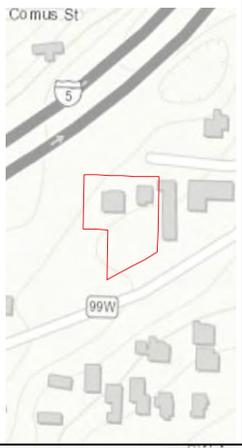
SW_9014 300 FULL	5350 SW PASADENA ST PORTLAND R894603870	1938 Building Tudor Revival Horizontal Board	Recommended Eligible/Contributing	The house is a good example of the Tudor Revival style for this area. Associated outbuildings do not contribute to the house's NRHP eligibility.

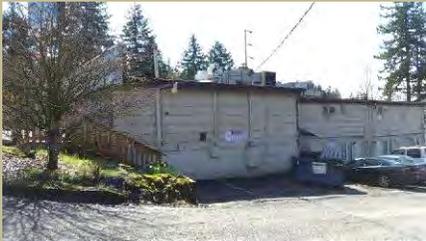
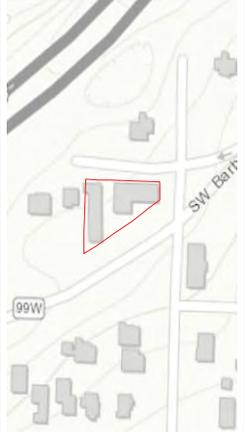
Project ID Survey # Acquisition	Resource Name Address & Assoc. Address Property ID Historic Name	Construction Date Resource Type Primary Style Primary Siding	NRHP Status	Integrity Comments / Notes	Photograph of Resource	Location
SW_20756 301 FULL	11051 SW BARBUR BLVD PORTLAND R894603900	1949 Building Commercial Concrete Block	Recommended Not Eligible/Non-Contributing	This complex consists of two buildings; the eastern building provides commercial and residential space while the building to the west is used for multi-family housing. The complex has no historical associations of significance under Criteria A through D.

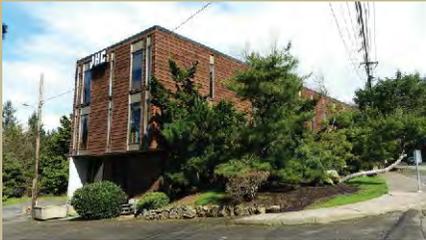
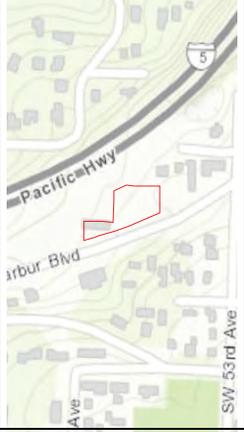
SW_9015 302 FULL	11125 SW BARBUR BLVD PORTLAND R894607370	1969 Building Modern Period Other Horizontal Board	Recommended Eligible/Contributing	This building is a good example of its type and period of construction, and is eligible for listing in the NRHP under Criterion C.

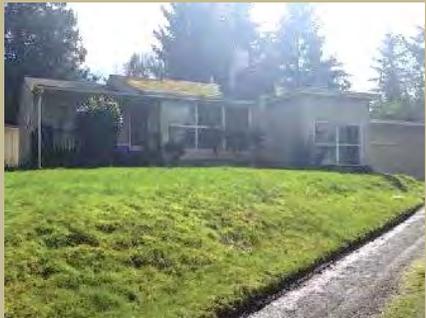
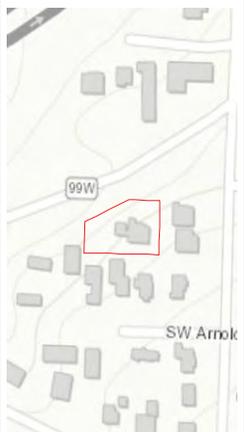
SW_14012 303 PARTIAL	11100 SW BARBUR BLVD PORTLAND R894607450	1945 Building Minimal Traditional Horizontal Board	Recommended Not Eligible/Non-Contributing	Modifications to plan, cladding, and windows diminish the building's historical integrity and its potential to meet minimum qualifications for listing in the NRHP.

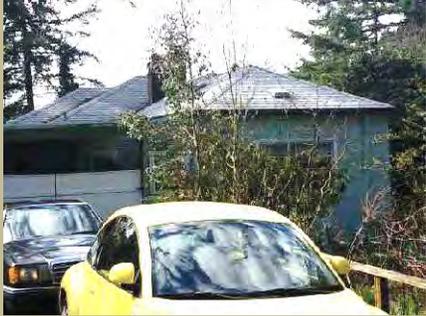
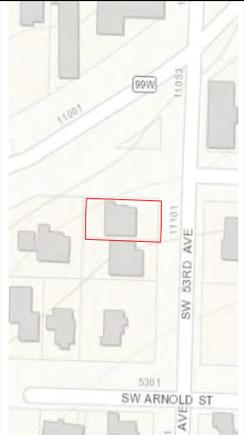
Project ID Survey # Acquisition	Resource Name Address & Assoc. Address Property ID Historic Name	Construction Date Resource Type Primary Style Primary Siding	NRHP Status	Integrity Comments / Notes	Photograph of Resource	Location
SW_19695 304 TCE	5308 SW POMONA ST PORTLAND R894607460	1942 Building WWII Era Cottage Horizontal Board	Recommended Not Eligible/Non-Contributing	House retains good integrity; however, modifications to the windows and setting were observed. In addition, the house is not a distinctive example of a type, period, or method of construction, nor does it have historical associations of significance under Criteria A through D.

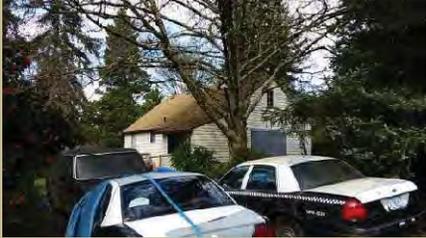
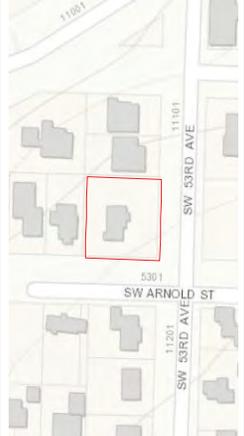
SW_6504 305 TCE	11133 SW 53RD AVE PORTLAND R894607480	1940 Building Colonial Revival Horizontal Board	Recommended Not Eligible/Non-Contributing	Modifications to fenestration diminish the building's historical integrity and its potential to meet minimum qualifications for listing in the NRHP.

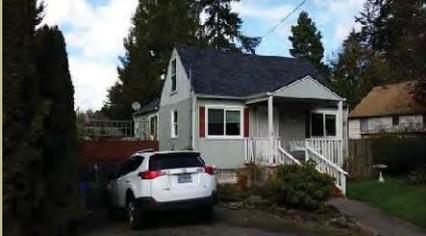
SW_183 306 NO IMPACT	5325 SW ARNOLD ST PORTLAND R894607500	1941 Building Minimal Traditional Vertical Board	Recommended Not Eligible/Non-Contributing	Modifications to siding and windows diminish the building's historical integrity and its potential to meet minimum qualifications for listing in the NRHP.

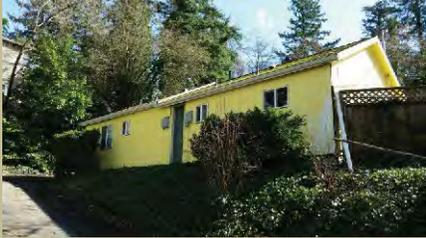
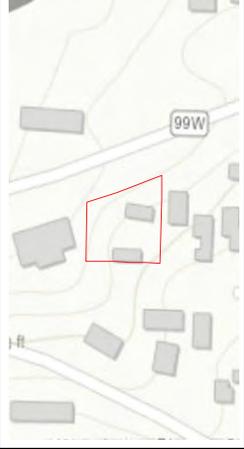
SW_964 308 EASEMENT	11120 SW BARBUR BLVD PORTLAND R894607540	1947 Building WWII Era Cottage Vertical Board	Recommended Not Eligible/Non-Contributing	Two buildings are situated on this parcel; a 1947 building and a circa 1960 building to the north. Both are clad with T1-11 siding and have vinyl windows, although the 1947 building does retain some original wood windows. Changes to the windows and cladding diminish each building's historical integrity and its potential to meet minimum qualifications for listing in the NRHP

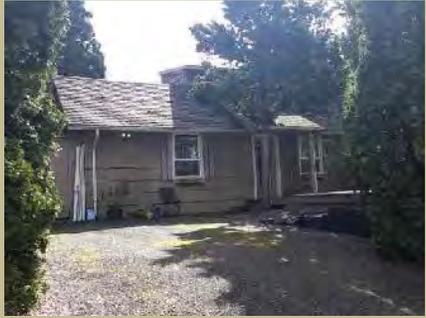
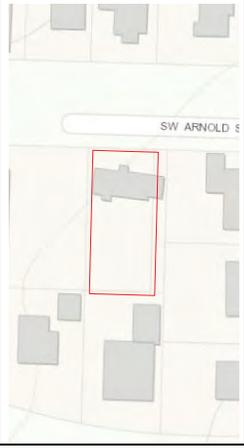
SW_7375 309 NO IMPACT	5324 SW ARNOLD ST PORTLAND R894607650	1940 Building Minimal Traditional Cedar Rake Shingle	Recommended Not Eligible/Non-Contributing	Modification to windows and siding diminish the building's historical integrity and its potential to meet minimum qualifications for listing in the NRHP. A large dormer has been added at the south elevation.

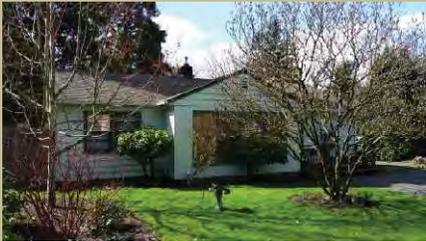
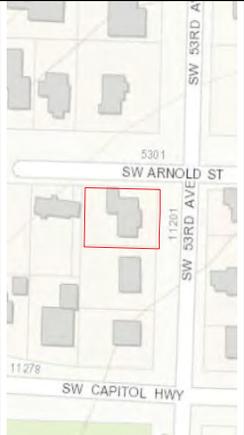
Project ID Survey # Acquisition	Resource Name Address & Assoc. Address Property ID Historic Name	Construction Date Resource Type Primary Style Primary Siding	NRHP Status	Integrity Comments / Notes	Photograph of Resource	Location
SW_15332 310 TCE	11207 SW 53RD AVE PORTLAND R894607660	1950 Building Minimal Traditional Horizontal Board	Recommended Not Eligible/Non-Contributing	Modifications to windows and siding diminish the building's historical integrity and its potential to meet minimum qualifications for listing in the NRHP.

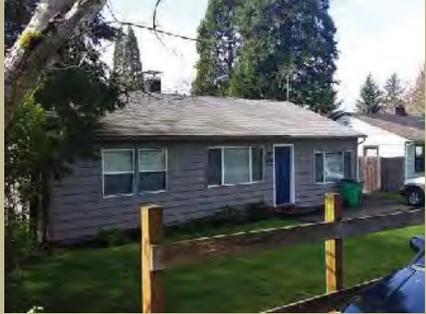
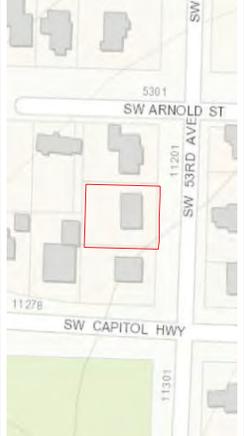
SW_8350 311 TCE	11221 SW 53RD AVE PORTLAND R894607680	1950 Building Ranch Horizontal Board	Recommended Not Eligible/Non-Contributing	Modifications to siding and fenestration diminish the building's historical integrity and its potential to meet minimum qualifications for listing in the NRHP. An attached garage has been converted to living space.

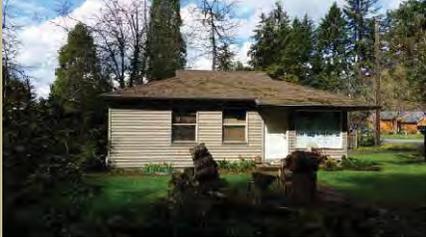
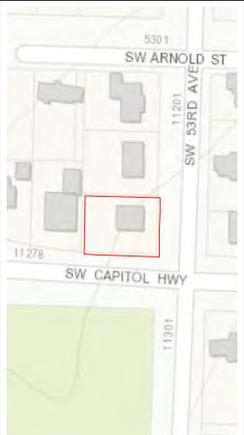
SW_9018 312 TCE	11271 SW CAPITOL HWY PORTLAND R894607690	1950 Building Vernacular Vinyl Siding	Recommended Not Eligible/Non-Contributing	Modifications to siding and windows diminish the building's historical integrity and its potential to meet minimum qualifications for listing in the NRHP. A detached outbuilding is situated west of the house.
