**Section 106 and 4(f) Public Documents
Supplemental Information: Potential Impacts and Mitigation
for Historic Properties and Public Parks
SW Corridor Light Rail Project
Draft – December 15th, 2020**

This technical memo details the potential SW Corridor Light Rail Project impacts to protected historic properties and parks resources, as well as the proposed mitigations. This memo is intended for public review and comment.

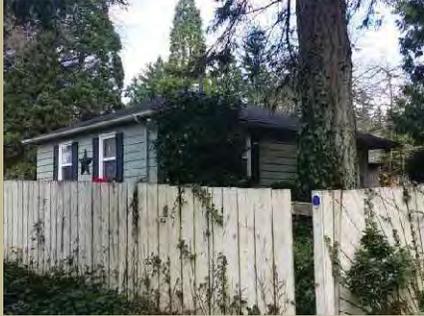
Project ID Survey # Acquisition	Resource Name Address & Assoc. Address Property ID Historic Name	Construction Date Resource Type Primary Style Primary Siding	NRHP Status	Integrity Comments / Notes	Photograph of Resource	Location
SW_18981 313 NO IMPACT	11273 SW CAPITOL HWY PORTLAND R894607700	1950 Building Vernacular Horizontal Board	Recommended Not Eligible/Non-Contributing	Modifications to windows; siding may be a replacement. A detached garage is situated northeast of the house. The house has no known historical associations of significance under Criteria A through D.

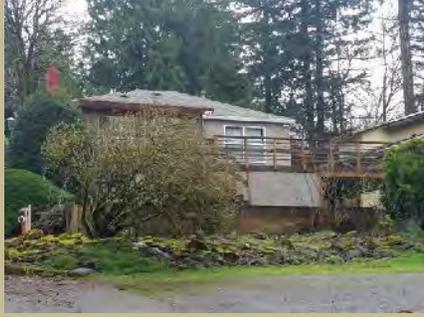
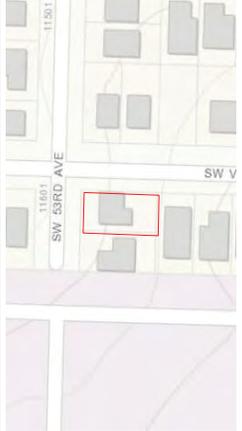
SW_18370 314 TCE	5238 SW VACUNA ST PORTLAND R894615710	1948 Building WWII Era Cottage Vertical Board	Recommended Not Eligible/Non-Contributing	Modifications to siding and windows diminish the building's historical integrity and its potential to meet minimum qualifications for listing in the NRHP. The original garage has been converted for use as living space.

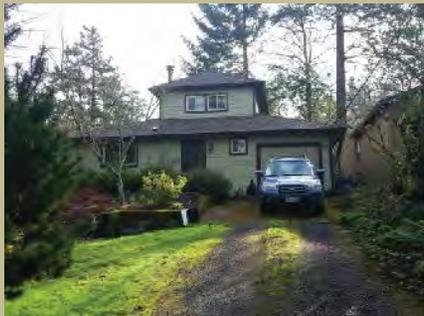
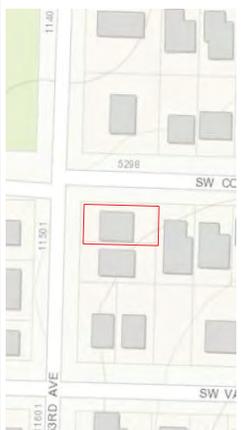
SW_17156 315 TCE	5234 SW CORONADO ST PORTLAND R894615110	1948 Building Ranch Horizontal Board	Recommended Not Eligible/Non-Contributing	Second story added; original windows and siding have been replaced, diminishing the building's historical integrity and its potential to meet minimum qualifications for listing in the NRHP.

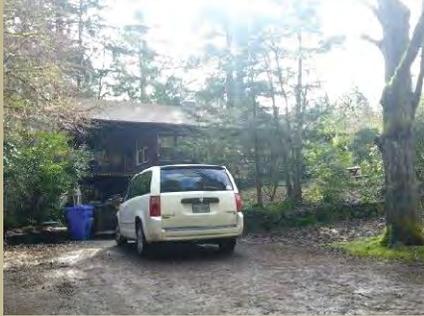
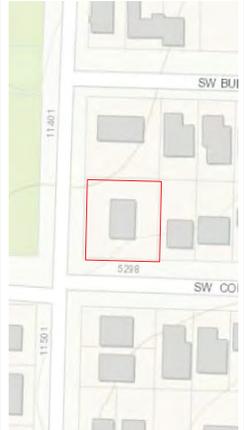
Project ID Survey # Acquisition	Resource Name Address & Assoc. Address Property ID Historic Name	Construction Date Resource Type Primary Style Primary Siding	NRHP Status	Integrity Comments / Notes	Photograph of Resource	Location
SW_14307 316 TCE	11434 SW 53RD AVE PORTLAND R894612090	1955 Building Ranch Horizontal Board	Recommended Not Eligible/Non-Contributing	Modifications to windows; not a distinctive example of a type, period, or method of construction. The building has no historical associations of significance under Criteria A through D.

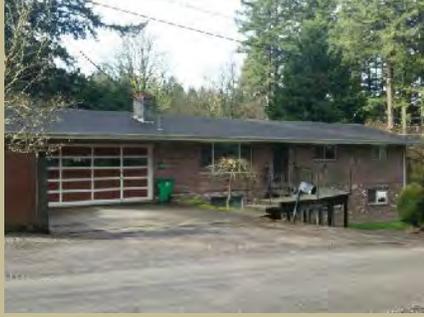
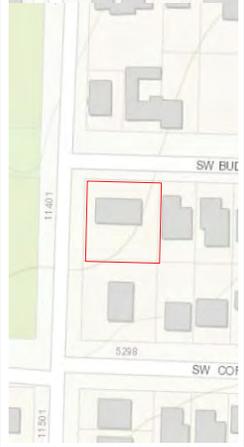
SW_3839 317 TCE	5232 SW BUDDINGTON ST PORTLAND R894612070	1962 Building Ranch Standard Brick	Recommended Not Eligible/Non-Contributing	Modifications to siding and windows diminish the building's historical integrity and its potential to meet minimum qualifications for listing in the NRHP.

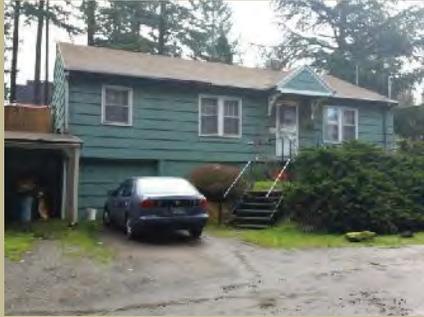
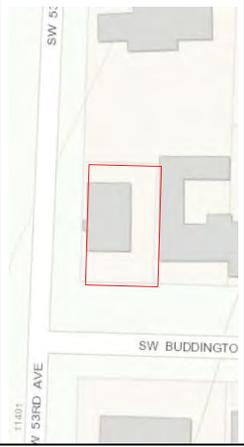
SW_22182 318 TCE	1336 SW 53RD AVE PORTLAND R894611520	1946 Building Minimal Traditional Cedar Shake Shingle	Recommended Not Eligible/Non-Contributing	Good integrity but not a distinctive example of a type, period, or method of construction. The building has no historical associations of significance under Criteria A through D.

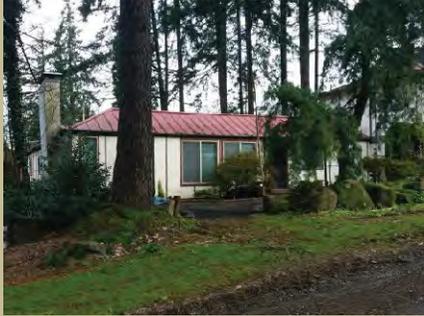
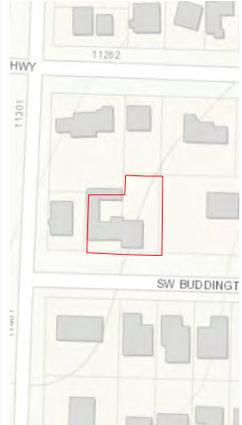
Project ID Survey # Acquisition	Resource Name Address & Assoc. Address Property ID Historic Name	Construction Date Resource Type Primary Style Primary Siding	NRHP Status	Integrity Comments / Notes	Photograph of Resource	Location
SW_7785 319 NO IMPACT	5223 SW BUDDINGTON ST PORTLAND R894611510	1940 Building Vernacular Stucco	Recommended Not Eligible/Non-Contributing	Extensive modifications to plan, cladding, and fenestration diminish the building's historical integrity and its potential to meet minimum qualifications for listing in the NRHP.

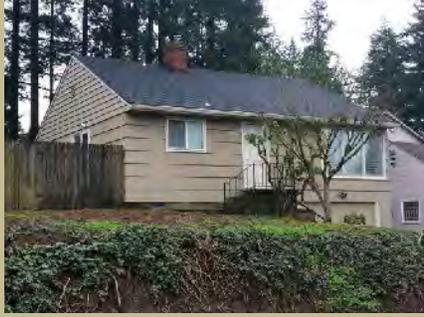
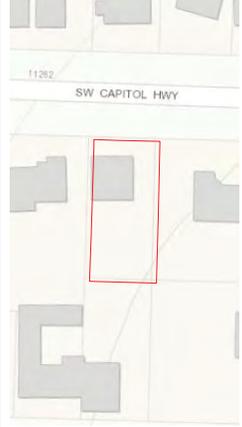
SW_8408 320 NO IMPACT	11256 SW CAPITOL HWY PORTLAND R894611530	1952 Building Minimal Traditional Cedar Shake Shingle	Recommended Not Eligible/Non-Contributing	Modifications to cladding and windows diminish the building's historical integrity and its potential to meet minimum qualifications for listing in the NRHP

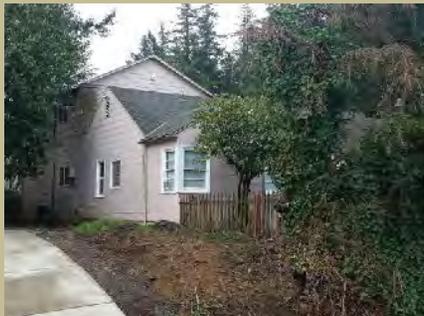
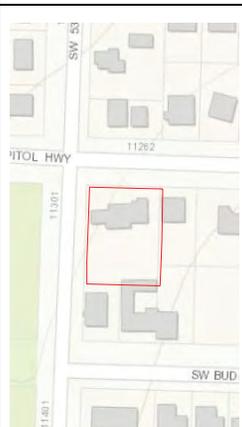
SW_14568 321 TCE	11262 SW CAPITOL HWY PORTLAND R894611490	1940 Building Other / Undefined Cement Fiber Siding	Recommended Not Eligible/Non-Contributing	Modifications to plan, siding, and windows diminish the building's historical integrity and its potential to meet minimum qualifications for listing in the NRHP

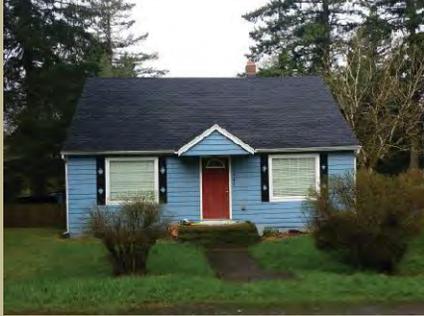
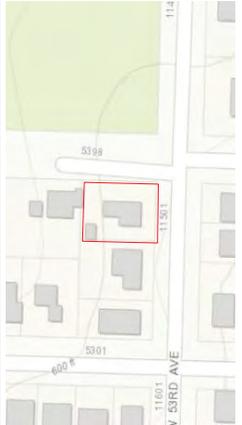
Project ID Survey # Acquisition	Resource Name Address & Assoc. Address Property ID Historic Name	Construction Date Resource Type Primary Style Primary Siding	NRHP Status	Integrity Comments / Notes	Photograph of Resource	Location
SW_20194 322 TCE	11505 SW 53RD AVE PORTLAND R894615390	1948 Building Minimal Traditional Horizontal Board	Recommended Not Eligible/Non-Contributing	Original wood windows replaced with vinyl sashes. The building has no historical associations of significance under Criteria A through D.

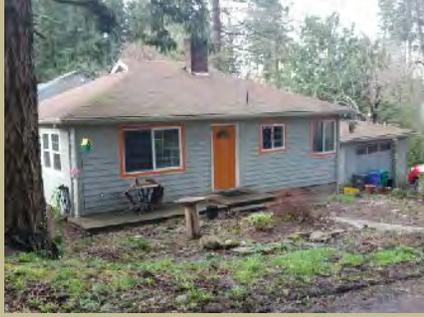
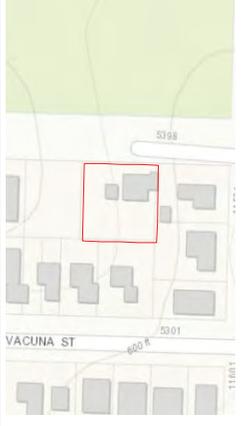
SW_18036 323 NO IMPACT	5322 SW CORONADO ST PORTLAND R894615360	1948 Building Vernacular Horizontal Board	Recommended Not Eligible/Non-Contributing	Modifications to siding and windows diminish the building's historical integrity and its potential to meet minimum qualifications for listing in the NRHP. A detached garage is situated west of the house.

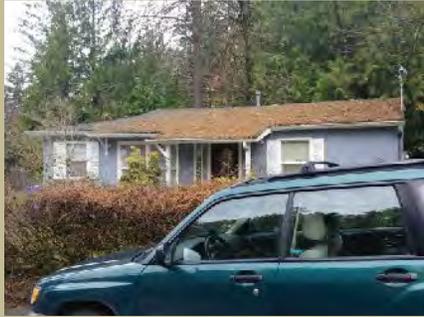
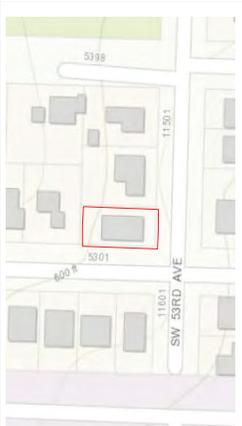
SW_22343 324 TCE	5309 SW VACUNA ST PORTLAND R894615420	1942 Building Vernacular Vertical Board	Recommended Not Eligible/Non-Contributing	Modifications to plan, siding, and windows diminish the building's historical integrity and its potential to meet minimum qualifications for listing in the NRHP.

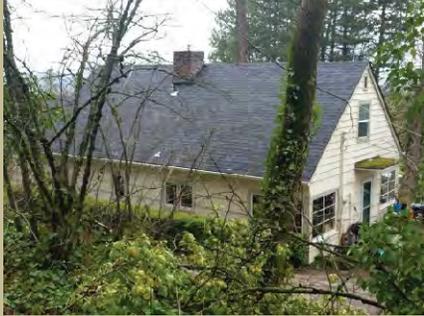
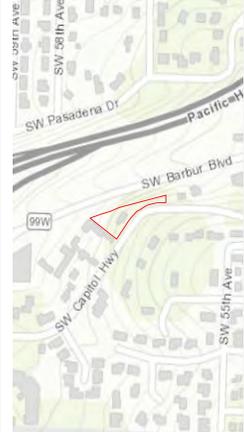
Project ID Survey # Acquisition	Resource Name Address & Assoc. Address Property ID Historic Name	Construction Date Resource Type Primary Style Primary Siding	NRHP Status	Integrity Comments / Notes	Photograph of Resource	Location
SW_21366 325 NO IMPACT	11323 SW CAPITOL HWY PORTLAND R991310210	1935 Building Minimal Traditional Cedar Shake Shingle	Recommended Not Eligible/Non-Contributing	Modifications to windows and siding diminish the building's historical integrity and its potential to meet minimum qualifications for listing in the NRHP. A detached garage is to the northeast.

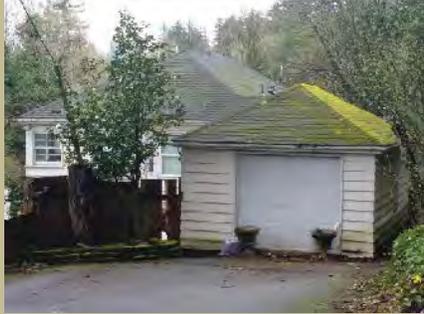
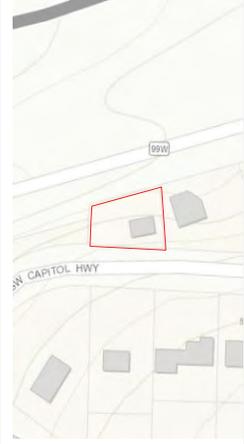
SW_4953 326 TCE	11305 SW CAPITOL HWY PORTLAND R991310370	1941 Building WWII Era Cottage Horizontal Board	Recommended Not Eligible/Non-Contributing	Some modern windows observed; not a distinctive example of a type, period, or method of construction. The building has no historical associations of significance under Criteria A through D.

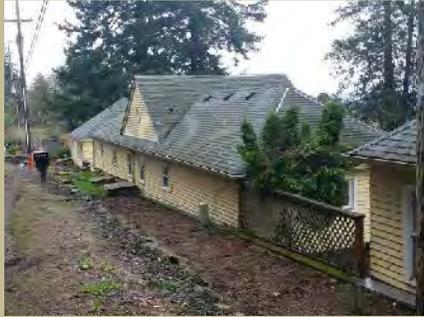
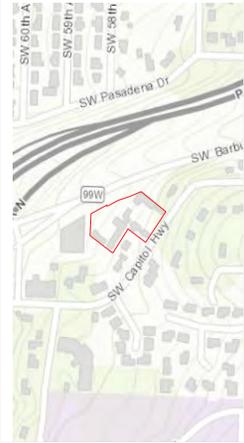
SW_14572 327 NO IMPACT	Westview Terrace 11240 SW BARBUR BLVD PORTLAND Parcel R991310850 R991311560 Breeze Hill Motel and Apartments	1938 Building WWII Era Cottage Horizontal Board	Recommended Not Eligible/Non-Contributing	Modifications to windows and siding diminish the building's historical integrity and its potential to meet minimum qualifications for listing in the NRHP. Units were constructed in 1938 and 1948 as hotel rooms and apartments. The complex is now operated as Westview Terrace; it is not a distinctive example of roadside architecture of SW Barbur Boulevard.

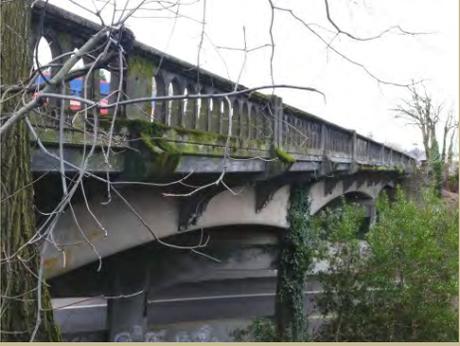
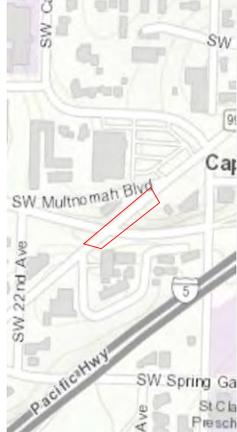
Project ID Survey # Acquisition	Resource Name Address & Assoc. Address Property ID Historic Name	Construction Date Resource Type Primary Style Primary Siding	NRHP Status	Integrity Comments / Notes	Photograph of Resource	Location
Overpass 328 NA	Hwy 1W over SW Multnomah Blvd Bridge #02010; Oregon Electric Railway Overcrossing	1934 Structure Not Applicable Not Applicable	Category II Bridge, ODOT Historic Bridge Field Guide (2013); Recommended Eligible/Contributing	Reinforced concrete deck girder bridge. ODOT bridge manual notes its date of construction as 1934, while the plaque on the bridge notes its date of completion as 1935.

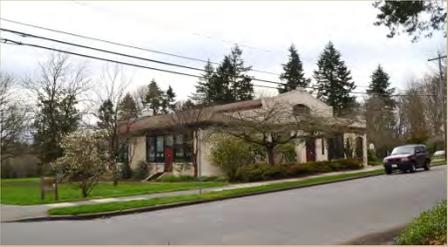
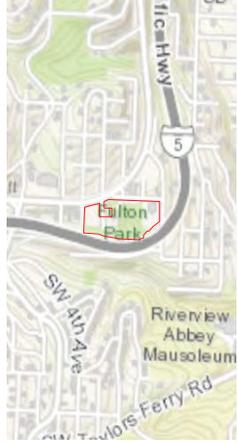
SW_16407 329 PARTIAL	Fulton Park 68 SW MILES ST PORTLAND	1941 Site Not Applicable	Fulton Park School Previously Recorded, City of Portland HRI (1984 - Rank II); Recommended Eligible/Contributing	Park encompasses the historic Fulton Park School and community gardens.

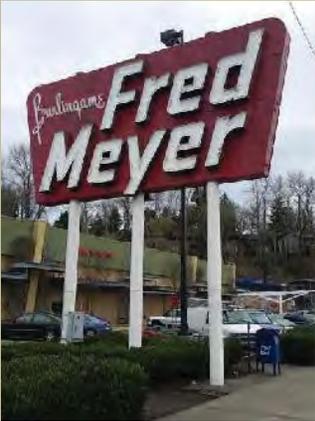
Sign 330 TCE	Burlingame Fred Meyer Sign 7529-7601 SW BARBUR BLVD PORTLAND	1950 Object Not Applicable Not Applicable	Recommended Eligible/Contributing	Sign designed and fabricated by Security Signs. The sign is a well- known visual landmark in the local community, and is a distinctive example of its type and period of construction.

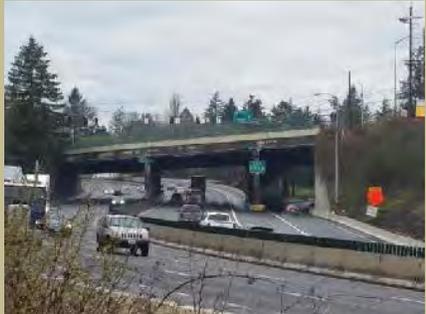
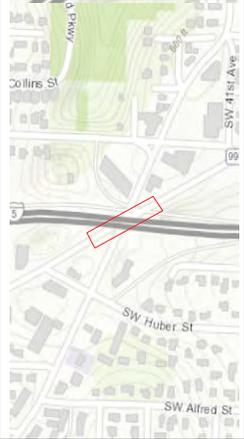
Overpass 332 NA	Hwy 1W (SW Barbur) over Hwy 1 Bridge #08205	1958 Structure Not Applicable Not Applicable	Recommended Not Eligible/Non-Contributing	Reinforced concrete deck girder. Not included in Oregon's Historic Bridge Field Guide (2013).

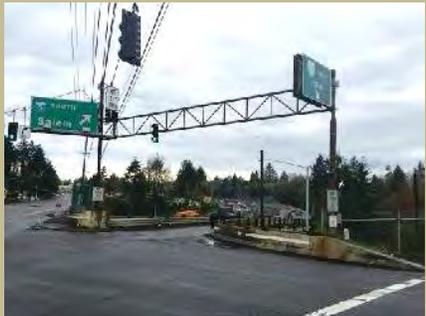
Overpass 333 NA	Sign Truss Br, Hwy 1W Conn at MP C6.21 Bridge #16496E	1961 Structure Not Applicable Not Applicable	Recommended Not Eligible/Non-Contributing	Steel truss sign bridge situated on an on-ramp constructed in 1958 that is not eligible for listing in the NRHP. Not a distinctive example of a type, period, or method of construction.

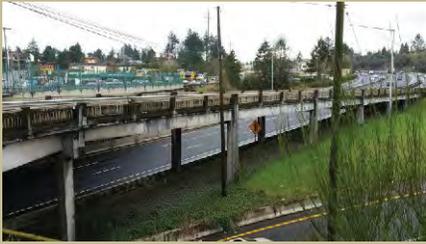
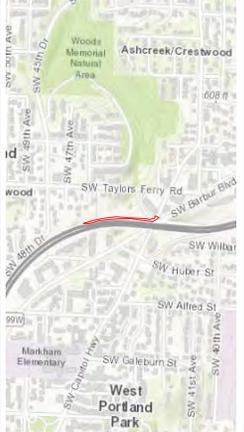
Project ID Survey # Acquisition	Resource Name Address & Assoc. Address Property ID Historic Name	Construction Date Resource Type Primary Style Primary Siding	NRHP Status	Integrity Comments / Notes	Photograph of Resource	Location
Overpass 334 NA	Hwy 1W SB Ramp to Hwy 1 SB Bridge #08205R	1958 Structure Not Applicable Not Applicable	Recommended Not Eligible/Non-Contributing	Reinforced concrete deck girder. Not included in Oregon's Historic Bridge Field Guide (2013).

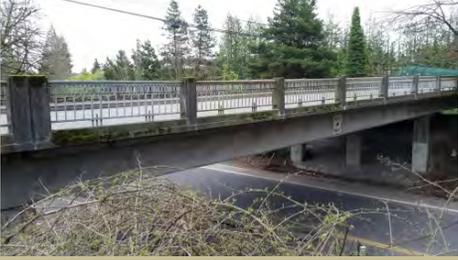
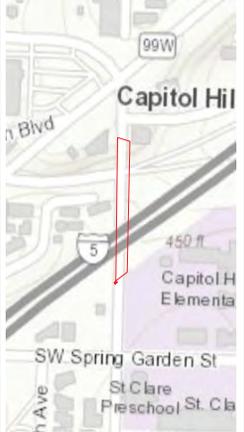
Overpass 335 NA	SW 19th Ave over Hwy 1 Conn Bridge #08201	1959 Structure Not Applicable Not Applicable	Recommended Not Eligible/Non-Contributing	Reinforced concrete deck girder. Not included in Oregon's Historic Bridge Field Guide (2013).

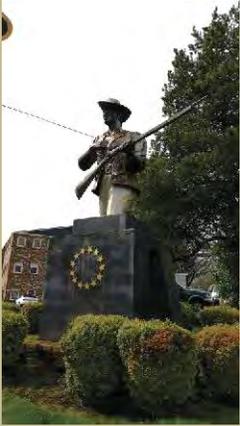
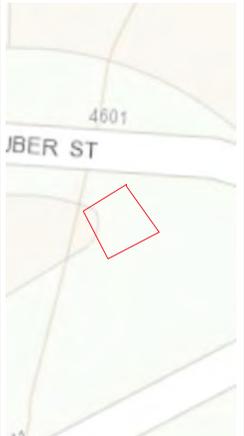
Access 336 NA	10149 SW Barbur Boulevard Soldier of Liberty	1976 Object Not Applicable Not Applicable	Created and installed less than 50 years ago; has potential to be locally significant but does not meet minimum NRHP eligibility requirements	Commissioned for the Colonial Office Campus at 10211 SW Barbur Boulevard. The statue was fabricated by Carlton Bell, a noted self-taught sculptor who arrived in Portland in 1970.

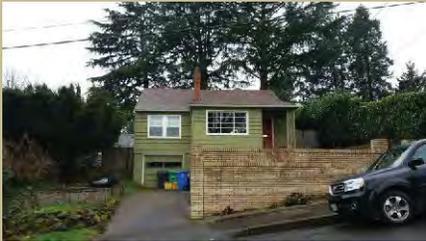
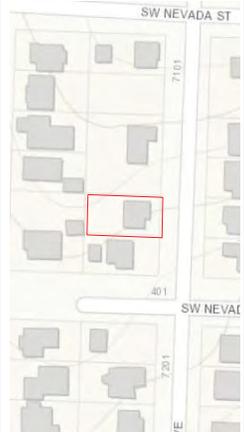
Project ID Survey # Acquisition	Resource Name Address & Assoc. Address Property ID Historic Name	Construction Date Resource Type Primary Style Primary Siding	NRHP Status	Integrity Comments / Notes	Photograph of Resource	Location
SW_8485 337 NO IMPACT	7147 SW 4TH AVE PORTLAND R300400790	1948 Building Minimal Traditional Horizontal Board	Recommended Eligible/Contributing	Intact and distinctive example of mixing Minimal Traditional and World War II-era Cottage styles.

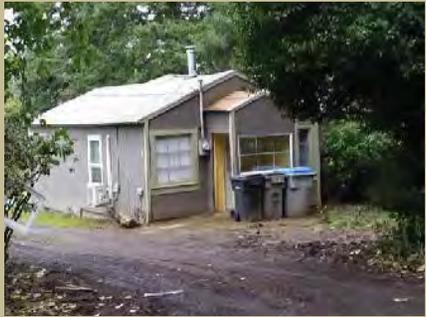
SW_7118 338 FULL	11515 SW 70TH AVE TIGARD R284873	Circa 1920 Building Vernacular Vertical Board	Recommended Not Eligible/Non-Contributing	Modifications to plan, windows, and siding diminish the building's historical integrity and its potential to meet minimum qualifications for listing in the NRHP

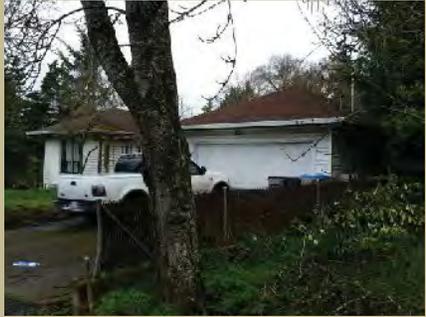
SW_17641 339 NO IMPACT	7135 SW BAYLOR ST TIGARD R285257	Circa 1910 Building Vernacular Vinyl Siding	Recommended Not Eligible/Non-Contributing	House appears to have been constructed circa 1910 and expanded circa 1955. Modern windows and vinyl siding were also observed that diminish the building's historical integrity and its potential to meet minimum qualifications for listing in the NRHP.

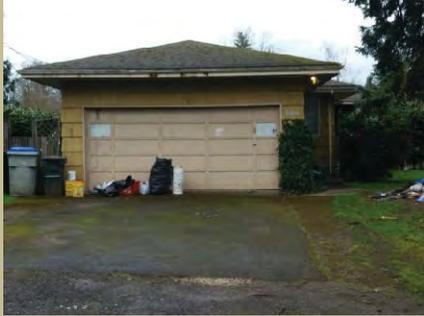
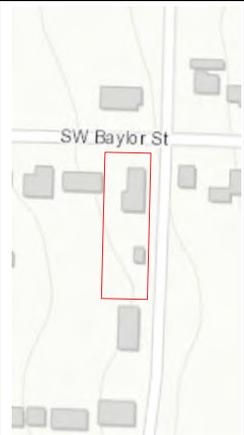
Project ID Survey # Acquisition	Resource Name Address & Assoc. Address Property ID Historic Name	Construction Date Resource Type Primary Style Primary Siding	NRHP Status	Integrity Comments / Notes	Photograph of Resource	Location
SW_18299 340 FULL	7010 SW BAYLOR ST TIGARD R285514	Circa 1955 Building Ranch Cedar Shake Siding	Recommended Not Eligible/Non-Contributing	Not a distinctive example of a type, period, or method of construction. This house does not have historical associations of significance under Criteria A through D.

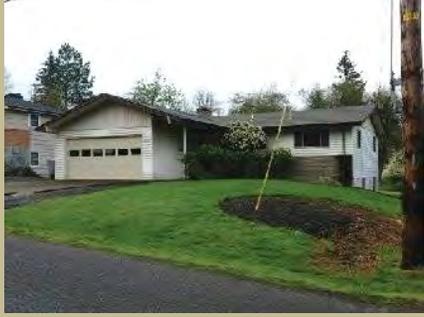
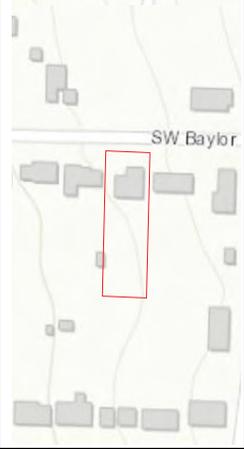
SW_3684 341 NO IMPACT	7070 SW BAYLOR ST TIGARD R285523	Circa 1960 Building Ranch Vinyl Siding	Recommended Not Eligible/Non-Contributing	Modifications to siding and windows diminish the building's historical integrity and its potential to meet minimum qualifications for listing in the NRHP.

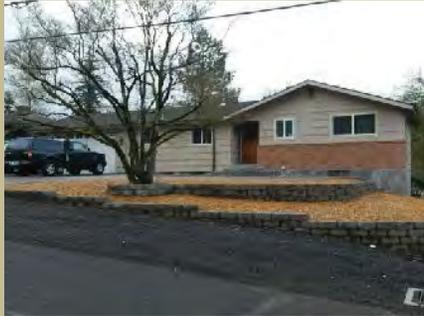
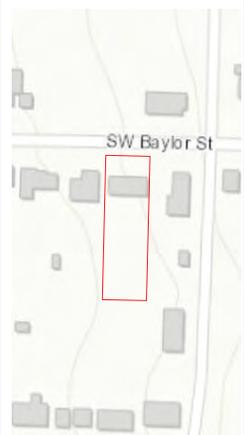
SW_6118 342 FULL	7040 SW BAYLOR ST TIGARD R285532	Circa 1960 Building Ranch Cedar Shake Siding	Recommended Not Eligible/Non-Contributing	Modifications to siding and windows diminish the building's historical integrity and its potential to meet minimum qualifications for listing in the NRHP.

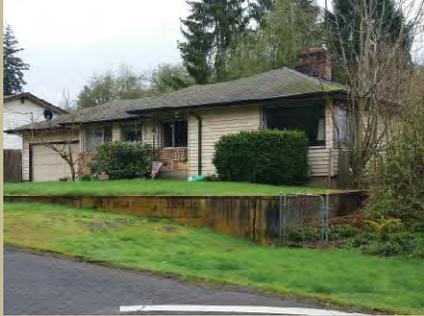
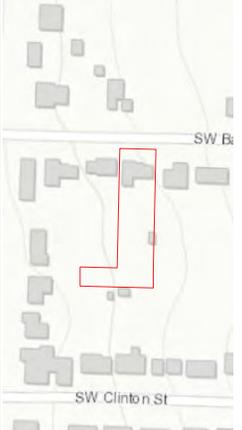
Project ID Survey # Acquisition	Resource Name Address & Assoc. Address Property ID Historic Name	Construction Date Resource Type Primary Style Primary Siding	NRHP Status	Integrity Comments / Notes	Photograph of Resource	Location
SW_17910 343 NO IMPACT	7100 SW BAYLOR ST TIGARD R285541	Circa 1958 Building Ranch Vinyl Siding	Recommended Not Eligible/Non-Contributing	Not a distinctive example of a type, period, or method of construction. This building has no historical associations of significance under Criteria A through D.

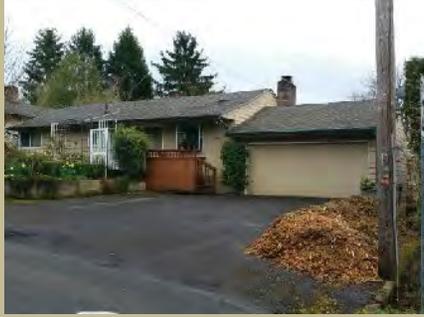
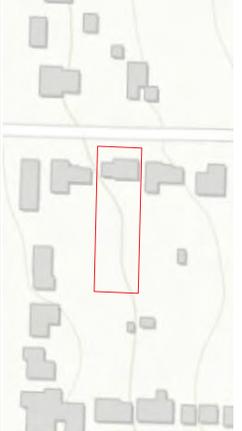
SW_10614 344 NO IMPACT	7130 SW BAYLOR ST TIGARD R285550	Circa 1955 Building Ranch Vertical Board	Recommended Not Eligible/Non-Contributing	Modifications to siding and windows diminish the building's historical integrity and its potential to meet minimum qualifications for listing in the NRHP.

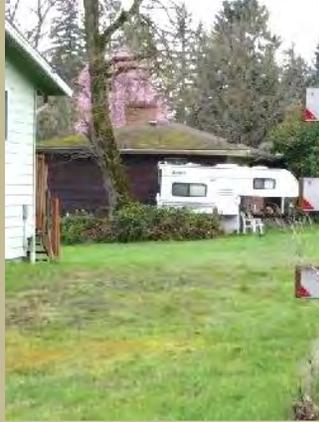
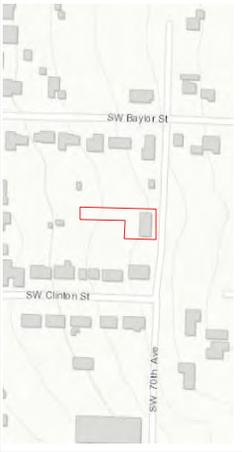
SW_22437 345 FULL	11745 SW 70TH AVE TIGARD R285612	Circa 1955 Building Ranch Vertical Board	Recommended Not Eligible/Non-Contributing	Modifications to siding diminish the building's historical integrity and its potential to meet minimum qualifications for listing in the NRHP. This building has no historical associations of significance under Criteria A through D.

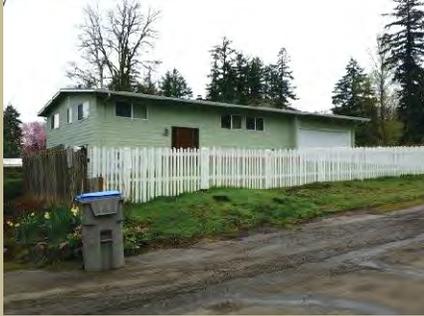
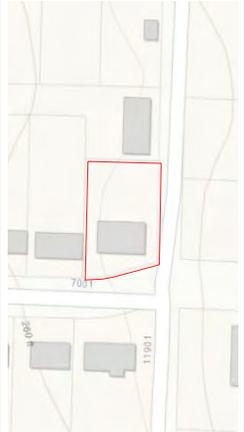
Project ID Survey # Acquisition	Resource Name Address & Assoc. Address Property ID Historic Name	Construction Date Resource Type Primary Style Primary Siding	NRHP Status	Integrity Comments / Notes	Photograph of Resource	Location
SW_22842 346 FULL	7015 SW CLINTON ST TIGARD R285630	Circa 1970 Building Split Entry Synthetic Wood Siding	Recommended Not Eligible/Non-Contributing	Modifications to windows and siding diminish the building's historical integrity and its potential to meet minimum qualifications for listing in the NRHP

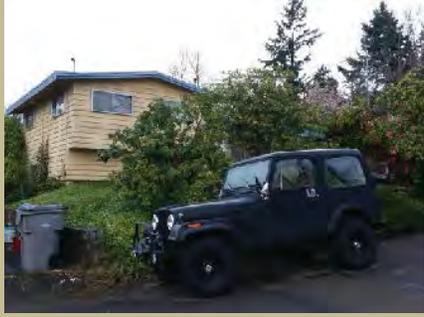
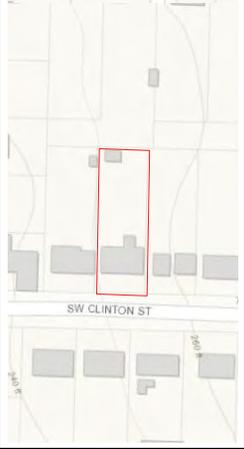
SW_13779 347 TCE	7105 SW CLINTON ST TIGARD R285649	Circa 1968 Building Split Level Horizontal Board	Recommended Not Eligible/Non-Contributing	Good integrity, but not a distinctive example of a type, period, or method of construction. The building has no historical associations of significance under Criteria A through D.

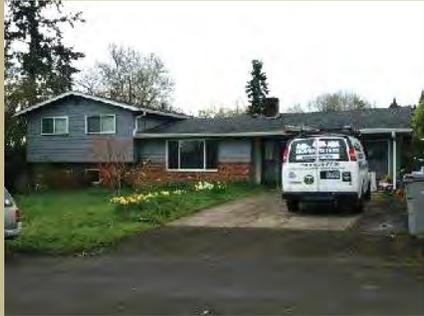
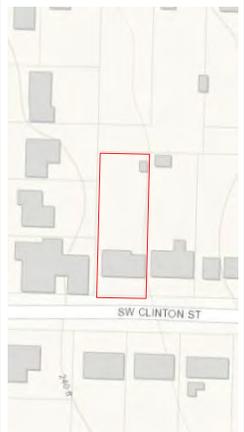
SW_21697 348 TCE	7135 SW CLINTON ST TIGARD R285658	Circa 1968 Building Split Level Horizontal Board	Recommended Not Eligible/Non-Contributing	All original windows replaced with vinyl sashes, diminishing the building's historical integrity and its potential to meet minimum qualifications for listing in the NRHP.

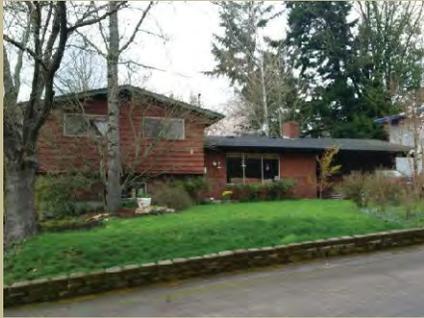
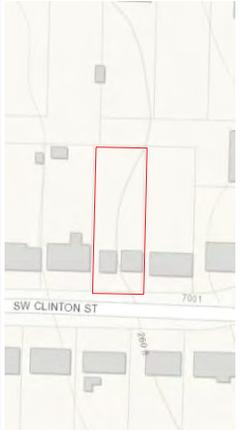
Project ID Survey # Acquisition	Resource Name Address & Assoc. Address Property ID Historic Name	Construction Date Resource Type Primary Style Primary Siding	NRHP Status	Integrity Comments / Notes	Photograph of Resource	Location
SW_5027 349 TCE	7075 SW CLINTON ST TIGARD R285667	Circa 1968 Building Split Level Horizontal Board	Recommended Not Eligible/Non-Contributing	Not a distinctive example of a type, period, or method of construction. The building has no historical associations of significance under Criteria A through D.

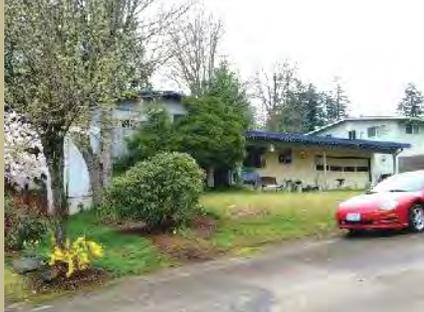
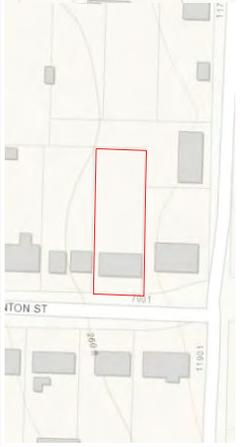
SW_9361 350 TCE	7045 SW CLINTON ST TIGARD R285676	Circa 1968 Building Split Level Vertical Board	Recommended Not Eligible/Non-Contributing	Modifications to siding diminish the building's historical integrity and its potential to meet minimum qualifications for listing in the NRHP.

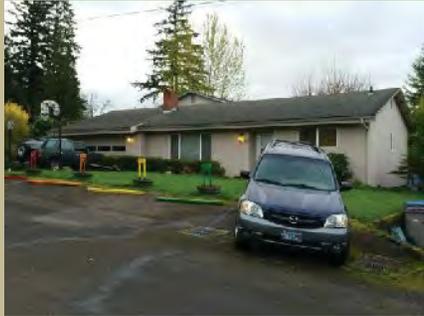
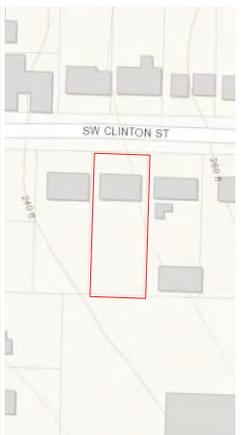
SW_5815 351 TCE	7110 SW CLINTON ST TIGARD R285710	Circa 1965 Building Ranch Vertical Board	Recommended Not Eligible/Non-Contributing	Modifications to cladding and windows diminish the building's historical integrity and its potential to meet minimum qualifications for listing in the NRHP.

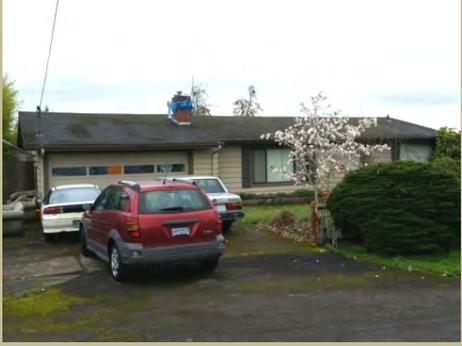
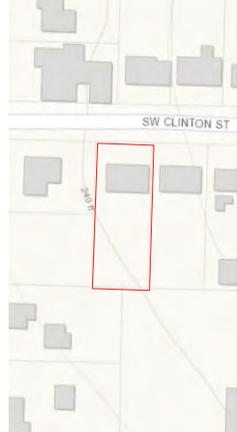
Project ID Survey # Acquisition	Resource Name Address & Assoc. Address Property ID Historic Name	Construction Date Resource Type Primary Style Primary Siding	NRHP Status	Integrity Comments / Notes	Photograph of Resource	Location
SW_12755 352 TCE	7140 SW CLINTON ST TIGARD R285729	Circa 1965 Building Ranch Horizontal Board	Recommended Not Eligible/Non-Contributing	Original windows replaced with anodized aluminum sashes. The house has no historical associations of significance under Criteria A through D.

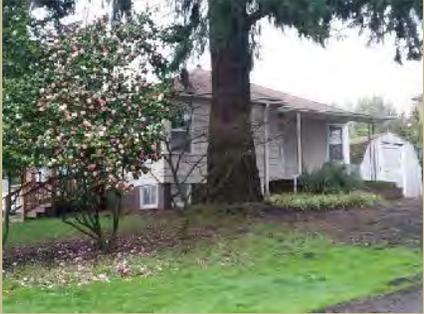
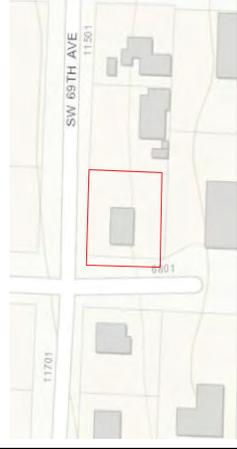
SW_1336 353 NO IMPACT	11600 SW 69TH AVE TIGARD R285916	Circa 1945 Building WWII-Era Cottage Horizontal Board	Recommended Not Eligible/Non-Contributing	Modifications to siding and main entry porch diminish the building's historical integrity and its potential to meet minimum qualifications for listing in the NRHP

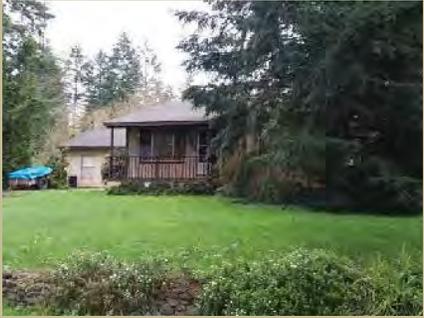
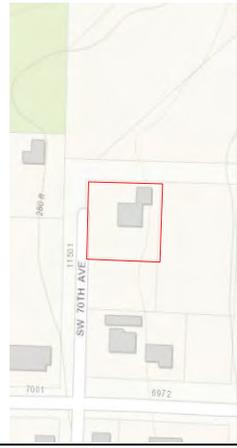
SW_7928 354 FULL	11540 SW 70TH AVE TIGARD R285952	Circa 1935 Building Minimal Traditional Vertical Board	Recommended Not Eligible/Non-Contributing	Modifications to windows and siding, and a large garage addition at the northeast corner of the house diminish the building's historical integrity and its potential to meet minimum qualifications for listing in the NRHP.

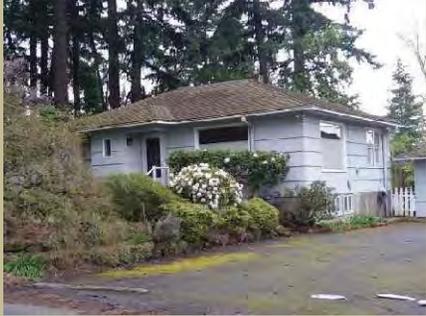
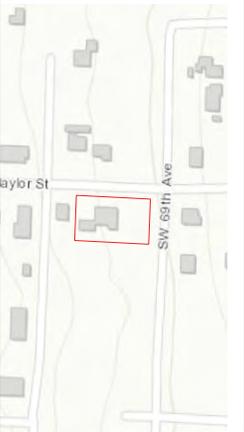
Project ID Survey # Acquisition	Resource Name Address & Assoc. Address Property ID Historic Name	Construction Date Resource Type Primary Style Primary Siding	NRHP Status	Integrity Comments / Notes	Photograph of Resource	Location
SW_3880 355 TCE	6940 SW BAYLOR ST TIGARD R286005	Circa 1955 Building Ranch Cedar Shake Shingle	Recommended Not Eligible/Non-Contributing	Siding may not be original; associated garage has been modified. Not a distinctive example of its type, period, or method of construction. The house has no historical associations of significance under Criteria A through D.

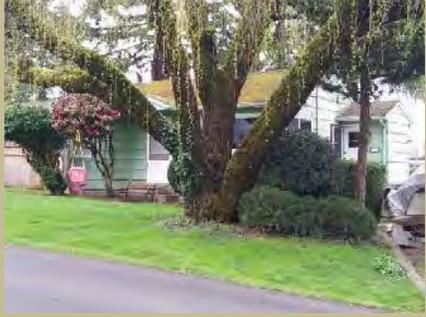
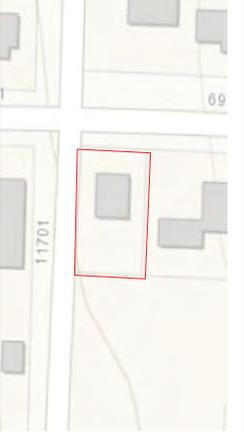
SW_21449 356 TCE	6980 SW BAYLOR ST TIGARD R286014	Circa 1935 Building Minimal Traditional Cedar Shake Shingle	Recommended Not Eligible/Non-Contributing	Modifications to windows and cladding diminish the building's historical integrity and its potential to meet minimum qualifications for listing in the NRHP.

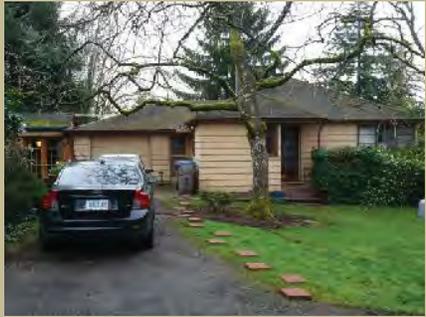
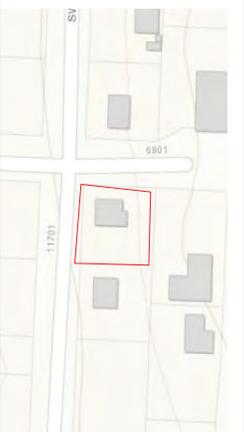
SW_13769 357 NO IMPACT	6870 SW BAYLOR ST TIGARD R286087	Circa 1948 Building WWII Era Cottage Horizontal Board	Recommended Not Eligible/Non-Contributing	Large addition to east elevation of the attached garage. The house is not a distinctive example of a type, period, or method of construction. The house has no historical associations of significance under Criteria A through D.

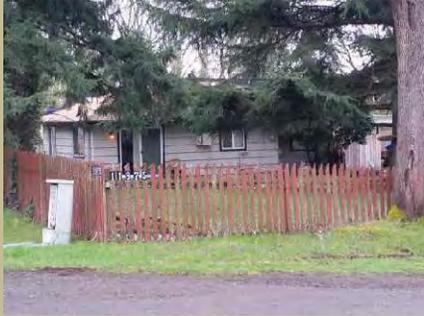
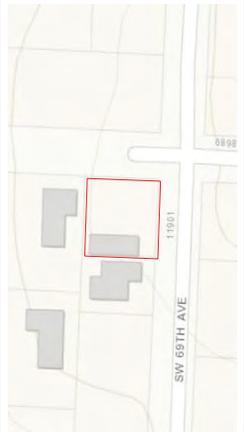
Project ID Survey # Acquisition	Resource Name Address & Assoc. Address Property ID Historic Name	Construction Date Resource Type Primary Style Primary Siding	NRHP Status	Integrity Comments / Notes	Photograph of Resource	Location
SW_17642 358 NO IMPACT	11875 SW 69TH AVE TIGARD R286522	Circa 1950 Building WWII Era Cottage Cedar Shake Shingle	Recommended Not Eligible/Non-Contributing	Extensive modifications to fenestration and a carport added to west elevation diminish the building's historical integrity and its potential to meet minimum qualifications for listing in the NRHP.

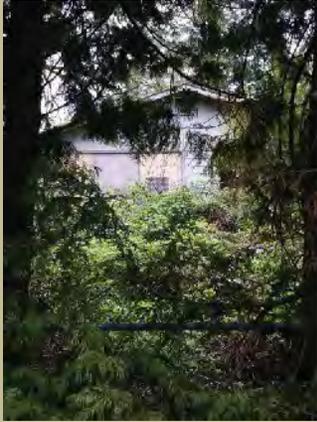
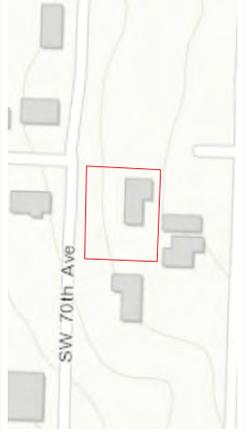
SW_17643 359 PARTIAL	6960 SW CLINTON ST TIGARD R1291854	Circa 1960 Building Ranch Vertical Board	Recommended Not Eligible/Non-Contributing	Modifications to windows and siding diminish the building's historical integrity and its potential to meet minimum qualifications for listing in the NRHP.

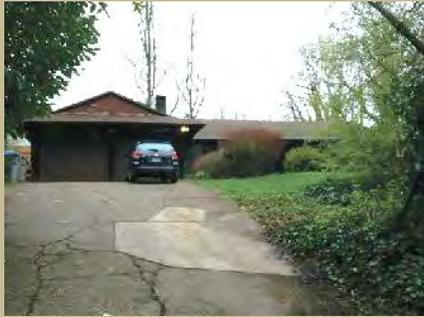
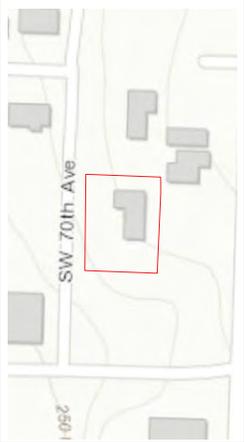
SW_19213 360 FULL	11930 SW 70TH AVE TIGARD R286568	Circa 1969 Building Ranch Vertical Board	Recommended Not Eligible/Non-Contributing	Modifications to windows and siding diminish the building's historical integrity and its potential to meet minimum qualifications for listing in the NRHP.

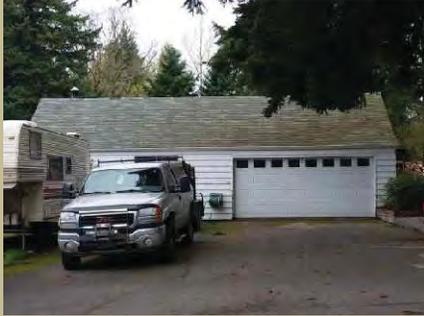
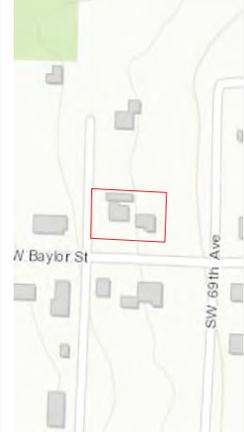
Project ID Survey # Acquisition	Resource Name Address & Assoc. Address Property ID Historic Name	Construction Date Resource Type Primary Style Primary Siding	NRHP Status	Integrity Comments / Notes	Photograph of Resource	Location
SW_11724 361 NO IMPACT	6945 SW BAYLOR ST TIGARD R 285970	1935 Building Colonial Revival/ Minimal Traditional Horizontal Board	Recommended Not Eligible/Non-Contributing	Modifications to siding and windows diminish the building's historical integrity and its potential to meet minimum qualifications for listing in the NRHP.

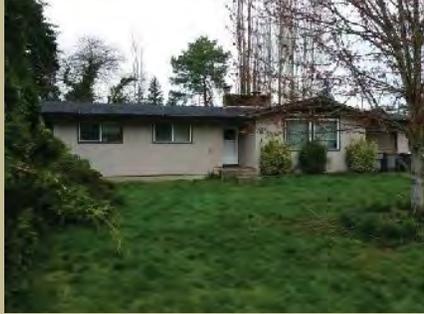
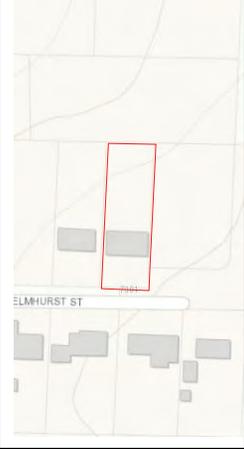
SW_16204 362 PARTIAL	7085 SW ELMHURST ST TIGARD R456982	Circa 1960 Building Ranch Vertical Board	Recommended Not Eligible/Non-Contributing	Modifications to siding and windows diminish the building's historical integrity and its potential to meet minimum qualifications for listing in the NRHP.

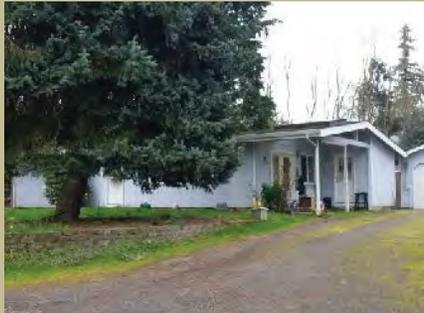
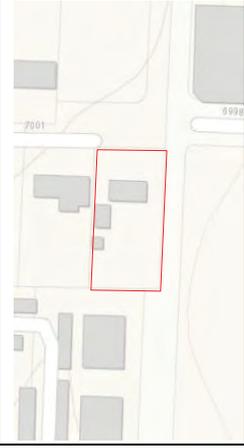
SW_14470 363 FULL	7040 SW ELMHURST ST TIGARD R457008	Circa 1970 Building Ranch Vertical Board	Recommended Not Eligible/Non-Contributing	Modifications to the windows and siding diminish the building's historical integrity and its potential to meet minimum qualifications for listing in the NRHP. An associated garage is situated southwest of the house.

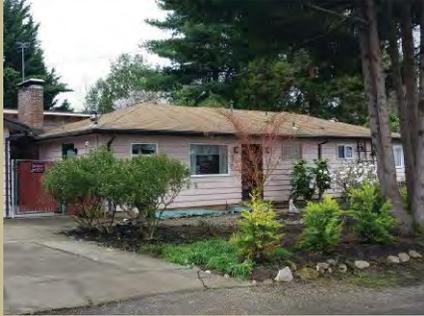
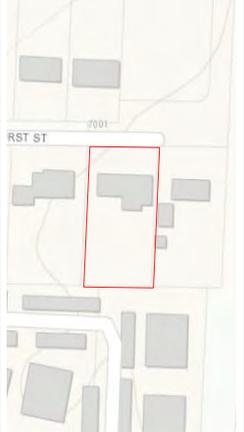
Project ID Survey # Acquisition	Resource Name Address & Assoc. Address Property ID Historic Name	Construction Date Resource Type Primary Style Primary Siding	NRHP Status	Integrity Comments / Notes	Photograph of Resource	Location
SW_13612 364 FULL	7070 SW ELMHURST ST TIGARD R457017	Circa 1955 Building Ranch Horizontal Board	Recommended Not Eligible/Non-Contributing	The fenestration has been extensively modified, diminishing the building's historical integrity and its potential to meet minimum qualifications for listing in the NRHP. A detached garage is situated east of the house.

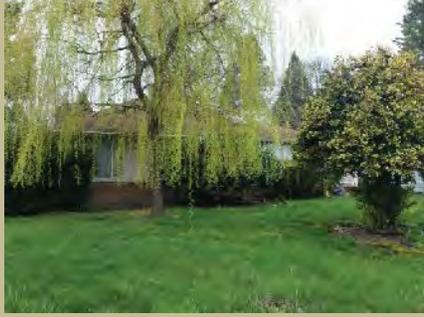
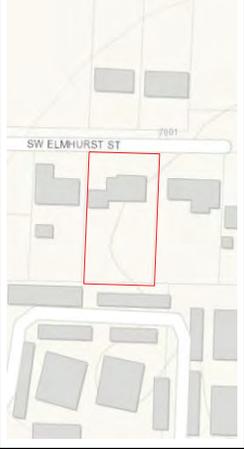
SW_6657 365 FULL	7100 SW ELMHURST ST TIGARD R457026	Circa 1955 Building Ranch Vertical Board	Recommended Not Eligible/Non-Contributing	Modifications to siding and windows diminish the building's historical integrity and its potential to meet minimum qualifications for listing in the NRHP

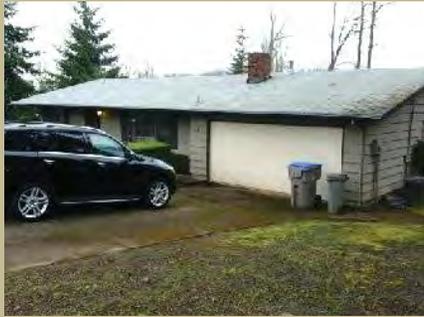
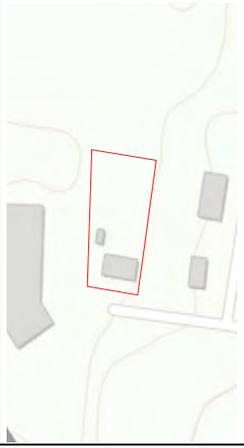
SW_18888 366 NO IMPACT	7615 SW BEVELAND RD TIGARD R457188	Circa 1960 Building Ranch Horizontal Board	Recommended Not Eligible/Non-Contributing	Not a distinctive example of a type, period, or method of construction. The building has no historical associations of significance under Criteria A through D.

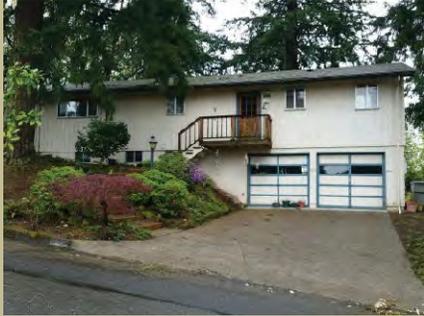
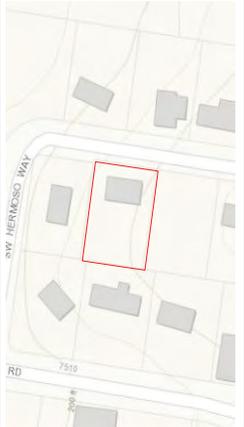
Project ID Survey # Acquisition	Resource Name Address & Assoc. Address Property ID Historic Name	Construction Date Resource Type Primary Style Primary Siding	NRHP Status	Integrity Comments / Notes	Photograph of Resource	Location
SW_17671 367 NO IMPACT	7460 SW HERMOSO WAY TIGARD R457268	1961 Building Ranch Vertical Board	Recommended Not Eligible/Non-Contributing	Original windows remain but siding has been replaced. Not a distinctive example of a type, period, or method of construction. The building has no historical associations of significance under Criteria A through D.

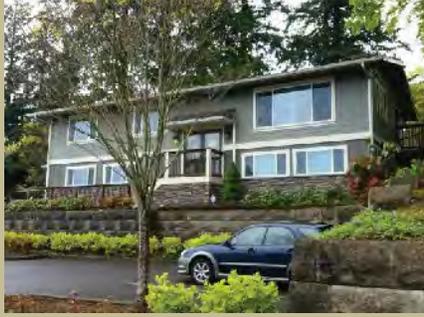
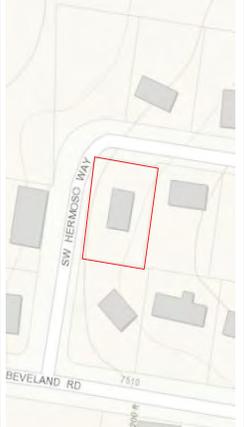
SW_155 368 NO IMPACT	Luby Professional Building 7540 SW HERMOSO WAY TIGARD R457286	1961 Building Split Entry Horizontal Board	Recommended Not Eligible/Non-Contributing	Split level house converted to commercial office space. Original siding and windows have been replaced, diminishing the building's historical integrity and its potential to meet minimum qualifications for listing in the NRHP.

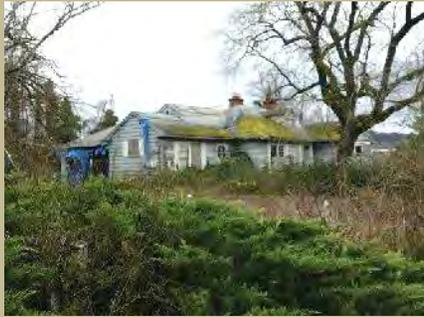
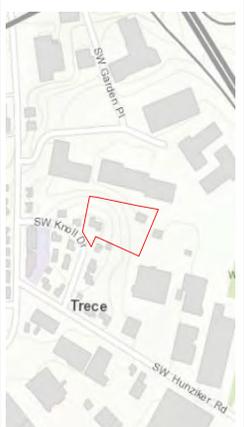
SW_5434 369 PARTIAL	12360 SW KNOLL DR TIGARD R458383	1938 Building Colonial Revival Horizontal Board	Recommended Not Eligible/Non-Contributing	Several windows have been removed while others have been replaced; house is in poor condition and its setting has been modified. Although the house has characteristics from its period of construction, it is no longer a distinctive example of its type, period, or method of construction. Furthermore, the building has no historic associations of significance under Criteria A through D.

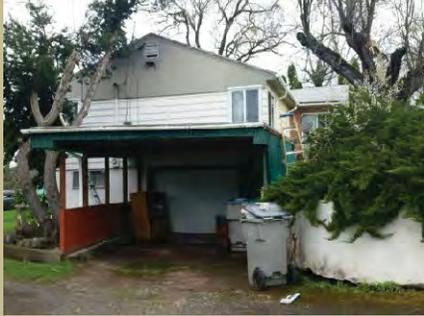
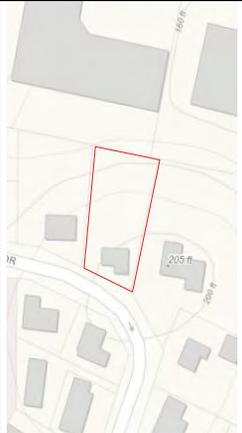
Project ID Survey # Acquisition	Resource Name Address & Assoc. Address Property ID Historic Name	Construction Date Resource Type Primary Style Primary Siding	NRHP Status	Integrity Comments / Notes	Photograph of Resource	Location
SW_2915 370 NO IMPACT	12330 SW KNOLL DR TIGARD R458392	1959 Building Ranch Horizontal Board	Recommended Not Eligible/Non-Contributing	Modifications to windows and siding diminish the building's historical integrity and its potential to meet minimum qualifications for listing in the NRHP.

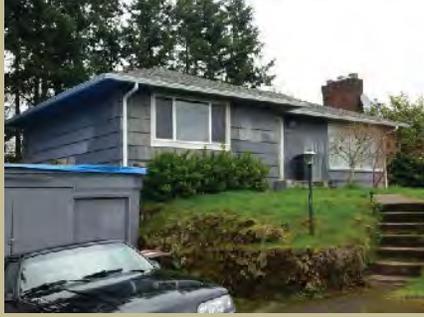
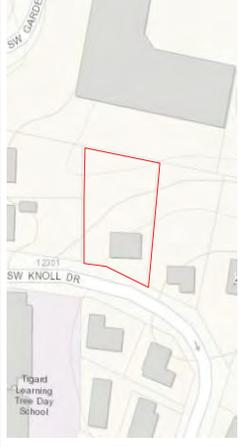
SW_19689 371 NO IMPACT	12300 SW KNOLL DR TIGARD R458409	1955 Building Ranch Cedar Shake Shingle	Recommended Not Eligible/Non-Contributing	Modifications to siding and windows diminish the building's historical integrity and its potential to meet minimum qualifications for listing in the NRHP.

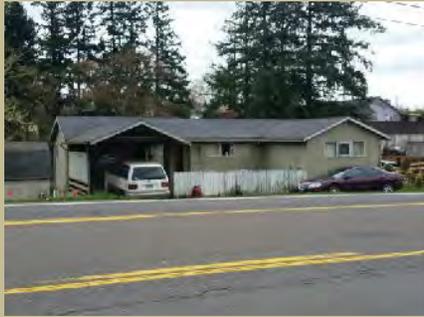
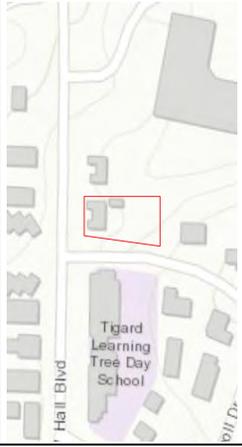
SW_6827 372 NO IMPACT	12280 SW HALL BLVD TIGARD R458427	1950 Building Ranch Vertical Board	Recommended Not Eligible/Non-Contributing	Siding not original; house is not a distinctive example of a type, period, or method of construction. The building has no known historical associations of significance under Criteria A through D.

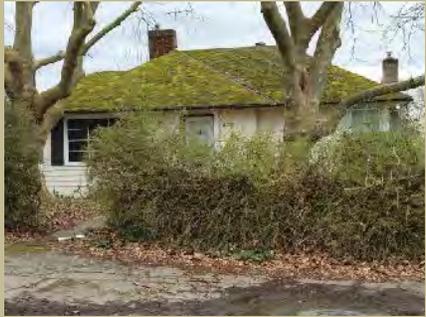
SW_17039 375 FULL	12390 SW KNOLL DR TIGARD R458506	1940 Building WWII Era Cottage Shingle	Recommended Not Eligible/Non-Contributing	Shingle siding does not appear to be original; some original wood windows have been replaced with vinyl sashes. Not a distinctive example of a type, period, or method of construction. The building has no historical associations of significance under Criteria A through D.

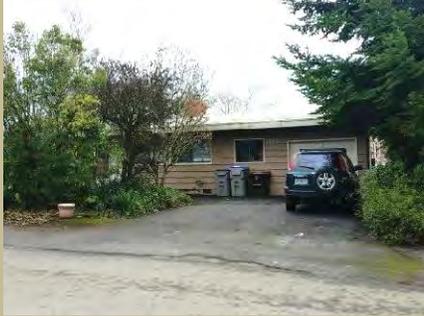
Project ID Survey # Acquisition	Resource Name Address & Assoc. Address Property ID Historic Name	Construction Date Resource Type Primary Style Primary Siding	NRHP Status	Integrity Comments / Notes	Photograph of Resource	Location
SW_19684 376 FULL	12420 SW KNOLL DR TIGARD R458515	1960 Building Ranch Cement Fiber Siding	Recommended Not Eligible/Non-Contributing	Modifications to windows and siding diminish the building's historical integrity and its potential to meet minimum qualifications for listing in the NRHP

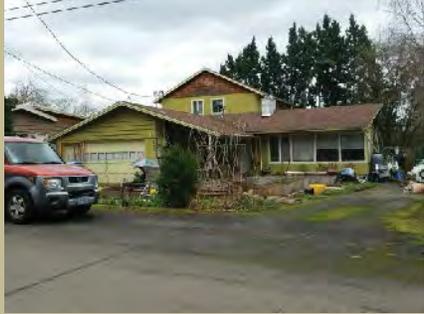
SW_19552 377 FULL	12450 SW KNOLL DR TIGARD R458524	1955 Building Modern Period Other Horizontal Board	Recommended Not Eligible/Non-Contributing	Second story added circa 2009. The plan, siding, and fenestration of the house have been modified, diminishing the building's historical integrity and its potential to meet minimum qualifications for listing in the NRHP.

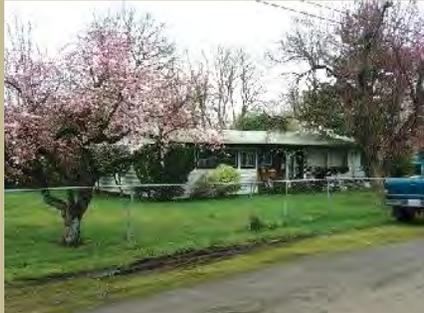
SW_1383 378 PARTIAL	12490 SW KNOLL DR TIGARD R458533	1946 Building Ranch Horizontal Board	Recommended Not Eligible/Non-Contributing	Modifications to plan, windows, and siding diminish the building's historical integrity and its potential to meet minimum qualifications for listing in the NRHP.

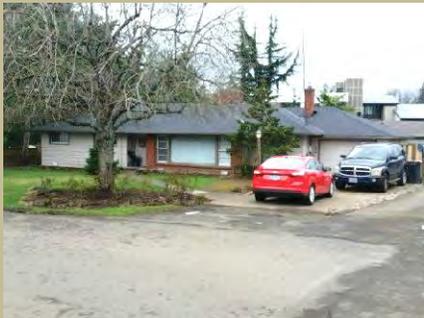
Project ID Survey # Acquisition	Resource Name Address & Assoc. Address Property ID Historic Name	Construction Date Resource Type Primary Style Primary Siding	NRHP Status	Integrity Comments / Notes	Photograph of Resource	Location
SW_17078 379 NO IMPACT	12435 SW KNOLL DR TIGARD R2037602	1955 Building Ranch Horizontal Board	Recommended Not Eligible/Non-Contributing	Most original windows have been replaced with vinyl sashes. The house has no historical associations of significance under Criteria A through D.

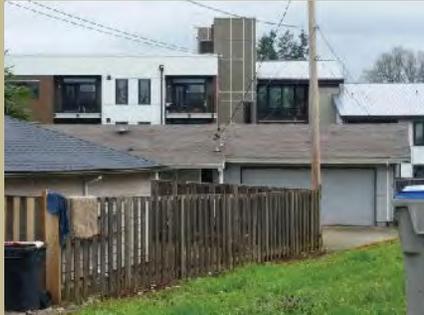
SW_18049 380 NO IMPACT	12419 SW KNOLL DR TIGARD R2037603	1958 Building Ranch Horizontal Board	Recommended Not Eligible/Non-Contributing	Modifications to siding and windows diminish the building's historical integrity and its potential to meet minimum qualifications for listing in the NRHP.

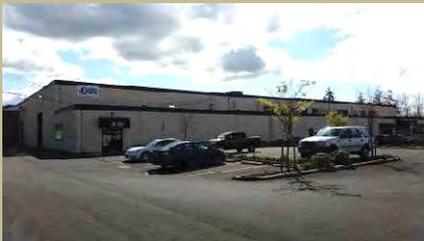
SW_13311 381 NO IMPACT	7940 SW HUNZIKER RD TIGARD R2157860	Circa 1963 Building Modern Commercial Concrete Panels	Recommended Not Eligible/Non-Contributing	North facade has been modernized; building is not a distinctive example of a type, period, or method of construction. The building has no historical associations of significance under Criteria A through D.

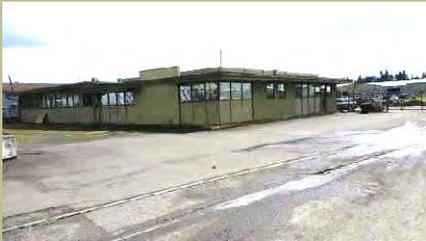
Project ID Survey # Acquisition	Resource Name Address & Assoc. Address Property ID Historic Name	Construction Date Resource Type Primary Style Primary Siding	NRHP Status	Integrity Comments / Notes	Photograph of Resource	Location
SW_19093 382 FULL	8200 SW HUNZIKER RD TIGARD R456054	Circa 1958 Building Modern Period Other Vertical Board	Recommended Not Eligible/Non-Contributing	Buildings once operated as part of a larger industrial operation that was constructed prior to 1960; the focal building of this operation was at the center of the parcel and was demolished during the modern era. Thus, the buildings that remain no longer retain historical integrity of design, setting, feeling, and association. This diminished integrity limits their eligibility to be listed in the NRHP.

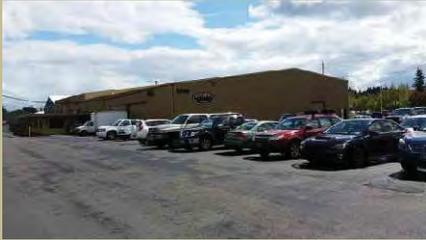
SW_13157 383 FULL	12700 SW HALL BLVD TIGARD R456045	Circa 1965 Building Modern Period Other Metal Other / Undefined	Recommended Not Eligible/Non-Contributing	A portion of this industrial complex was constructed prior to 1970; all buildings were completed by 1986. Not a distinctive example of a type, period, or method of construction. The building has no historical associations of significance.
