**Section 106 and 4(f) Public Documents
Supplemental Information: Potential Impacts and Mitigation
for Historic Properties and Public Parks
SW Corridor Light Rail Project
Draft – December 15th, 2020**

This technical memo details the potential SW Corridor Light Rail Project impacts to protected historic properties and parks resources, as well as the proposed mitigations. This memo is intended for public review and comment.

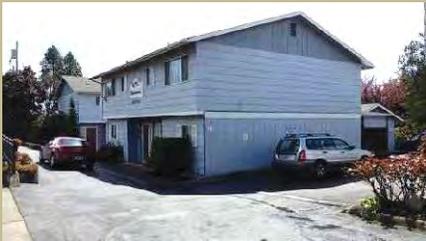
SW_20505 384 NO IMPACT	12375 SW HALL TIGARD R460502	Circa 1968 Building Modern Period Other Vertical Board	Recommended Not Eligible/Non-Contributing	Modifications to siding and windows diminish the building's historical integrity and its potential to meet minimum qualifications for listing in the NRHP.

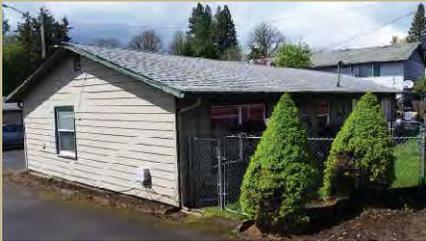
Project ID Survey # Acquisition	Resource Name Address & Assoc. Address Property ID Historic Name	Construction Date Resource Type Primary Style Primary Siding	NRHP Status	Integrity Comments / Notes	Photograph of Resource	Location
SW_18761 385 NO IMPACT	12437 SW HALL BLVD TIGARD R460511	Circa 1955 Building Modern Period Other Cement Fiber Siding	Recommended Not Eligible/Non-Contributing	Six small buildings, each with two units; original siding and windows have been replaced, diminishing the building's historical integrity and its potential to meet minimum qualifications for listing in the NRHP

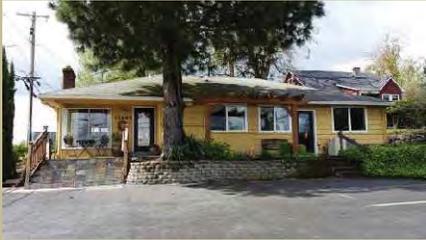
SW_12263 386 TCE	12665 SW HALL BLVD TIGARD R462001	Circa 1950 Building Ranch Horizontal Board	Recommended Not Eligible/Non-Contributing	The house is now used for commercial purposes. Most original windows have been removed and replaced with vinyl sashes. The building has no historical associations of significance under Criteria A through D.

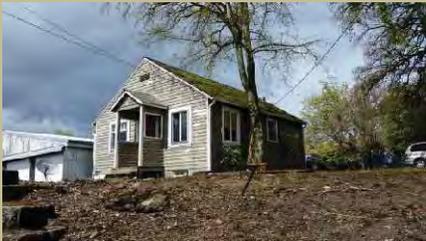
SW_122 387 TCE	8725 SW COMMERCIAL ST TIGARD R462010	Circa 1955 Building Minimal Traditional/ Period Cottage Horizontal Board	Recommended Not Eligible/Non-Contributing	Most all original windows have been replaced with vinyl sashes. A large outbuilding is situated northwest of the house; it is clad with vertical wood siding and has four bays. The building has no historical associations of significance under Criteria A through D.

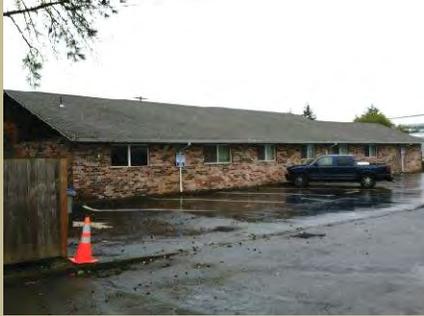
Project ID Survey # Acquisition	Resource Name Address & Assoc. Address Property ID Historic Name	Construction Date Resource Type Primary Style Primary Siding	NRHP Status	Integrity Comments / Notes	Photograph of Resource	Location
SW_166 388 TCE	8775 SW COMMERCIAL ST TIGARD R462029	1969 Building Ranch Standard Brick	Recommended Not Eligible/Non-Contributing	All original windows replaced with vinyl sliders. Not a distinctive example of a type, period, or method of construction. The building has no historical associations of significance under Criteria A through D.

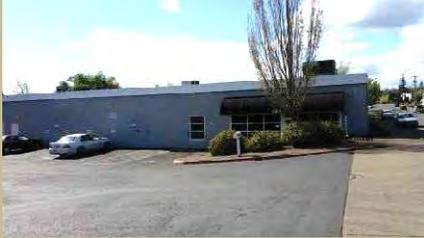
SW_12247 389 TCE	8800 SW COMMERCIAL ST TIGARD R462083	Circa 1965 Building Utilitarian Concrete Block	Recommended Not Eligible/Non-Contributing	Two buildings are on this parcel; the northernmost building was constructed circa 1965 while the building to the south was constructed circa 1990. The buildings have no historical associations of significance under Criteria A through D.

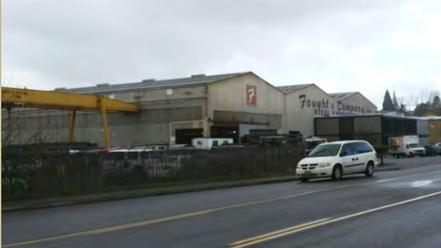
SW_6256 390 NO IMPACT	Fought & Company, Inc. 14255 SW 72ND AVE TIGARD R510931 Fought & Company	1962 Building Utilitarian Corrugated Metal	Recommended Eligible/Contributing	Fought & Company moved to this location from Swan Island in 1962; the company is associated with industrial development in Tigard during the mid-twentieth century.

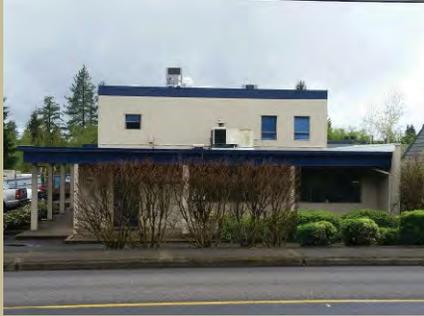
Project ID Survey # Acquisition	Resource Name Address & Assoc. Address Property ID Historic Name	Construction Date Resource Type Primary Style Primary Siding	NRHP Status	Integrity Comments / Notes	Photograph of Resource	Location
SW_8430 391 PARTIAL	14945 SW 72ND AVE TIGARD R511280	Circa 1970 Building 20 th Century Other Vertical Board	Recommended Not Eligible/Non-Contributing	Building is not a distinctive example of a type, period, or method of construction, nor does it have historical associations of significance under Criteria A through D. The western portion of the building may have been constructed prior to the eastern office area.

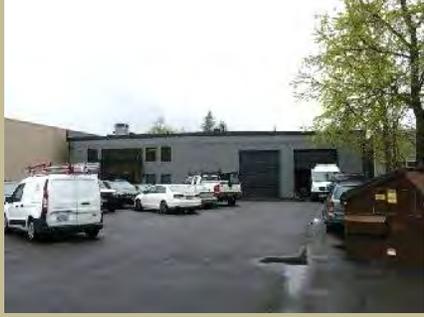
SW_6957 392 PARTIAL	14915 SW 72ND AVE TIGARD R511271	1969 Building 20 th Century Other Concrete Block	Recommended Not Eligible/Non-Contributing	A detached modern building is situated to the east. Modifications to the fenestration were observed. The building does not have historical associations of significance under Criteria A through D.

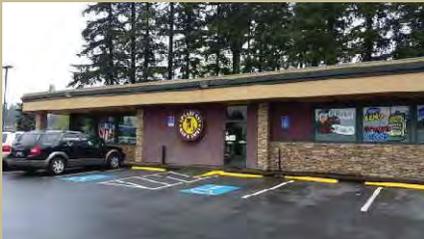
SW_1722 393 TCE	15680 SW UPPER BOONES FERRY RD LAKE OSWEGO R513091	Circa 1969 Building Commercial Stucco	Recommended Not Eligible/Non-Contributing	This circa 1969 building has been extensively modified and no longer retains historical integrity.

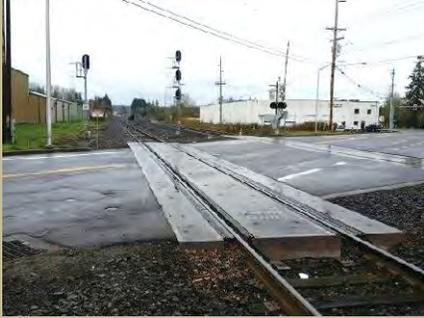
Project ID Survey # Acquisition	Resource Name Address & Assoc. Address Property ID Historic Name	Construction Date Resource Type Primary Style Primary Siding	NRHP Status	Integrity Comments / Notes	Photograph of Resource	Location
SW_20802 394 NO IMPACT	Southern Pacific Railroad, Tigard Branch	Circa 1910 Structure Not Applicable Not Applicable	Previously Documented as Eligible/Contributing (2010); Recommended Eligible/Contributing	The railroad is associated with Tigard's development near the turn of the twentieth century.

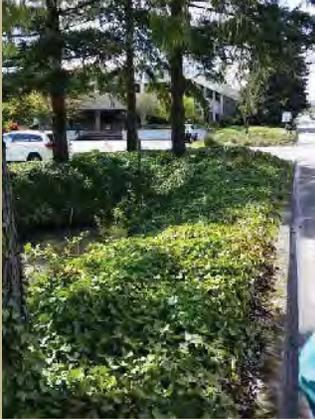
Creek 395 NA	Red Rock Creek	Circa 1945 Structure Not Applicable Earth	Recommended Not Eligible/Non-Contributing	This channel and pond were constructed during the mid- twentieth century, likely to assist with the commercial development of the surrounding area. The channelized creek has no distinctive features and has no known historical associations of significance under Criteria A through D.

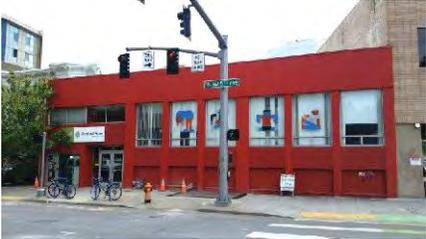
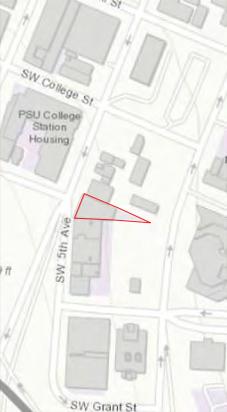
Project ID Survey # Acquisition	Resource Name Address & Assoc. Address Property ID Historic Name	Construction Date Resource Type Primary Style Primary Siding	NRHP Status	Integrity Comments / Notes	Photograph of Resource	Location
SW_15013 396 NO IMPACT	Art Building Annex 1990 SW 5TH AVE PORTLAND R667715810	1926 Building Other / Undefined Stucco	Recommended Not Eligible/Non-Contributing	This annex to PSU's Art Building was constructed in 1926 and appears to have been modified circa 1976 when both buildings were first used together as the Bassist College and Art Institute. The adjacent Art Building was constructed in 1965. Modifications have diminished the building's historical integrity.

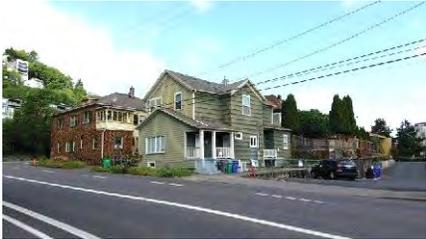
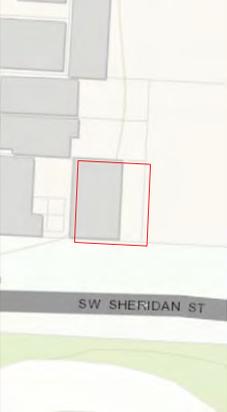
SW_1102 397 NO IMPACT	425 SW SHERIDAN ST PORTLAND R140902540	1900 Building Colonial Revival Cedar Shake Shingle	Recommended Not Eligible/Non-Contributing	Modifications to the plan, siding, and windows of the house have diminished its historical integrity.

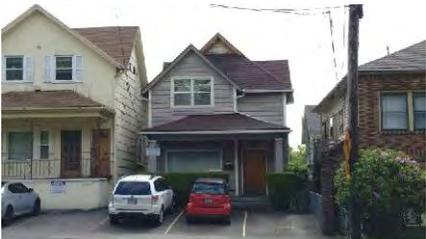
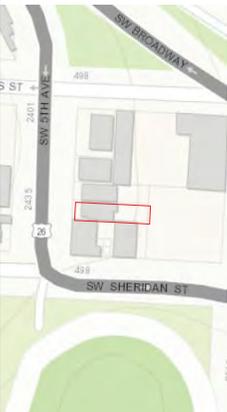
SW_1461 398 NO IMPACT	2430 SW 5TH AVE PORTLAND R140902560	1890 Building Colonial Revival Horizontal Board	Recommended Not Eligible/Non-Contributing	Modifications to the plan, windows, and siding have diminished the historical integrity of the house.

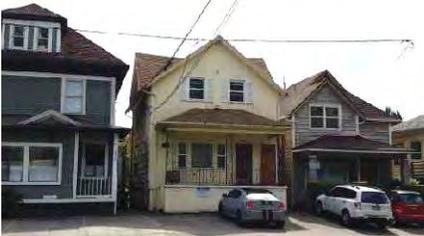
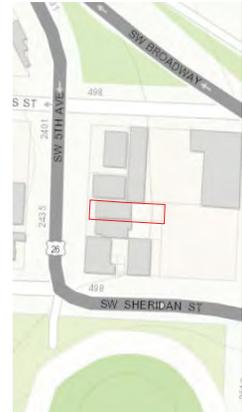
Project ID Survey # Acquisition	Resource Name Address & Assoc. Address Property ID Historic Name	Construction Date Resource Type Primary Style Primary Siding	NRHP Status	Integrity Comments / Notes	Photograph of Resource	Location
SW_18060 399 NO IMPACT	2422 SW 5TH AVE PORTLAND R140902550	1890 Building Colonial Revival Vertical Board	Recommended Not Eligible/Non-Contributing	Modifications to the windows and siding diminish the house's historical integrity.

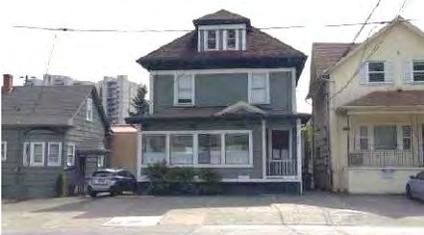
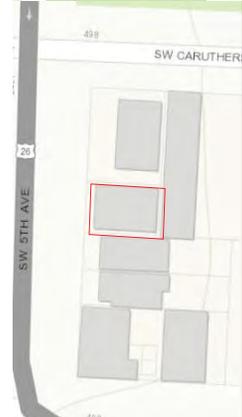
SW_19283 400 NO IMPACT	2416 SW 5TH AVE PORTLAND R140902590	1900 Building Classical Revival Horizontal Board	Recommended Not Eligible/Non-Contributing	Porch and window modifications, in addition to the house's setting and a change in use from residential to commercial diminish the integrity of this house.

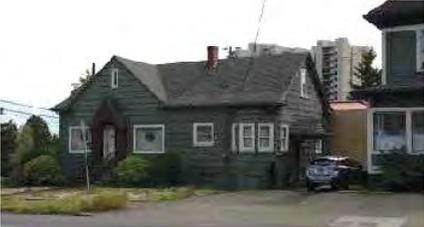
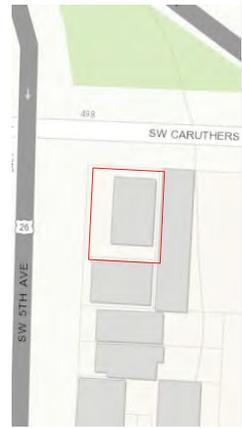
SW_5314 401 NO IMPACT	2404 SW 5TH AVE PORTLAND R140902580	1890 Building Minimal Traditional Cedar Rake Shingle	Recommended Not Eligible/Non-Contributing	This 1890 house was extensively remodeled circa 1940, and is now used as a commercial office space. The building has diminished integrity of design, setting, materials, workmanship, feeling, and association.

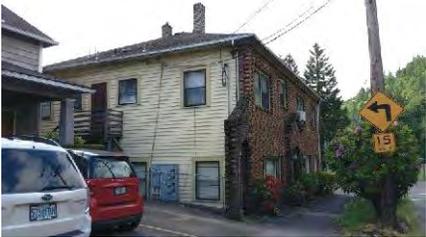
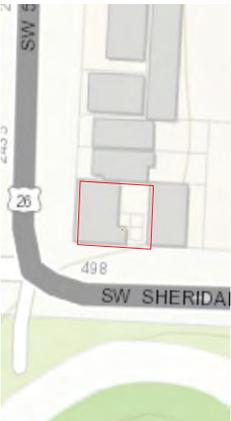
Project ID Survey # Acquisition	Resource Name Address & Assoc. Address Property ID Historic Name	Construction Date Resource Type Primary Style Primary Siding	NRHP Status	Integrity Comments / Notes	Photograph of Resource	Location
SW_14916 402 NO IMPACT	SW 5TH AVE PORTLAND R627820010	Circa 1915 Building Standard Brick	Recommended Not Eligible/Non-Contributing	Modifications to the windows and siding have diminished this building's historical integrity. Windows are a mixture of aluminum and wood sashes.

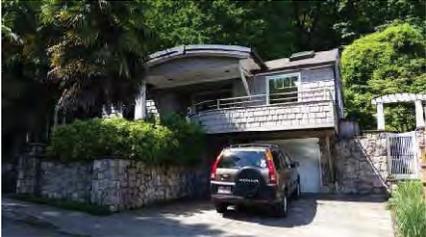
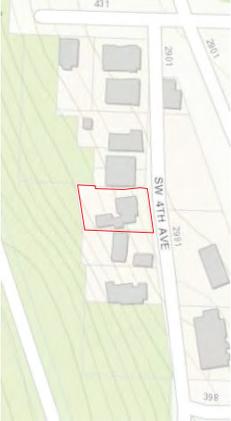
SW_21881 403 NO IMPACT	2945 SW 4TH AVE PORTLAND R991091750	1944 Building Minimal Traditional Shingle	Recommended Not Eligible/Non-Contributing	This house has modern siding and windows. The east facade porch was constructed in 2003. Modifications have diminished the house's integrity of design, materials, workmanship, feeling, and association.

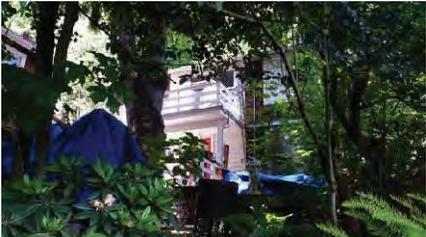
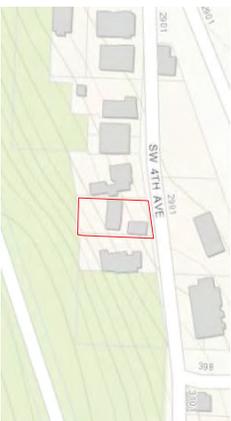
SW_15969 404 NO IMPACT	3007 SW 4TH AVE PORTLAND R140907890	1880 Building Victorian Era Shingle	Recommended Not Eligible/Non-Contributing	Sanborn maps indicate that the front entrance was moved from the north elevation to the east sometime after 1950. Windows are vinyl replacements. Once section of drop siding was observed on the east elevation; modern shingles clad remaining portions of the house. A detached garage appears to have been constructed during the modern era.

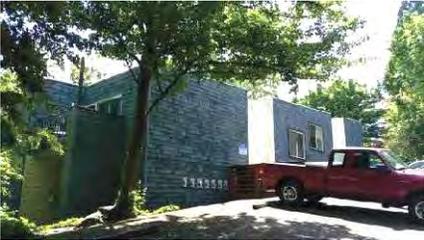
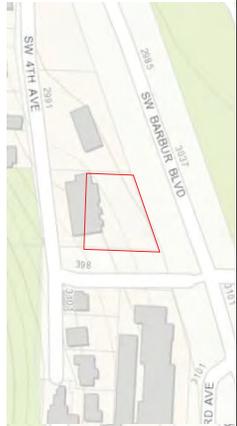
Project ID Survey # Acquisition	Resource Name Address & Assoc. Address Property ID Historic Name	Construction Date Resource Type Primary Style Primary Siding	NRHP Status	Integrity Comments / Notes	Photograph of Resource	Location
SW_11018 405 PARTIAL	3030-3032 SW 4TH AVE PORTLAND R140907900	1975 Building Shed Shingle	Recommended Not Eligible/Non-Contributing	Windows are modern vinyl sashes. The building has no historical associations of significance, and does not embody distinctive characteristics of a type, period, or method of construction.

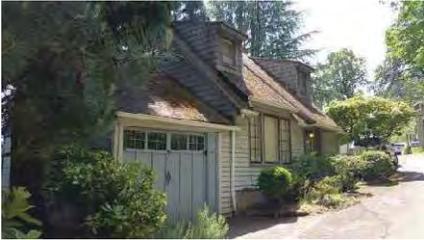
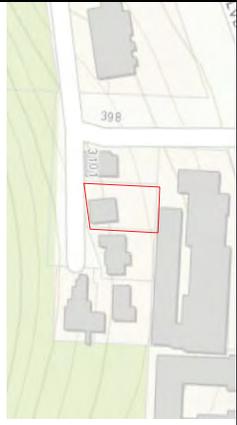
SW_19579 406 NO IMPACT	3114 SW 4TH AVE PORTLAND R140910540	1935 Building Minimal Traditional Horizontal Board	Recommended Not Eligible/Non-Contributing	The roof appears to have been modified circa 1950, and the lap siding does not appear to be original to 1935. The house has no historical associations of significance, and does not embody distinctive characteristics of a type, period, or method of construction.

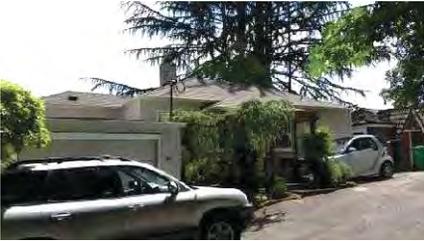
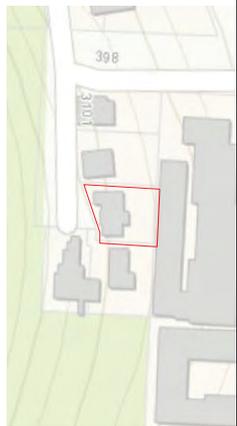
SW_3859 407 NO IMPACT	3118 SW 4TH AVE PORTLAND R140910530	1938 Building WWII Era Cottage Horizontal Board	Recommended Not Eligible/Non-Contributing	Replacement of the house's original siding and windows has diminished its historical integrity.

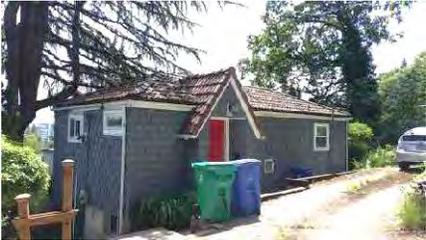
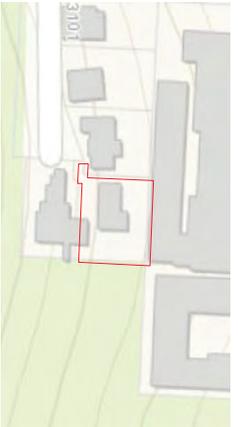
Project ID Survey # Acquisition	Resource Name Address & Assoc. Address Property ID Historic Name	Construction Date Resource Type Primary Style Primary Siding	NRHP Status	Integrity Comments / Notes	Photograph of Resource	Location
SW_9620 408 NO IMPACT	3120 SW 4TH AVE PORTLAND R140910520	1940 Building Minimal Traditional Shingle	Recommended Not Eligible/Non-Contributing	The house's modern siding and fenestration diminish its historical integrity.

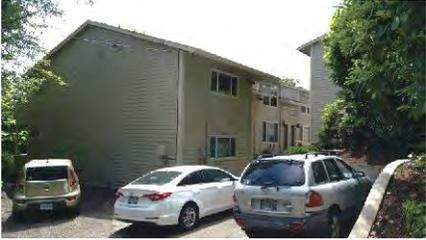
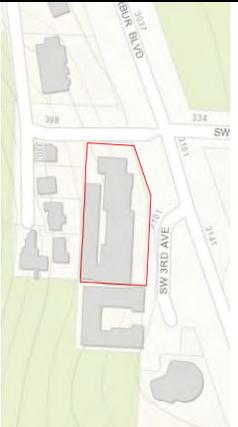
SW_9265 409 PARTIAL	3105 SW BARBUR BLVD PORTLAND R140910470	1973 Building No Style Horizontal Board	Recommended Not Eligible/Non-Contributing	Modern siding and vinyl windows diminish the apartment building's historical integrity of design, materials, workmanship, feeling, and association.

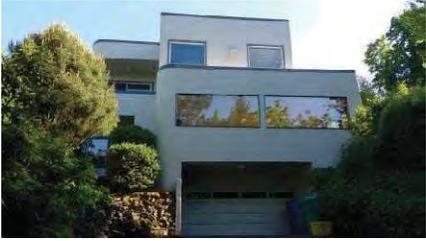
SW_18672 410 NO IMPACT	16 SW ABERNETHY ST PORTLAND R864500200 Hudson, Harvey S., House	1937 Building Modern Period Other Stucco	City of Portland HRI (Rank II - 1984); Recommended Eligible/Contributing	This house is one of the few Streamline Moderne/International style houses designed by Roscoe Hemenway in Portland. Most original windows have been replaced, but this house retains many aspects of its historical integrity and embodies distinctive characteristics of its period of construction.

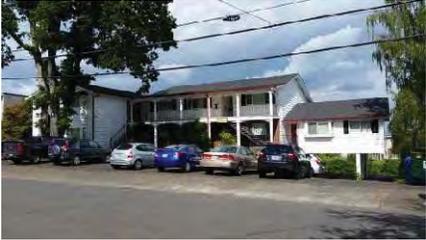
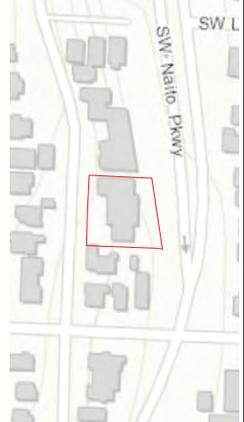
Project ID Survey # Acquisition	Resource Name Address & Assoc. Address Property ID Historic Name	Construction Date Resource Type Primary Style Primary Siding	NRHP Status	Integrity Comments / Notes	Photograph of Resource	Location
SW_1147 411 PARTIAL	4210-4230 SW VIEW POINT TER PORTLAND R669101850	1974 Building Colonial Revival Synthetic Wood Siding	Recommended Not Eligible/Non-Contributing	Modern siding and vinyl windows diminish the building's integrity of design, materials, workmanship, feeling, and association.

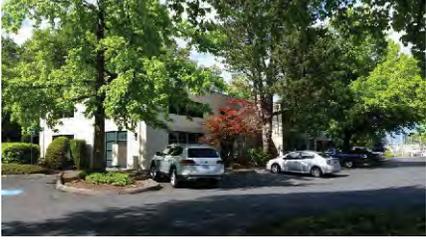
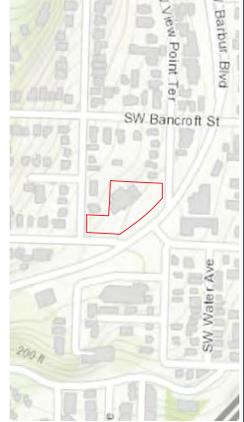
SW_20303 412 PARTIAL	4445 SW BARBUR BLVD PORTLAND R669102440	1974 Building Contemporary Concrete Panels	Recommended Not Eligible/Non-Contributing	This commercial office building has no known historical associations of significance, nor does it embody distinctive characteristics of a type, period, or method of construction.

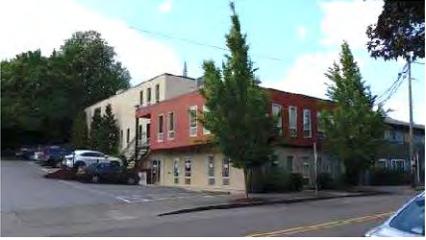
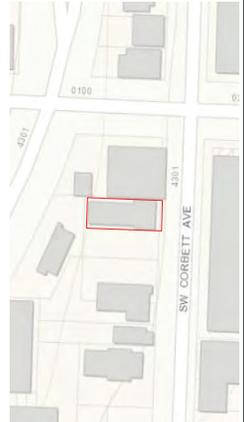
SW_3917 413 PARTIAL	4321 SW CORBETT AVE PORTLAND R669101420	1973 Building Contemporary Concrete Panels	Recommended Not Eligible/Non-Contributing	The building has no historical associations of significance, and does not embody distinctive characteristics of a type, period, or method of construction.

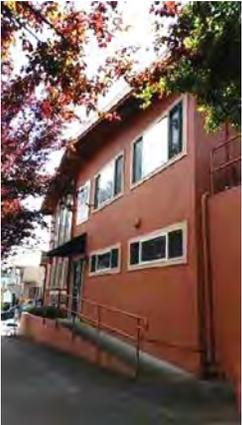
Project ID Survey # Acquisition	Resource Name Address & Assoc. Address Property ID Historic Name	Construction Date Resource Type Primary Style Primary Siding	NRHP Status	Integrity Comments / Notes	Photograph of Resource	Location
SW_17805 414 TCE	0123 SW HAMILTON ST PORTLAND R669101550	1961 Building Modern Commercial Vertical Board	Recommended Not Eligible/Non-Contributing	All original windows appear to have been replaced with vinyl sashes. This building has no known associations of significance, and it does not embody distinctive characteristics of a type, period, or method of construction.

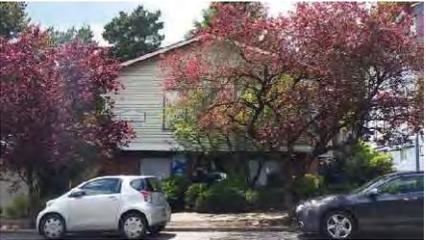
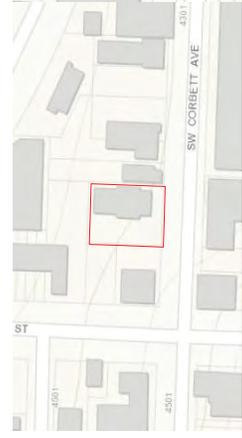
SW_127 415 NO IMPACT	4425 SW CORBETT AVE PORTLAND R669101530	1975 Building Contemporary Vinyl Siding	Recommended Not Eligible/Non-Contributing	This building has no known historical associations of significance, nor does it embody distinctive characteristics of a type, period, or method of construction.

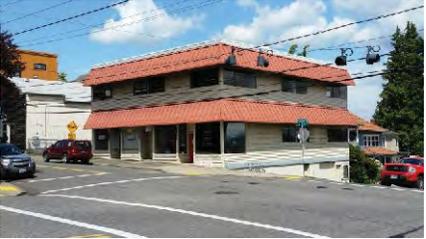
SW_20043 416 NO IMPACT	4438-4444 SW CORBETT AVE PORTLAND R669100480	1908 Building Commercial Horizontal Board	Recommended Not Eligible/Non-Contributing	The original siding has been replaced with vinyl siding, and windows are modern aluminum sashes installed circa 1980. A 1950 Sanborn map indicates that this building had two storefronts at the west facade; it now has three. A warehouse area is accessed from SW Hamilton Street to the south.

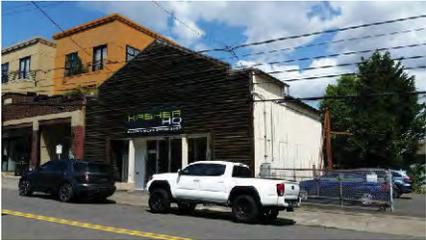
Project ID Survey # Acquisition	Resource Name Address & Assoc. Address Property ID Historic Name	Construction Date Resource Type Primary Style Primary Siding	NRHP Status	Integrity Comments / Notes	Photograph of Resource	Location
SW_20045 417 NO IMPACT	4422-4424 SW CORBETT AVE PORTLAND R669100490	1949 Building Commercial Horizontal Board	Recommended Not Eligible/Non-Contributing	This building has no known historical associations of significance, and it does not embody distinctive characteristics of a type, period, or method of construction.

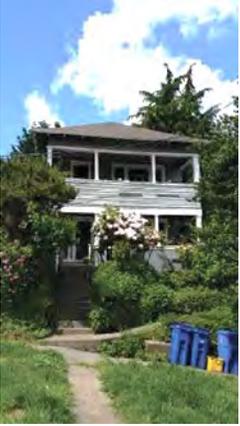
SW_16663 418 NO IMPACT	0219-0221 SW HAMILTON ST PORTLAND R669100450	1912 Building Colonial Revival Horizontal Board	Recommended Eligible/Contributing	This multi-family residential building is a good local example of its period of construction. The lap siding may have been added after the building's construction, but it dates to the historic period. Original windows appear to be intact, but are obscured from view by vinyl storm windows.

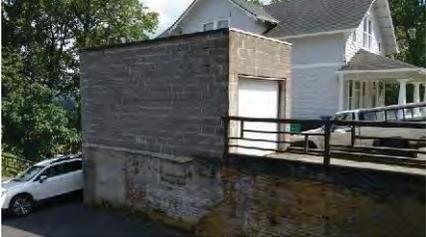
SW_18930 419 NO IMPACT	0224 W/ SW HAMILTON ST PORTLAND R669100870	Building Utilitarian Concrete Block	Recommended Not Eligible/Non-Contributing	This concrete block garage was associated with a historic building that is no longer standing. It has diminished integrity of materials, workmanship, feeling, and association.

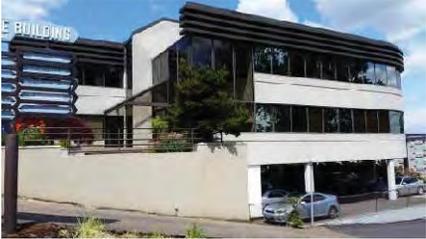
Project ID Survey # Acquisition	Resource Name Address & Assoc. Address Property ID Historic Name	Construction Date Resource Type Primary Style Primary Siding	NRHP Status	Integrity Comments / Notes	Photograph of Resource	Location
SW_4606 420 PARTIAL	4504 SW CORBETT AVE PORTLAND R669100840 Panorama Building	1954 Building Contemporary Concrete Panels	Recommended Not Eligible/Non-Contributing	All windows are modern anodized aluminum sashes. This change, in addition to the building's modern parapet diminish historical integrity of design, materials, workmanship, feeling, and association. A search of local newspapers yielded no information pertaining to the building's design or construction.

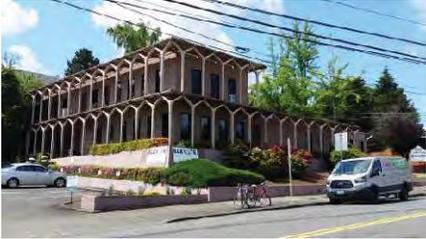
SW_18936 421 TCE	4515 SW CORBETT AVE PORTLAND R669101000 Oregon Insurance Center	1963 Building Modern Commercial Concrete Panels	Recommended Eligible/Contributing	Windows appear to be anodized aluminum replacements, but are likely in original window openings. At the building's northeast corner, a small infilled section was observed. The building appears to be clad with concrete panels that are coated with stucco.

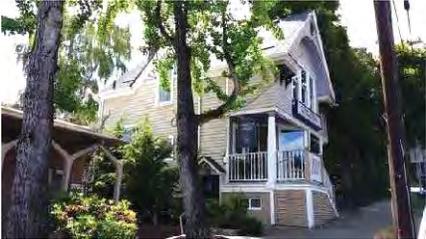
SW_817 422 NO IMPACT	0112 SW HAMILTON ST PORTLAND R669100980	1905 Building Queen Anne Horizontal Board	Recommended Eligible/Contributing	This former residence has been converted for commercial use. Most original wood windows have been replaced with vinyl sashes, but some original wood windows remain. The building is a good local example of its period of construction.

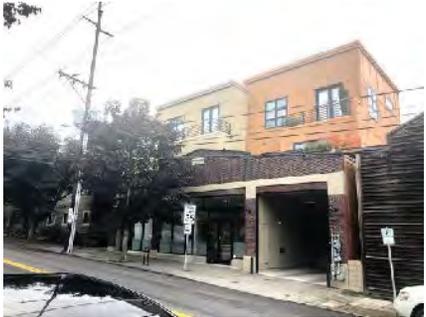
SW_3923 424 NO IMPACT	Corbett Garage SW CORBETT AVE PORTLAND R178050010	1919 Building Commercial Synthetic Other / Undefined	Recommended Not Eligible/Non-Contributing	An expansion and renovation project completed in 2002 has diminished the building's historical integrity.

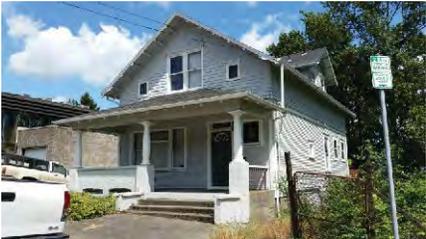
SW_8311 425 NO IMPACT	4606 SW CORBETT AVE PORTLAND R669100880	1910 Building Colonial Revival Horizontal Board	Recommended Eligible/Contributing	Some original windows have been replaced with vinyl sashes, and Sanborn maps indicate the house had an associated garage to the north. However, this house retains many aspects of its historical integrity, and is a good example of its period of construction in the local area.

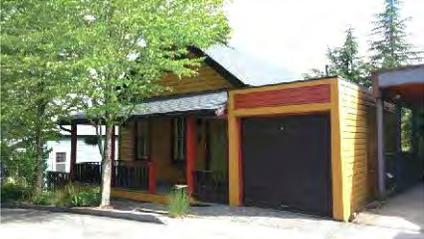
Project ID Survey # Acquisition	Resource Name Address & Assoc. Address Property ID Historic Name	Construction Date Resource Type Primary Style Primary Siding	NRHP Status	Integrity Comments / Notes	Photograph of Resource	Location
SW_7796 426 NO IMPACT	374 SW HAMILTON CT PORTLAND R669104620	1894 Building Victorian Era Horizontal Board	Recommended Eligible/Contributing	Original siding and windows have been retained, although anodized aluminum windows were observed in the basement. The house rests on a brick foundation, and has a detached garage.

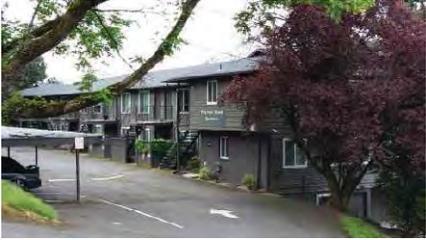
SW_6508 431 TCE	7350 SW BARBUR BLVD PORTLAND R300402560	1975 Building Other / Undefined Horizontal Board	Recommended Not Eligible/Non-Contributing	Vinyl windows have replaced what were likely aluminum windows. This building has no known historical associations of significance, and it does not embody distinctive characteristics of a type, period, or method of construction.

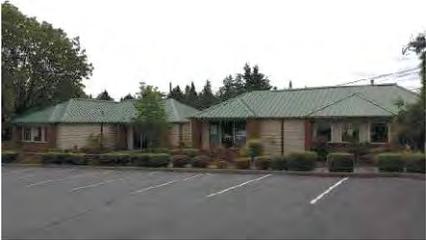
Project ID Survey # Acquisition	Resource Name Address & Assoc. Address Property ID Historic Name	Construction Date Resource Type Primary Style Primary Siding	NRHP Status	Integrity Comments / Notes	Photograph of Resource	Location
SW_156 432 FULL	7800 SW BARBUR BLVD PORTLAND R133902390	Circa 1950 Building Commercial Horizontal Board	Recommended Not Eligible/Non-Contributing	Westernmost building was constructed by 1952; central building completed by 1960; eastern building constructed circa 1985. Historic buildings are clad with modern materials and have modern aluminum and vinyl windows. These modifications have diminished the resource's historical integrity.

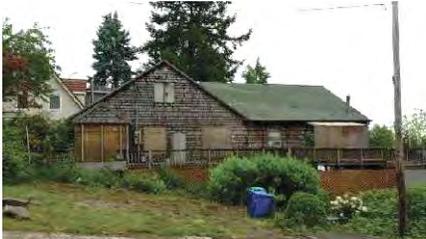
SW_19514 437 NO IMPACT	7136 SW BRIER PL PORTLAND R178200340	1949 Building Modern Period Other Standard Brick	Recommended Not Eligible/Non-Contributing	Original windows have been replaced with aluminum sashes, and shingles on the south elevation do not appear to be original to the date of construction. The house has no known historical associations of significance, and it does not embody distinctive characteristics of a type, period, or method of construction.

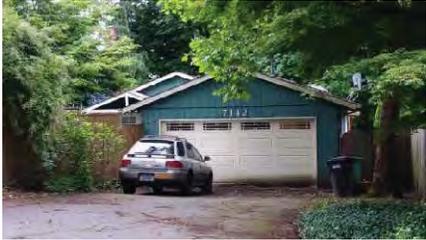
Project ID Survey # Acquisition	Resource Name Address & Assoc. Address Property ID Historic Name	Construction Date Resource Type Primary Style Primary Siding	NRHP Status	Integrity Comments / Notes	Photograph of Resource	Location
SW_8096 438 FULL	7142 SW 2ND AVE PORTLAND R300400950	1975 Building Ranch Vertical Board	Recommended Not Eligible/Non-Contributing	Modifications to cladding and doors diminish the building's integrity of design, materials, workmanship, feeling, and association.

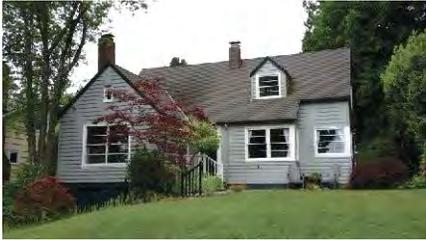
SW_13236 439 NO IMPACT	7211 SW BRIER PL PORTLAND R178200130	1942 Building Tudor Revival Cement Fiber Siding	Recommended Eligible/Contributing	The house's lap siding appears to be a modern replacement, but windows are original wood multi-light sashes. This house embodies distinctive characteristics of its period of construction, and retains good historical integrity.

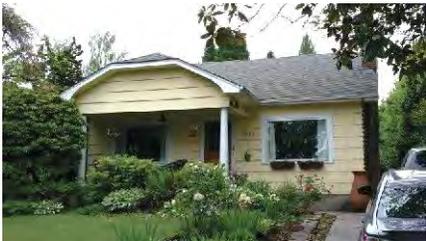
SW_19834 440 NO IMPACT	7221 SW BRIER PL PORTLAND R178200160	1926 Building Colonial Revival Cedar Shake Shingle	Recommended Eligible/Contributing	Original wood windows likely remain in place, but are obscured by aluminum storm windows. The shingle siding may represent a historic-period modification.

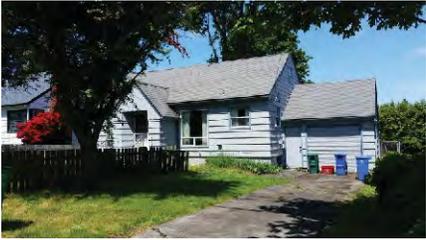
SW_18756 442 PARTIAL	3145 SW PRIMROSE ST PORTLAND R383800030	1942 Building Tudor Revival Cedar Shake Shingle	Recommended Not Eligible/Non-Contributing	Original wood windows have been replaced with vinyl sashes. This house has no known historical associations of significance, and it does not embody distinctive characteristics of a type, period, or method of construction compared to other houses in the vicinity.

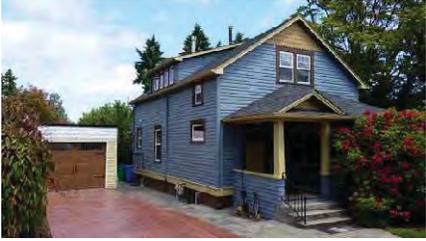
SW_3356 443 NO IMPACT	3415 SW ALICE ST PORTLAND R892300880	1921 Building Colonial Revival Horizontal Board	Recommended Not Eligible/Non-Contributing	Modifications to the windows and siding of the house diminish its historical integrity.

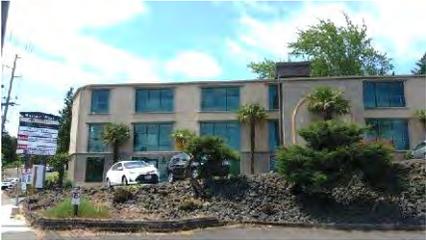
Project ID Survey # Acquisition	Resource Name Address & Assoc. Address Property ID Historic Name	Construction Date Resource Type Primary Style Primary Siding	NRHP Status	Integrity Comments / Notes	Photograph of Resource	Location
SW_1181 444 PARTIAL	9221 SW BARBUR BLVD PORTLAND R892300760	1975 Building Other/Undefined Concrete Panels	Recommended Not Eligible/Non-Contributing	A modern envelope has been constructed over the 1975 building. The 1975 portion of the building is clad with horizontal boards and has anodized aluminum windows. The modern envelope is made of concrete panels that are coated with stucco. The building has diminished historical integrity, and has no historical associations of significance.

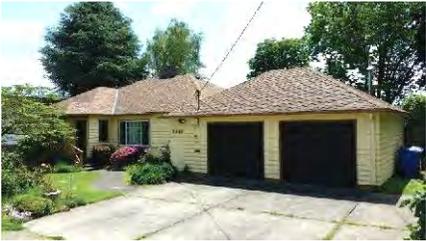
SW_10586 445 NO IMPACT	3446 SW ALICE ST PORTLAND R892301300	1946 Building WWII Era Cottage Horizontal Board	Recommended Not Eligible/Non-Contributing	All original windows have been replaced with gridded vinyl sashes. This change diminishes the house's integrity of design, materials, workmanship, feeling, and association.

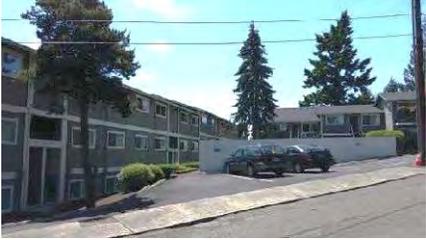
SW_4145 446 NO IMPACT	3822-3830 SW PLUM ST PORTLAND R111000666	1974 Building Other / Undefined Vertical Board	Recommended Not Eligible/Non-Contributing	Operated in association with apartment buildings on adjacent parcel (R111000600); vinyl windows and modern cladding diminish the building's historical integrity.

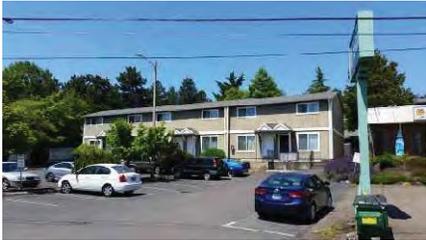
Project ID Survey # Acquisition	Resource Name Address & Assoc. Address Property ID Historic Name	Construction Date Resource Type Primary Style Primary Siding	NRHP Status	Integrity Comments / Notes	Photograph of Resource	Location
SW_4146 447 NO IMPACT	9671-9677 SW BARBUR BLVD PORTLAND R111000600	1975 Building Other/Undefined Vertical Board	Recommended Not Eligible/Non-Contributing	Operated in association with apartment buildings on adjacent parcel (R111000666); vinyl windows and modern siding diminish the building's historical integrity.

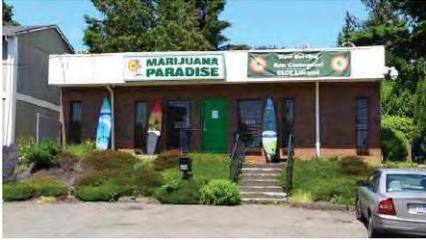
SW_8774 448 NO IMPACT	9663 SW BARBUR BLVD PORTLAND R111000700	1974 Building Other / Undefined Standard Brick	Recommended Not Eligible/Non-Contributing	This building has no historical associations of significance, and it does not embody distinctive characteristics of a type, period, or method of construction.

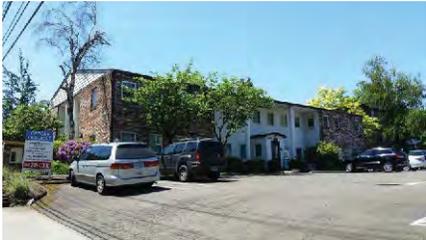
SW_21066 449 PARTIAL	Colonial Office Campus 10157-10213 SW BARBUR BLVD PORTLAND R516000520	1974 Building Colonial Revival Vinyl Siding	Recommended Not Eligible/Non-Contributing	There are three buildings on this parcel, and a fourth is on an adjacent parcel to the northeast that was constructed in 1976. Most original lap siding has been replaced with vinyl siding, and most original windows have been replaced with vinyl sashes. This office complex has no known historical associations of significance, and does not have adequate integrity to embody distinctive characteristics of a type, period, or method of construction.

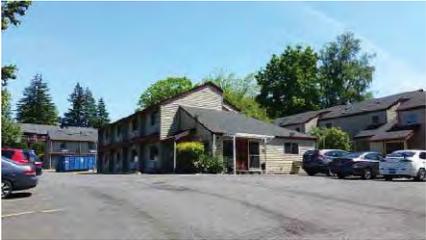
Project ID Survey # Acquisition	Resource Name Address & Assoc. Address Property ID Historic Name	Construction Date Resource Type Primary Style Primary Siding	NRHP Status	Integrity Comments / Notes	Photograph of Resource	Location
SW_19187 450 EASEMENT	10450 SW BARBUR BLVD PORTLAND R991302150	1973 Building Shed Vinyl Siding	Recommended Not Eligible/Non-Contributing	Siding and windows are modern vinyl replacements, diminishing the building's historical integrity.

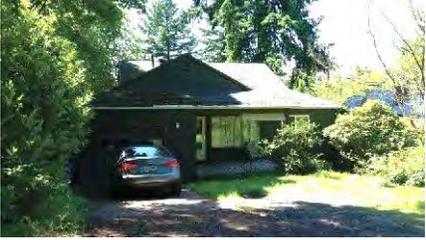
SW_4676 451 TCE	11117 SW 53RD AVE PORTLAND R894607470	1974 Building Ranch Vertical Board	Recommended Not Eligible/Non-Contributing	This house has a mixture of vinyl and aluminum windows. It appears that the plan has been expanded since the date of construction. The house no longer has historical integrity of design, materials, workmanship, feeling, and association.

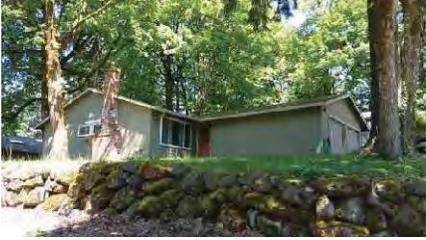
SW_9028 452 TCE	5241 SW VACUNA ST PORTLAND R894615140	1973 Building Ranch Vertical Board	Recommended Not Eligible/Non-Contributing	All original windows have been replaced with vinyl sashes, diminishing the house's integrity of materials, feeling, and association. The house has no known associations with significant events or people of the past, and it does not embody distinctive characteristics of a type, period, or method of construction.

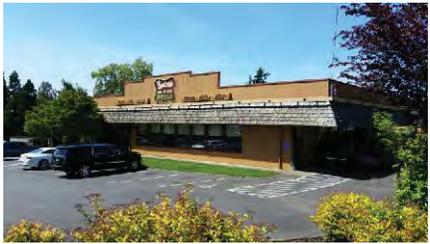
Project ID Survey # Acquisition	Resource Name Address & Assoc. Address Property ID Historic Name	Construction Date Resource Type Primary Style Primary Siding	NRHP Status	Integrity Comments / Notes	Photograph of Resource	Location
SW_18245 453 NO IMPACT	11419 SW PACIFIC HWY TIGARD R279521	Circa 1973 Building Modern Commercial Vertical Board	Recommended Not Eligible/Non-Contributing	This building has no known associations of historical significance, and does not embody distinctive characteristics of a type, period, or method of construction.

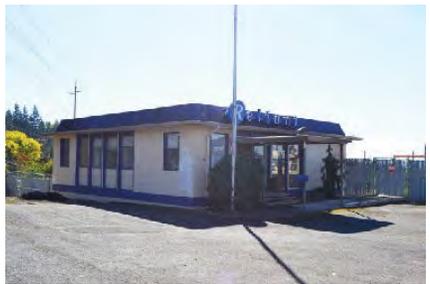
SW_20486 454 FULL	11424 SW PACIFIC HWY TIGARD R279530	Circa 1968 Building Commercial Vertical Board	Recommended Not Eligible/Non-Contributing	The building has no historical associations of significance, and does not embody distinctive characteristics of a type, period, or method of construction.

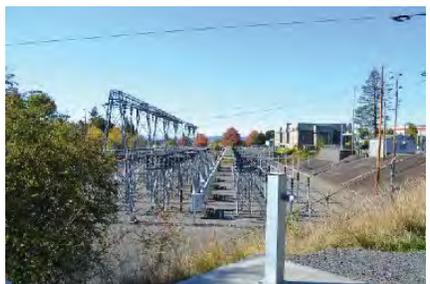
SW_16553 455 PARTIAL	PGE West Portland Substation 10955 SW 65TH AVE TIGARD R2144057	Circa 1958 Structure Not Applicable Not Applicable	Recommended Not Eligible/Non-Contributing	The substation was significantly expanded by 1970. It has no known associations of significance, and does not embody distinctive characteristics of a type, period, or method of construction.

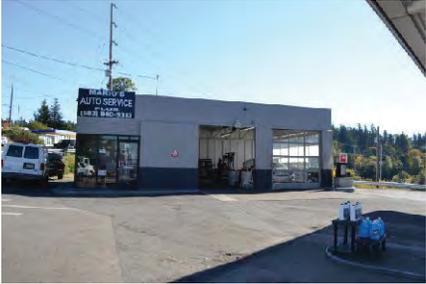
Project ID Survey # Acquisition	Resource Name Address & Assoc. Address Property ID Historic Name	Construction Date Resource Type Primary Style Primary Siding	NRHP Status	Integrity Comments / Notes	Photograph of Resource	Location
SW_20487 456 FULL	11440 SW PACIFIC HWY TIGARD R2194205	Circa 1956 Building Utilitarian Metal Sheet	Recommended Not Eligible/Non-Contributing	A new anodized aluminum storefront entrance is at the north corner. Brick veneer is not original. The building, which is now associated with a modern gas station, no longer has historical integrity of design, materials, workmanship, feeling, and association.

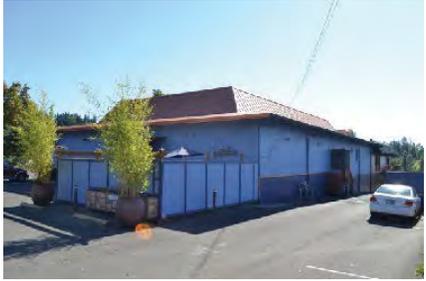
SW_8431 457 FULL	11530 SW PACIFIC HWY TIGARD R284631	Circa 1967 Building Commercial Concrete Block	Recommended Not Eligible/Non-Contributing	Large addition to the rear elevation constructed circa 1970s. The building has no historical associations of significance, and does not embody distinctive characteristics of a type, period, or method of construction.

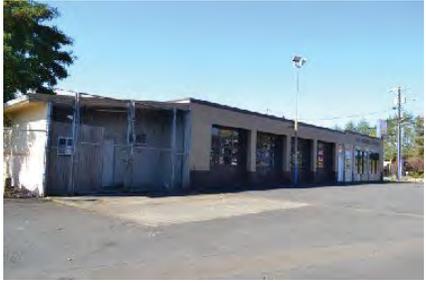
SW_8470 458 NO IMPACT	11540 SW PACIFIC HWY TIGARD R284640	Circa 1959 Building Commercial Concrete Block	Recommended Not Eligible/Non-Contributing	The showroom at the north end of the building was added by 1970. The building no longer has integrity of design, materials, workmanship, feeling, and association.

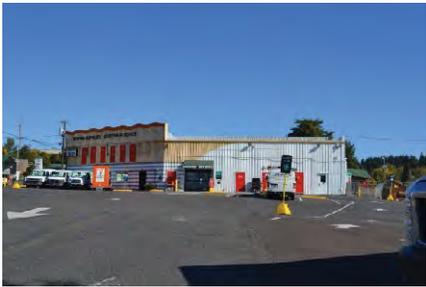
Project ID Survey # Acquisition	Resource Name Address & Assoc. Address Property ID Historic Name	Construction Date Resource Type Primary Style Primary Siding	NRHP Status	Integrity Comments / Notes	Photograph of Resource	Location
SW_20959 459 NO IMPACT	11552 SW PACIFIC HWY TIGARD R284668	Circa 1958 Building Utilitarian Metal Other / Undefined	Recommended Not Eligible/Non-Contributing	Second floor windows have been painted over, and the parapet at the north end of the roof is not original to construction. Varied roof lines indicate different phases of construction. There are four modern buildings on the same parcel that are situated to the south. The building no longer has integrity of design, materials, workmanship, feeling, and association.

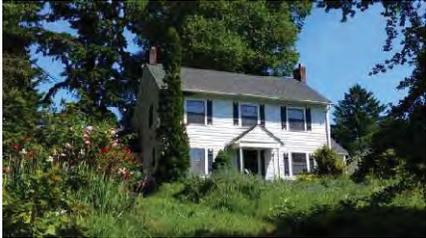
SW_1354 460 NO IMPACT	11530 SW 72ND AVE TIGARD R284864	Circa 1920 Building Colonial Revival Horizontal Board	Recommended Eligible/Contributing	Additional research is needed to establish this house's date of construction and historical associations. Within its local context the house has potential for significant historical associations, and likely embodies distinctive characteristics of its type, period, and method of construction.

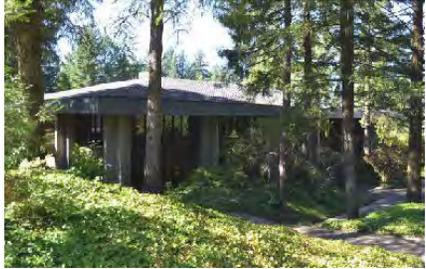
SW_15211 461 PARTIAL	Oregon Education Association 6900 SW ATLANTA ST TIGARD R284882	1968 Building Northwest Regional Horizontal Board	Recommended Eligible/Significant	Was intended to be part of a larger mixed-use development that never materialized. The building embodies distinctive characteristics of its period of construction.

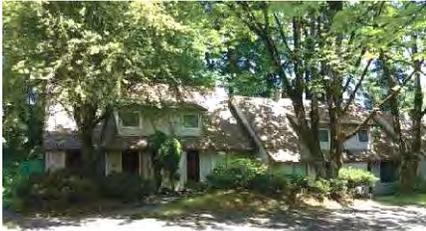
Project ID Survey # Acquisition	Resource Name Address & Assoc. Address Property ID Historic Name	Construction Date Resource Type Primary Style Primary Siding	NRHP Status	Integrity Comments / Notes	Photograph of Resource	Location
SW_9434 462 EASEMENT	10800 SW BARBUR BLVD PORTLAND R894600320	1973 Building Vertical Board	Recommended Not Eligible/Non-Contributing	This apartment complex has no known historical associations of significance, and does not embody distinctive characteristics of a type, period, or method of construction.

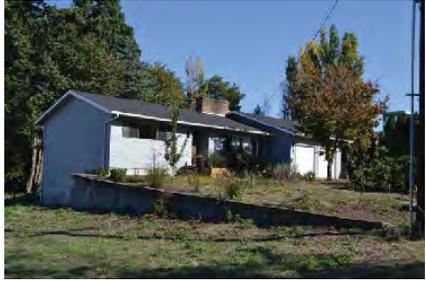
SW_14634 463 PARTIAL	7105 SW ELMHURST ST TIGARD R456991	Circa 1967 Building Ranch Horizontal Board	Recommended Not Eligible/Non-Contributing	This house has good historical integrity but has no historical associations of significance. It does not embody distinctive characteristics of a type, period, or method of construction.

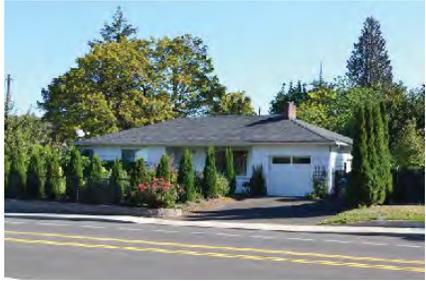
SW_7449 464 FULL	12260 SW 72ND AVE TIGARD R457035	Circa 1952 Building Ranch Cedar Shake Shingle	Recommended Not Eligible/Non-Contributing	All original windows have been replaced with vinyl siding and fixed sashes. The house has no historical associations of significance, and it does not embody distinctive characteristics of a type, period, or method of construction.

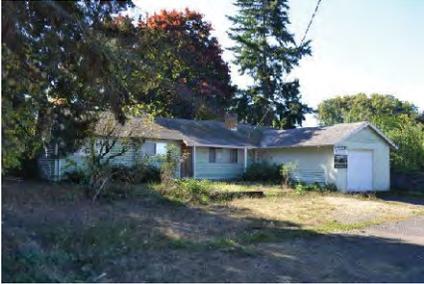
Project ID Survey # Acquisition	Resource Name Address & Assoc. Address Property ID Historic Name	Construction Date Resource Type Primary Style Primary Siding	NRHP Status	Integrity Comments / Notes	Photograph of Resource	Location
SW_5755 465 FULL	7130 SW ELMHURST ST TIGARD R457044	Circa 1966 Building Ranch Vinyl Siding	Recommended Not Eligible/Non-Contributing	The house's north wing was added during the modern era to expand garage space. The house no longer has integrity of design, materials, workmanship, feeling, and association.

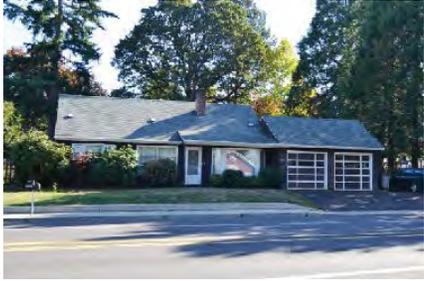
SW_8315 466 FULL	12280 SW 72ND AVE TIGARD R457053	Circa 1940 Building Minimal Traditional Cedar Shake Shingle	Recommended Not Eligible/Non-Contributing	Garage added to the south elevation between 1960 and 1970. The house has no historical associations of significance, and it does not embody distinctive characteristics of a type, period, or method of construction.

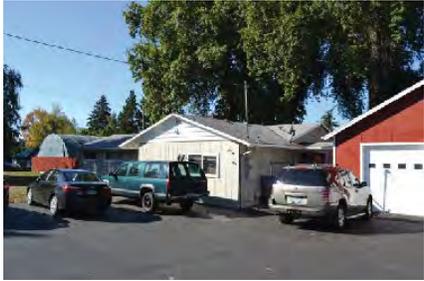
SW_1322 467 NO IMPACT	12335 SW 72ND AVE TIGARD R457106	1954 Building Ranch Horizontal Board	Recommended Not Eligible/Non-Contributing	Original windows have been replaced with vinyl sashes, and vertical wood siding has been added to portions of the house. A modern building situated north of the house is operated as a dog boarding facility. The house no longer has integrity of materials, workmanship, feeling, and association.

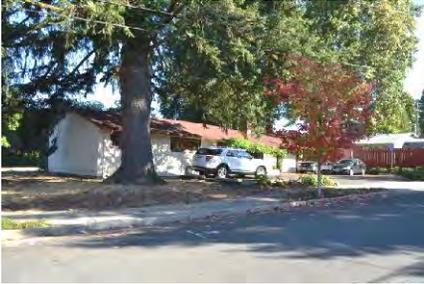
Project ID Survey # Acquisition	Resource Name Address & Assoc. Address Property ID Historic Name	Construction Date Resource Type Primary Style Primary Siding	NRHP Status	Integrity Comments / Notes	Photograph of Resource	Location
SW_10753 468 NO IMPACT	7275 SW HERMOSO WAY TIGARD R457115	Circa 1958 Building Ranch Vertical Board	Recommended Not Eligible/Non-Contributing	This house has no historical associations of significance, and it does not embody distinctive characteristics of a type, period, or method of construction.

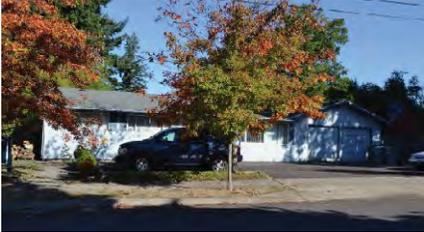
SW_13721 469 NO IMPACT	7315 SW HERMOSO WAY TIGARD R457124	Circa 1958 Building Ranch Vertical Board	Recommended Not Eligible/Non-Contributing	This house has no historical associations of significance, and does not embody distinctive characteristics of a type, period, or method of construction.

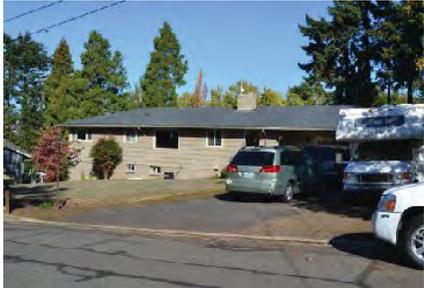
SW_9208 470 PARTIAL	7355 SW HERMOSO WAY TIGARD R457142	Circa 1958 Building Ranch Horizontal Board	Recommended Not Eligible/Non-Contributing	Modifications to the windows and siding have diminished this house's historical integrity.

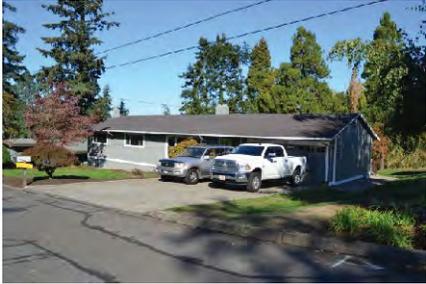
Project ID Survey # Acquisition	Resource Name Address & Assoc. Address Property ID Historic Name	Construction Date Resource Type Primary Style Primary Siding	NRHP Status	Integrity Comments / Notes	Photograph of Resource	Location
SW_12088 471 FULL	7395 SW HERMOSO WAY TIGARD R457151	Circa 1958 Building Ranch Vertical Board	Recommended Not Eligible/Non-Contributing	Modifications to the siding and windows have diminished the house's historical integrity.

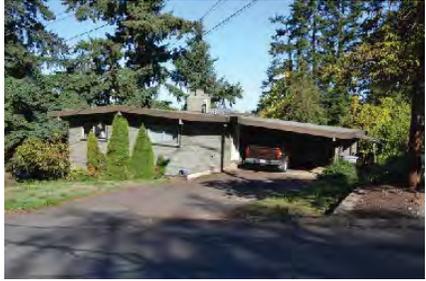
SW_3784 472 FULL	7435 SW HERMOSO WAY TIGARD R457160	Circa 1965 Building Ranch Horizontal Board	Recommended Not Eligible/Non-Contributing	Small addition to west elevation constructed circa 1980. The house does not embody distinctive characteristics of a type, period, or method of construction, and has no associations with significant events or people of the past.

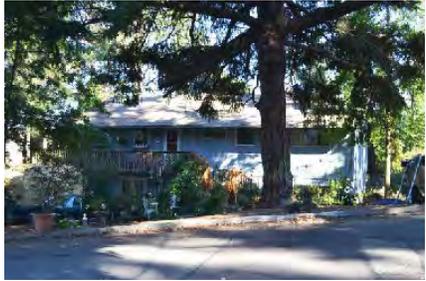
SW_21384 473 FULL	7475 SW HERMOSO WAY TIGARD R457179	Circa 1965 Building Ranch Vertical Board	Recommended Not Eligible/Non-Contributing	Basement-level garage has been converted to living space, garage door has been removed and infilled with modern vinyl doors. The house lacks integrity of design, materials, workmanship, feeling, and association.

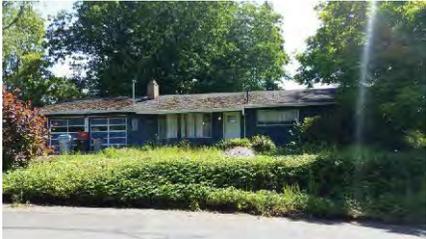
Project ID Survey # Acquisition	Resource Name Address & Assoc. Address Property ID Historic Name	Construction Date Resource Type Primary Style Primary Siding	NRHP Status	Integrity Comments / Notes	Photograph of Resource	Location
SW_13478 474 NO IMPACT	7420 SW HERMOSO WAY TIGARD R457311	Circa 1958 Building Ranch Shingle	Recommended Not Eligible/Non- Contributing	The house does not embody distinctive characteristics of a type, period, or method of construction, nor does it have known associations with significant events and people of the past.

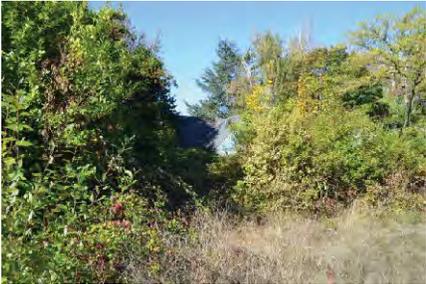
Project ID Survey # Acquisition	Resource Name Address & Assoc. Address Property ID Historic Name	Construction Date Resource Type Primary Style Primary Siding	NRHP Status	Integrity Comments / Notes	Photograph of Resource	Location
SW_1293 477 NO IMPACT	12235 SW 72ND AVE TIGARD R458123	Circa 1940 Building Tudor Revival Horizontal Board	Recommended Not Eligible/Non-Contributing	This house is abandoned, and being overtaken by vegetation. It appears to have a Tudor Revival form and World War II-era materials. The house has no historical associations of significance, and it does not embody distinctive characteristics of a type, period, or method of construction.

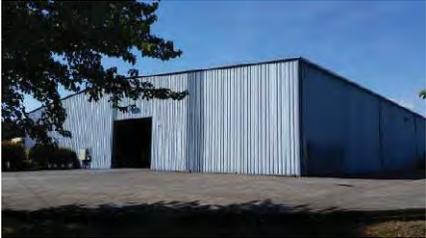
SW_9067 478 NO IMPACT	8185 SW HUNZIKER RD TIGARD R458347	Circa 1973 Building Utilitarian Corrugated Metal	Recommended Not Eligible/Non-Contributing	The western building on the parcel was constructed circa 1973, and the eastern building was constructed circa 1990. The buildings do not embody distinctive characteristics of a type, period, or method of construction, and have no known associations with historically significant events or people of the past.

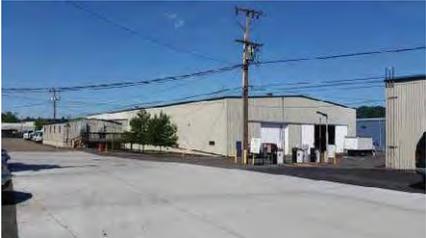
SW_10574 479 PARTIAL	8195 SW HUNZIKER RD TIGARD R458356	Circa 1973 Building Utilitarian Corrugated Metal	Recommended Not Eligible/Non-Contributing	Main building was constructed circa 1973; a small building to the west was added circa 1990. These buildings do not embody distinctive characteristics of a type, period, or method of construction, nor do they have an association with significant events or people of the past.

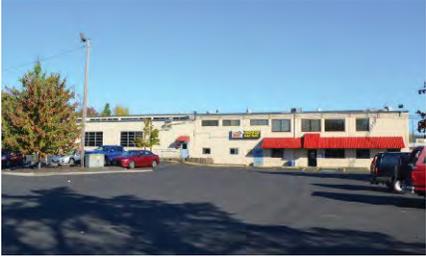
Project ID Survey # Acquisition	Resource Name Address & Assoc. Address Property ID Historic Name	Construction Date Resource Type Primary Style Primary Siding	NRHP Status	Integrity Comments / Notes	Photograph of Resource	Location
SW_10575 480 PARTIAL	8205 SW HUNZIKER RD TIGARD R458365	Circa 1958 Building Utilitarian Concrete Other / Undefined	Recommended Not Eligible/Non-Contributing	The building appears to be a mixture of poured concrete and tilt-up concrete construction. This difference in wall construction, in addition to the mixture of circa 1950s multi-light and circa 1970s sliding metal windows, indicates that the building has been modified since its original construction circa 1958. These modifications diminish the building's integrity.

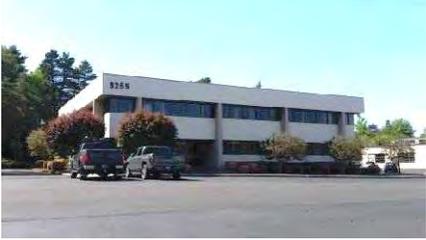
SW_9577 481 NO IMPACT	8255 SW HUNZIKER RD TIGARD R458374	Circa 1973 Building International Concrete Panels	Recommended Not Eligible/Non-Contributing	Anodized aluminum windows may have replaced original windows circa 1990. The building does not embody distinctive characteristics of a type, period, or method of construction, nor does it have associations with significant people or events of the past.

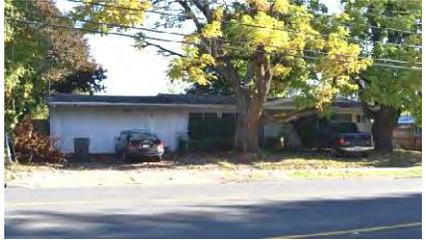
SW_13614 482 NO IMPACT	8365 SW HUNZIKER RD TIGARD R458542	1958 Building Ranch Vertical Board	Recommended Not Eligible/Non-Contributing	Original windows have been replaced with vinyl sliders. The house does not embody distinctive characteristics of a type, period, or method of construction, nor does it have an association with significant events or people of the past.
