**Section 106 and 4(f) Public Documents
Supplemental Information: Potential Impacts and Mitigation
for Historic Properties and Public Parks
SW Corridor Light Rail Project
Draft – December 15th, 2020**

This technical memo details the potential SW Corridor Light Rail Project impacts to protected historic properties and parks resources, as well as the proposed mitigations. This memo is intended for public review and comment.

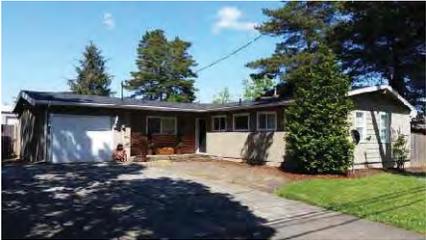
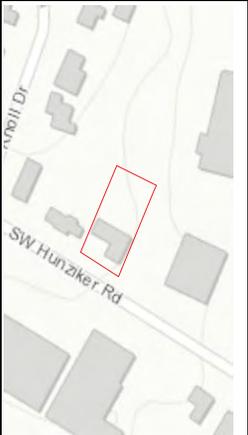
Project ID Survey # Acquisition	Resource Name Address & Assoc. Address Property ID Historic Name	Construction Date Resource Type Primary Style Primary Siding	NRHP Status	Integrity Comments / Notes	Photograph of Resource	Location
SW_22057 483 NO IMPACT	8335 SW HUNZIKER RD TIGARD R458551	1959 Building Ranch Vertical Board	Recommended Not Eligible/Non-Contributing	The replacement of original windows with vinyl sashes, in addition to the replacement of the house's original siding, have diminished its integrity of design, materials, workmanship, feeling, and association.

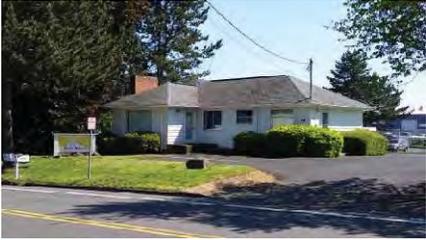
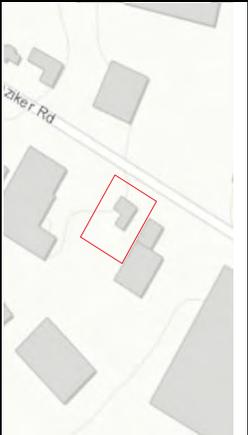
SW_686 484 NO IMPACT	8260 SW HUNZIKER RD TIGARD R458560	Circa 1948 Building WWII Era Cottage Horizontal Board	Recommended Not Eligible/Non-Contributing	This building was constructed as a single-family residence, and has been converted for use as commercial office space. The windows are a mixture of wood, vinyl, and anodized aluminum. The house no longer has integrity of design, materials, workmanship, feeling, and association, and has no historical associations of significance.

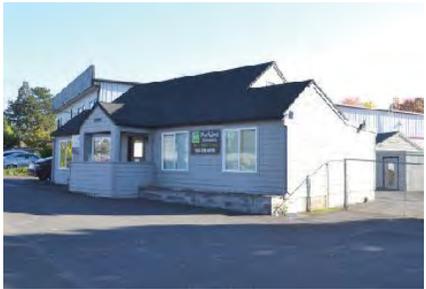
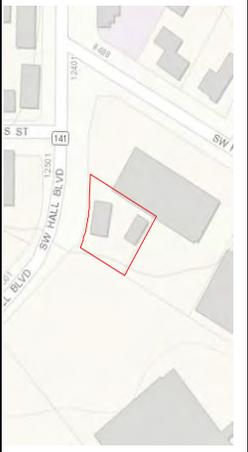
SW_3485 485 FULL	12530 SW HALL BLVD TIGARD R458588	Circa 1948 Building Minimal Traditional Horizontal Board	Recommended Not Eligible/Non-Contributing	Originally constructed as a single-family residence, this house has been converted for use as commercial office space. The siding and vinyl windows are not original to the date of construction. The building no longer has integrity of design, materials, workmanship, feeling, and association.

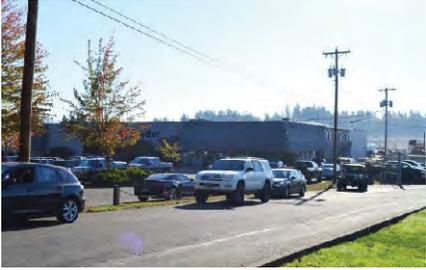
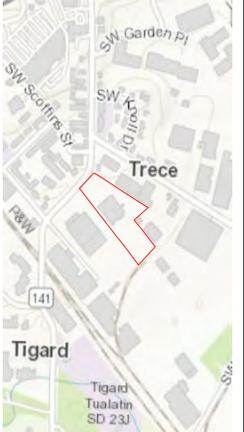
Project ID Survey # Acquisition	Resource Name Address & Assoc. Address Property ID Historic Name	Construction Date Resource Type Primary Style Primary Siding	NRHP Status	Integrity Comments / Notes	Photograph of Resource	Location
SW_10458 486 FULL	12650 SW HALL BLVD TIGARD R458604	Circa 1955 Building Utilitarian Concrete Panels	Recommended Not Eligible/Non-Contributing	The circa 1955 industrial building appears to have been modified circa 1970s, at which point metal awnings were added. Windows are a mixture of vinyl and aluminum sashes. The building no longer has integrity of design, materials, workmanship, feeling, and association, and has no historical associations of significance.

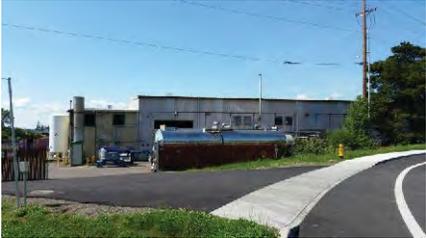
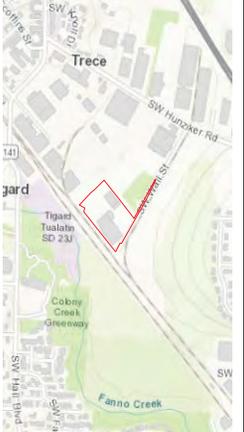
SW_21539 487 PARTIAL	7920 SW HUNZIKER RD TIGARD R456090	Circa 1972 Building Utilitarian Corrugated Metal	Previously Documented and Determined Not Eligible/Non-Contributing (2017); Recommended Not Eligible/Non-Contributing	No change was observed since the building was last documented and determined not eligible in 2017.

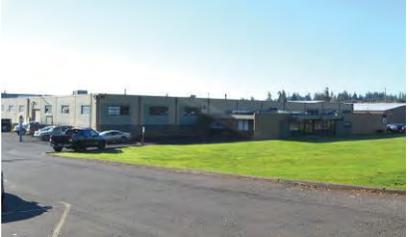
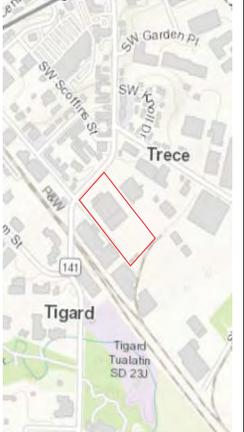
SW_705 488 FULL	12670 SW HALL BLVD TIGARD R2183630	Circa 1955 Building Utilitarian Concrete Panels	Recommended Not Eligible/Non-Contributing	Warehouse space was expanded to the southeast and an office space was added to the northwest circa 1968. The building does not embody distinctive characteristics of a type, period, or method of construction, and has no known associations with historically significant events or people of the past.

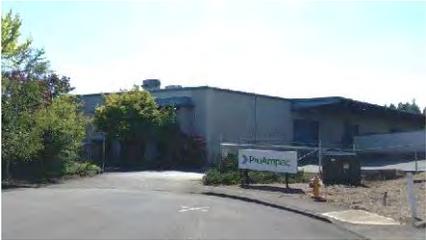
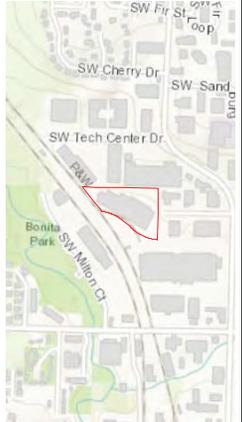
Project ID Survey # Acquisition	Resource Name Address & Assoc. Address Property ID Historic Name	Construction Date Resource Type Primary Style Primary Siding	NRHP Status	Integrity Comments / Notes	Photograph of Resource	Location
SW_2017 489 PARTIAL	7400 SW LANDMARK LN TIGARD R2105152	Circa 1973 Building Utilitarian Corrugated Metal	Recommended Not Eligible/Non-Contributing	The southeast end of this building was constructed circa 1973; it features an office area with anodized aluminum windows. Circa 2000, a large addition expanded the building's footprint to the northwest. The building no longer has integrity of design, workmanship, feeling, and association, and it has no historical associations of significance.

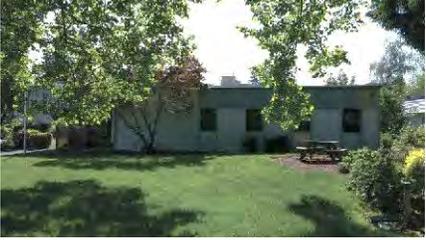
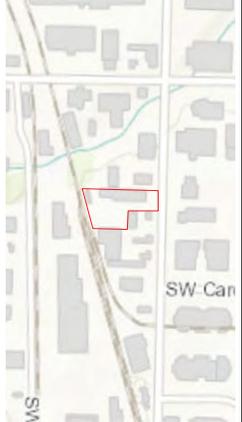
SW_2772 490 PARTIAL	14795 SW 72ND AVE TIGARD R511253	Circa 1975 Building Utilitarian Vertical Board	Recommended Not Eligible/Non-Contributing	This building has an office space to the east that is clad with vertical wood siding, and has anodized aluminum windows. To the west is a warehouse space that is obscured from view of SW 72nd Avenue. The building does not embody distinctive characteristics of a type, period, or method of construction, nor is it associated with significant people or events of our past.

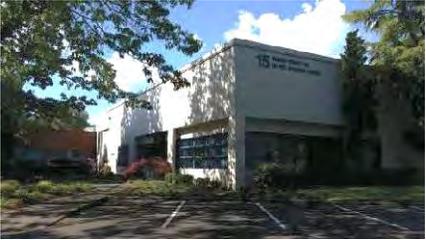
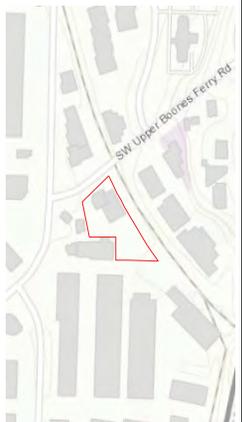
SW_15419 491 NO IMPACT	15860 SW UPPER BOONES FERRY RD TIGARD R513135	Circa 1974 Building Utilitarian Concrete Panels	Recommended Not Eligible/Non-Contributing	The circa 1974 warehouse space was remodeled circa 1990; metal multi-light windows were installed, and a projecting, curved office space was constructed at the northwest corner. The building no longer has integrity of design, materials, workmanship, feeling, and association.

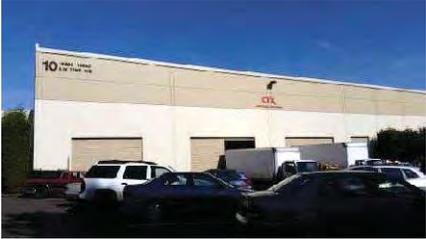
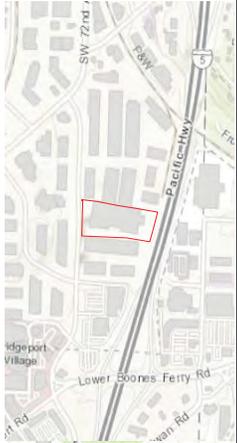
Project ID Survey # Acquisition	Resource Name Address & Assoc. Address Property ID Historic Name	Construction Date Resource Type Primary Style Primary Siding	NRHP Status	Integrity Comments / Notes	Photograph of Resource	Location
SW_15447 492 PARTIAL	16640 SW 72ND AVE TIGARD R513545	Circa 1975 Building Utilitarian Concrete Panels	Recommended Not Eligible/Non-Contributing	Office at the southwest corner was constructed circa 1995; it has anodized aluminum windows and brick veneer

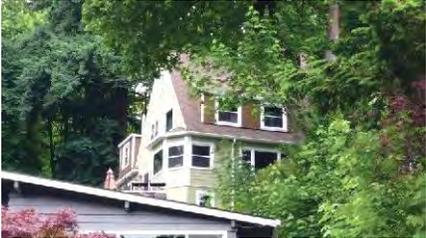
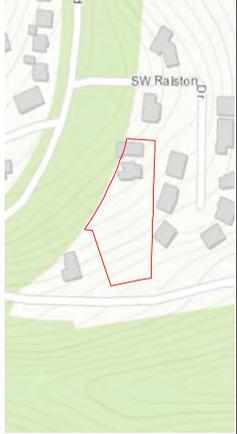
SW_976 493 NO IMPACT	5870 SW TERWILLIGER BLVD PORTLAND R119105570	1926 Building Tudor Revival Synthetic Wood Siding	Recommended Not Eligible/Non-Contributing	The house's vinyl windows and modern siding diminish its historical integrity of design, materials, workmanship, feeling, and association.

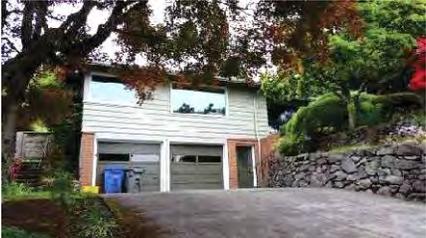
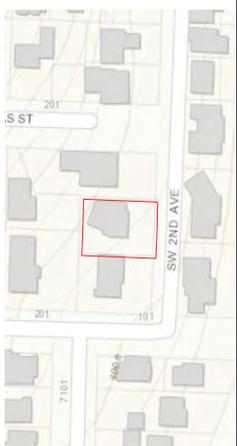
SW_13840 494 NO IMPACT	7021 SW 2ND AVE PORTLAND R780207790	1953 Building Ranch Horizontal Board	Recommended Not Eligible/Non-Contributing	Vinyl windows have replaced the original windows. This house has no known associations of significance, and it does not embody distinctive characteristics of a type, period, or method of construction.

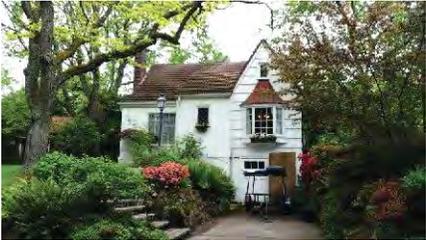
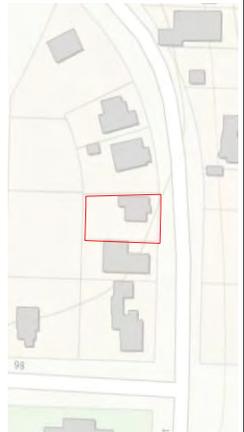
Project ID Survey # Acquisition	Resource Name Address & Assoc. Address Property ID Historic Name	Construction Date Resource Type Primary Style Primary Siding	NRHP Status	Integrity Comments / Notes	Photograph of Resource	Location
SW_11518 495 NO IMPACT	7301 SW BRIER PL PORTLAND R300401640	1940 Building Tudor Revival Cedar Shake Siding	Recommended Eligible/Contributing	This house retains its original wood windows. Shingles that clad portions of the exterior may represent a historic-period modification. An outbuilding is located west of the house.

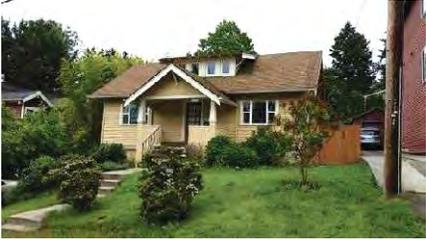
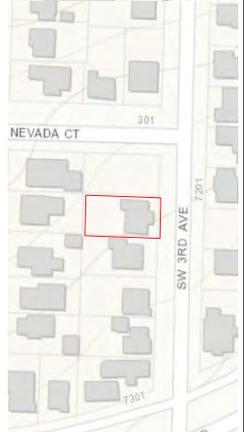
SW_20883 496 NO IMPACT	7215 SW 3RD AVE PORTLAND R300401330	1923 Building Craftsman Horizontal Board	Recommended Not Eligible/Non-Contributing	Modifications to the windows, siding, front porch, and east-facing dormer diminish the house's integrity of design, materials, workmanship, feeling, and association.

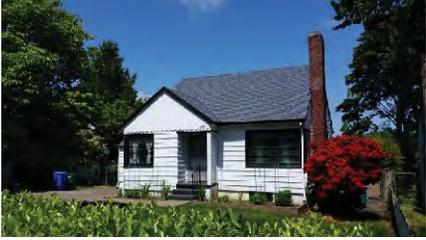
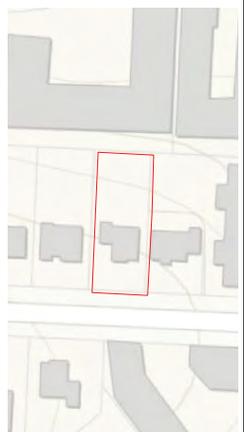
SW_12027 497 NO IMPACT	3211 SW PRIMROSE ST PORTLAND R383800050	1943 Building WWII Era Cottage Horizontal Board	Recommended Eligible/Contributing	The lap siding on the house exterior may represent a modification made at an unknown date. However, the original wood windows have been retained, and the house embodies distinctive characteristics of its period of construction.

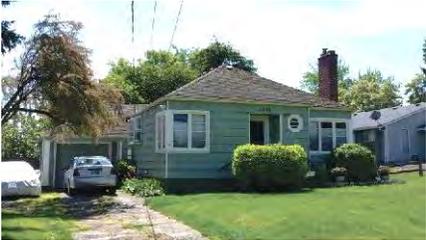
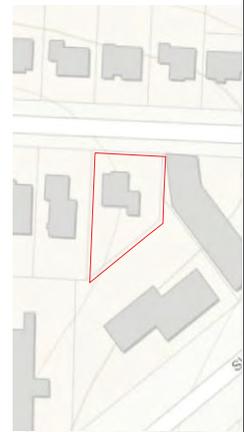
Project ID Survey # Acquisition	Resource Name Address & Assoc. Address Property ID Historic Name	Construction Date Resource Type Primary Style Primary Siding	NRHP Status	Integrity Comments / Notes	Photograph of Resource	Location
SW_7485 498 NO IMPACT	3220 SW PRIMROSE ST PORTLAND R383800490	1942 Building WWII Era Cottage Cedar Shake Siding	Recommended Eligible/Contributing	An small overhang has been constructed over the garage door, and a modern garden window has been added to the east elevation. However, this house has good historical integrity, and embodies distinctive characteristics of its period of construction.

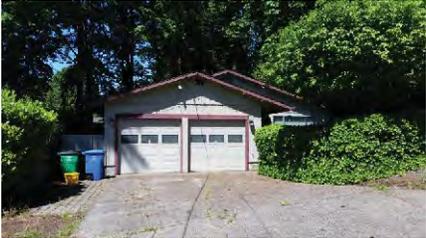
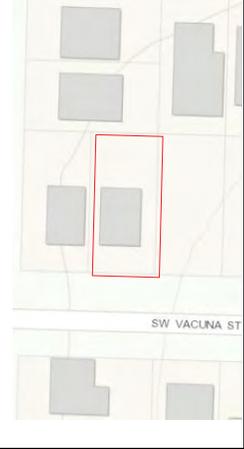
SW_14415 499 NO IMPACT	5235 SW VACUNA ST PORTLAND R894615130	1973 Building Ranch Vertical Board	Recommended Not Eligible/Non-Contributing	This house has no historical associations of significance, and does not embody distinctive characteristics of a type, period, or method of construction.

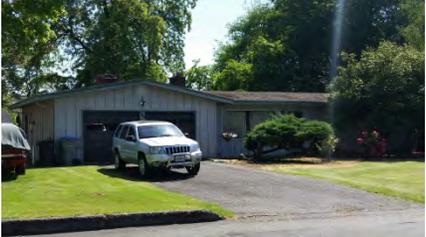
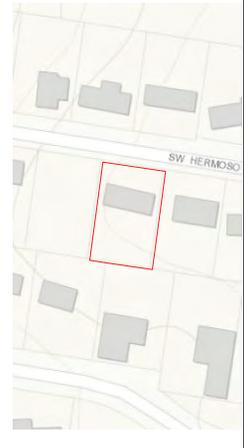
SW_1944 500 NO IMPACT	7380 SW HERMOSO WAY TIGARD R457320	Circa 1958 Building Ranch Vertical Board	Recommended Not Eligible/Non-Contributing	The house does not embody distinctive characteristics of a type, period, or method of construction, nor does it have known associations with significant events and people of the past.

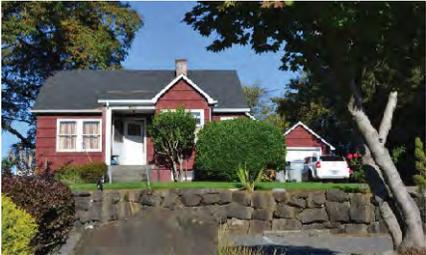
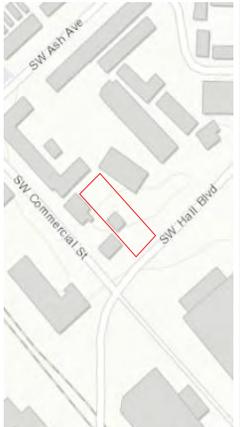
Project ID Survey # Acquisition	Resource Name Address & Assoc. Address Property ID Historic Name	Construction Date Resource Type Primary Style Primary Siding	NRHP Status	Integrity Comments / Notes	Photograph of Resource	Location
SW_121 501 TCE	12645 SW HALL BLVD TIGARD R461994	Circa 1940 Building Minimal Traditional Shingle	Recommended Not Eligible/Non-Contributing	Originally constructed as a single-family house, the building has been converted for use as a commercial space and is surrounded by multi-family, commercial, and industrial development. The building does not embody distinctive characteristics of a type, period, or method of construction, and has no associations with historically significant events or people of the past.

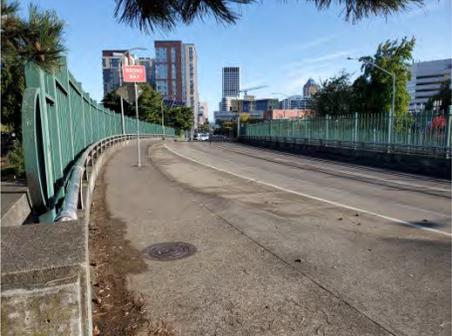
502 NO IMPACT	SW 5th Ave over Hwy 61 Bridge #09157	1964 Structure Not Applicable Not Applicable	Recommended Not Eligible/Non-Contributing	Reinforced concrete box girder. Not included in Oregon's Historic Bridge Field Guide (2013).

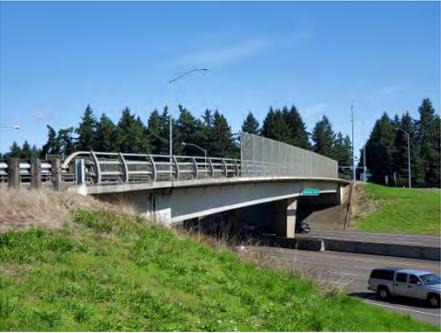
503 NO IMPACT	SW Upper Boones Ferry Rd (Carman Dr) over Hwy 1 Bridge #07728A	1975 Structure Not Applicable Not Applicable	Recommended Not Eligible/Non-Contributing	Reinforced concrete box girder. Not included in Oregon's Historic Bridge Field Guide (2013).

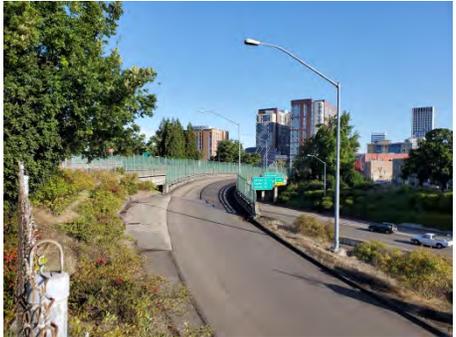
Project ID Survey # Acquisition	Resource Name Address & Assoc. Address Property ID Historic Name	Construction Date Resource Type Primary Style Primary Siding	NRHP Status	Integrity Comments / Notes	Photograph of Resource	Location
504 NO IMPACT	SW 5th Ave Conn #8 to Hwy 61 SB over Hwy 61 Bridge #09156	1964 Structure Not Applicable Not Applicable	Recommended Not Eligible/Non-Contributing	Reinforced concrete box girder. Not included in Oregon's Historic Bridge Field Guide (2013).

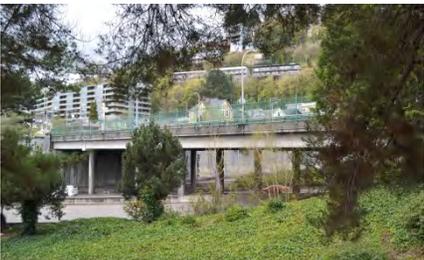
Project ID Survey # Acquisition	Resource Name Address & Assoc. Address Property ID Historic Name	Construction Date Resource Type Primary Style Primary Siding	NRHP Status	Integrity Comments / Notes	Photograph of Resource	Location
507 NO IMPACT	SW 6th Ave Conn #3 over Hwy 61 Bridge #09158	1964 Structure Not Applicable Not Applicable	Recommended Not Eligible/Non-Contributing	Reinforced concrete box girder with modern metal barriers installed at the railing. Not included in Oregon's Historic Bridge Field Guide (2013).

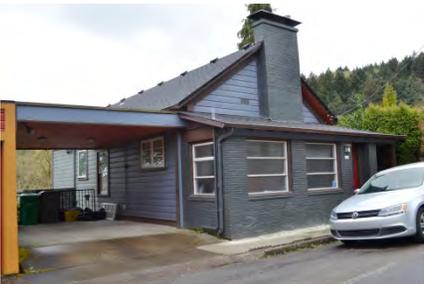
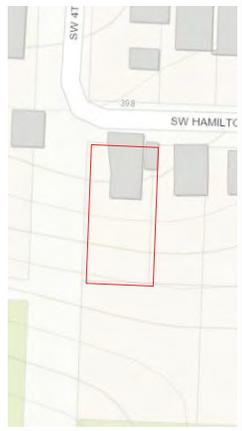
See Appendix A
SW_13864 508 NO IMPACT	382 SW HAMILTON CT Portland R669104690	1894 Building Victorian Era Horizontal Board	Recommended Not Eligible/Non-Contributing	The house has been modified by the construction of a circa 1950s entry vestibule at the north facade and a carport at the east elevation. All original windows have been replaced with wood and vinyl sashes.

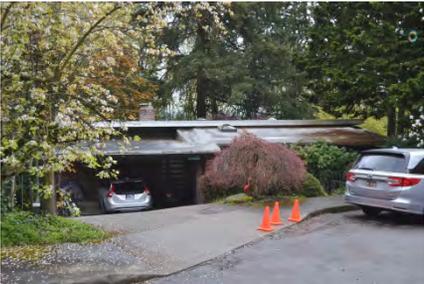
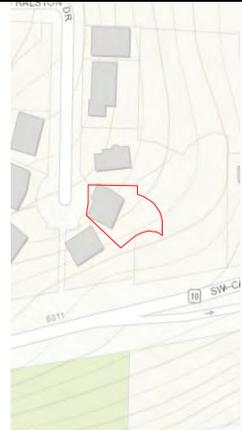
SW_6790 509 NO IMPACT	5920 SW RALSTON DR Portland R300600070	1959 Building Ranch Synthetic Other/Undefined	Recommended Not Eligible/Non-Contributing	The roof is comprised of multiple sheds. Original siding has been replaced with composite lap siding, and original windows have been replaced with vinyl sashes.

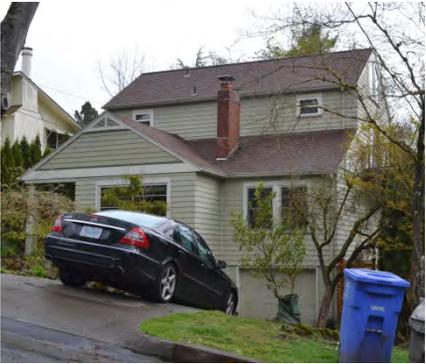
Project ID Survey # Acquisition	Resource Name Address & Assoc. Address Property ID Historic Name	Construction Date Resource Type Primary Style Primary Siding	NRHP Status	Integrity Comments / Notes	Photograph of Resource	Location
SW_11494 510 NO IMPACT	7148 SW 4TH AVE Portland R300400820	1948 Building Minimal Traditional Synthetic Other/Undefined	Recommended Not Eligible/Non-Contributing	A second floor was added during the modern period. First floor has some original wood windows; remaining windows are vinyl. The original wood siding was likely replaced when the second floor was added; the house is now clad in synthetic siding.

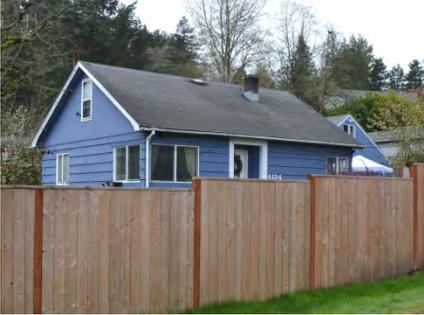
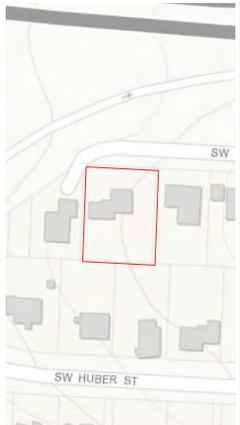
Project ID Survey # Acquisition	Resource Name Address & Assoc. Address Property ID Historic Name	Construction Date Resource Type Primary Style Primary Siding	NRHP Status	Integrity Comments / Notes	Photograph of Resource	Location
SW_7962 511 NO IMPACT	4134 SW WILBARD ST Portland R406401000	1949 Building Modern Period Other Shingle	Recommended Not Eligible/Non-Contributing	All original windows have been replaced with vinyl sashes, and a former garage (that may have once been detached) has been converted for use as living space. The building's diminished historical integrity limits its eligibility for listing in the NRHP.

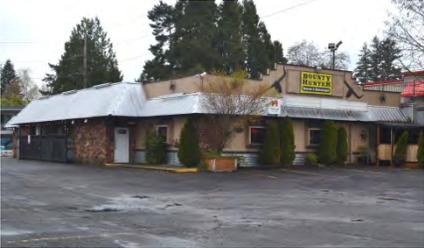
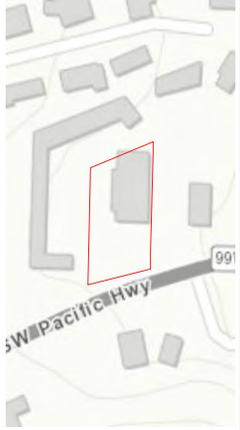
SW_13339 512 NO IMPACT	11445 SW PACIFIC HWY Tigard R279497	Circa 1975 Building Commercial Vertical Board	Recommended Not Eligible/Non-Contributing	The building's false front appears to be of modern construction. The windows and much of the building's siding date to the modern period. The building's diminished historical integrity limits its eligibility for listing in the NRHP.

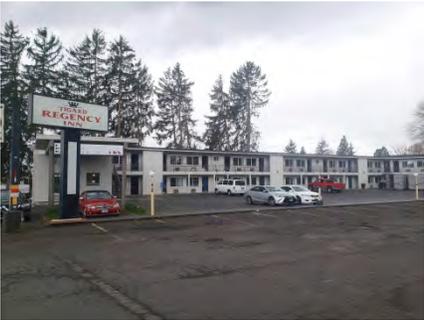
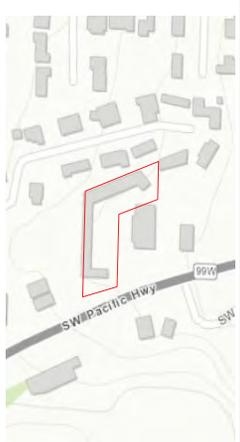
SW_7099 513 NO IMPACT	11455 SW PACIFIC HWY Tigard R2164668	Circa 1975 Building Late 20 th Century Other Synthetic Other/Undefined	Recommended Not Eligible/Non-Contributing	Windows are modern vinyl sliding sashes with grid inserts, and the siding is a modern synthetic replacement. The building lacks historical integrity and has no known historical associations of significance.

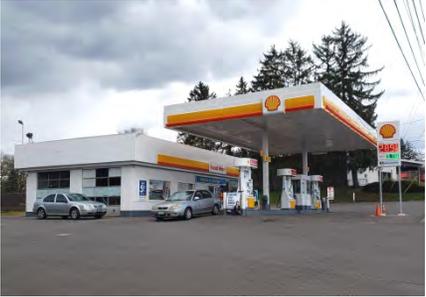
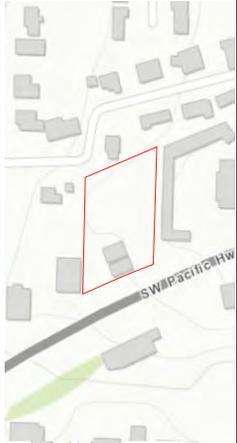
Project ID Survey # Acquisition	Resource Name Address & Assoc. Address Property ID Historic Name	Construction Date Resource Type Primary Style Primary Siding	NRHP Status	Integrity Comments / Notes	Photograph of Resource	Location
SW_20284 514 NO IMPACT	11465 SW PACIFIC HWY Tigard R2079845	Circa 1975 Building Late 20 th Century Other Metal Sheet	Recommended Not Eligible/Non-Contributing	Windows appear to be original fixed aluminum sashes, while the siding is modern corrugated metal. The building has diminished aspects of historical integrity and no historical associations of significance under Criteria A through D.

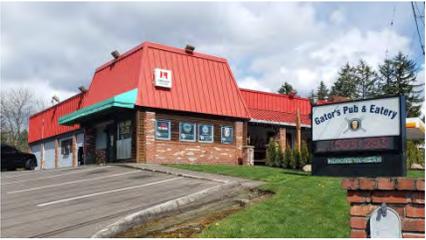
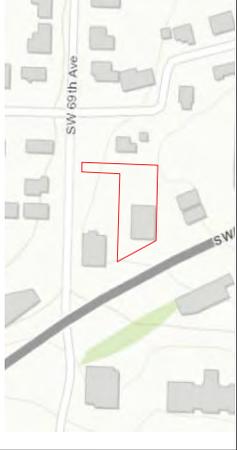
SW_18402 515 NO IMPACT	11475 SW PACIFIC HWY Tigard R279335	Circa 1975 Building Commercial Concrete Block	Recommended Not Eligible/Non-Contributing	Former openings have been infilled, and modern cladding has been added to the exterior. The building has diminished integrity and no known associations of significance under Criteria A through D.

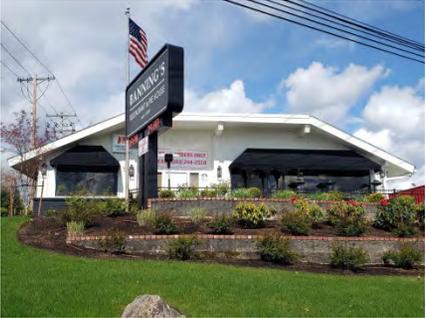
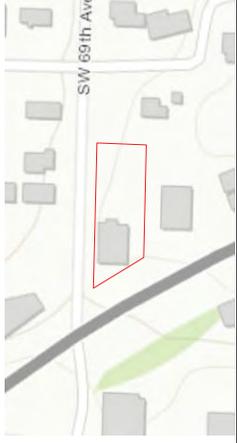
SW_1150 516 NO IMPACT	11477 SW PACIFIC HWY Tigard R279326	Circa 1975 Building Commercial Vertical Board	Recommended Not Eligible/Non-Contributing	Board and batten siding is not original to the date of construction. The building has no known historical associations of significance under Criteria A through D.

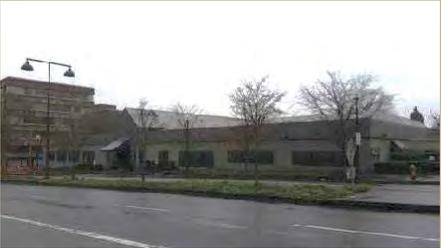
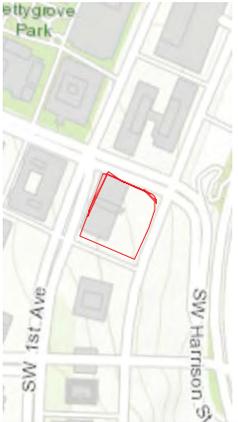
Project ID Survey # Acquisition	Resource Name Address & Assoc. Address Property ID Historic Name	Construction Date Resource Type Primary Style Primary Siding	NRHP Status	Integrity Comments / Notes	Photograph of Resource	Location
SW_13450 B517 PARTIAL	1881 SW NAITO PKWY PORTLAND R777502200	1922 Building Contemporary	Recommended Not Eligible/Non-Contributing	Despite its modern appearance, Multnomah County records note this building as having been constructed in 1922. A 1950 Sanborn Fire Insurance map confirms that the north portion of the building matches the footprint of a steam laundry business. A later expansion of the building's footprint and an extensive remodel done in 2000 give the building its modern appearance.

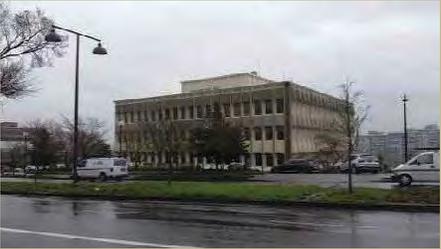
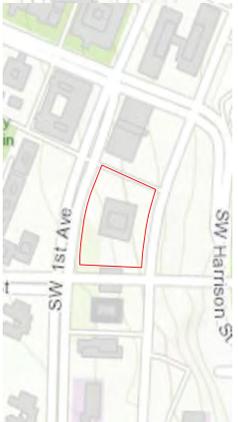
SW_479 B518 PARTIAL	2000 SW 1ST AVE PORTLAND R777502400 IBM Building	1965 Building New Formalism Concrete Other / Undefined	Recommended Eligible/Contributing	Designed by Paul Kirk and constructed in the South Auditorium Urban Renewal area.

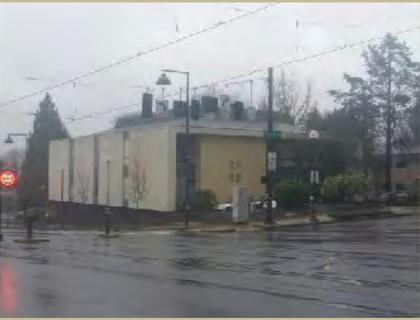
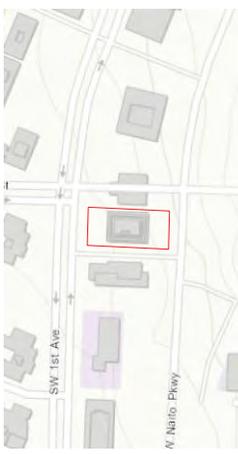
SW_99 B519 PARTIAL	2112 SW 1ST AVE PORTLAND R777502310	1968 Building Modern Commercial Concrete Panels	Recommended Eligible/Contributing	Retains good integrity, and is within the South Auditorium Urban Renewal area.

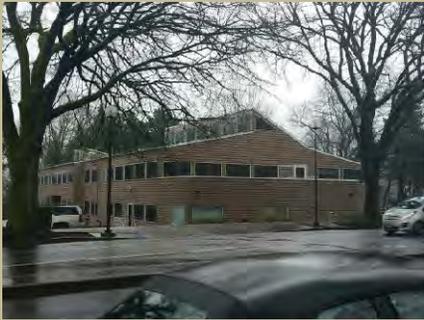
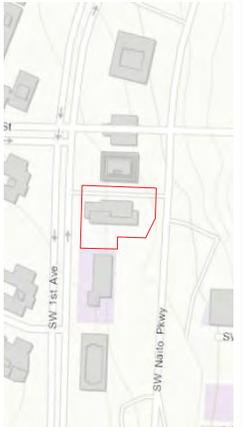
Project ID Survey # Acquisition	Resource Name Address & Assoc. Address Property ID Historic Name	Construction Date Resource Type Primary Style Primary Siding	NRHP Status	Integrity Comments / Notes	Photograph of Resource	Location
SW_3061 B520 PARTIAL	Boy Scouts of America 2145 SW NAITO PKWY PORTLAND 25 SW Grant Street R777502600 Columbia River Council Boy Scouts of America Service Center	1958 Building Shed Vinyl Siding	City of Portland HRI (1984 - No Rank); Recommended Not Eligible/Non- Contributing	This building has been extensively modified; it is clad with modern siding and has vinyl windows. The building's diminished integrity limits its potential to be eligible for listing in the NRHP.

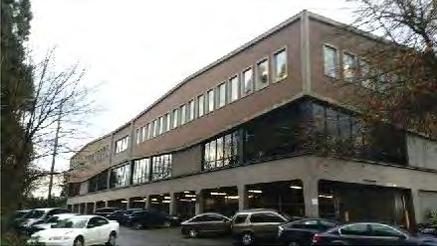
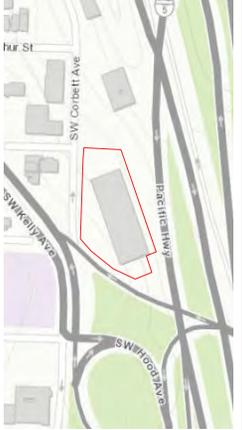
SW_106 B521 NO IMPACT	2828 SW CORBETT AVE PORTLAND R140909340 Cascade Plaza	1965 Building Modern Period Other Standard Brick	Recommended Not Eligible/Non-Contributing	Modern aluminum windows and concrete block observed on exterior diminish the building's historical integrity and its eligibility to be listed in the NRHP.

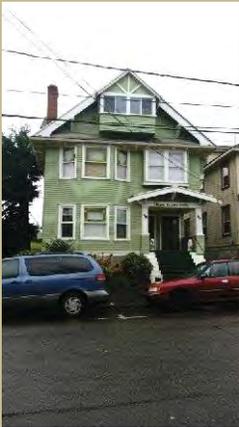
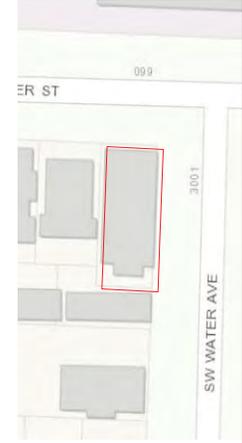
SW_7139 B522 NO IMPACT	036-038 SW PORTER ST PORTLAND R140904810	1908 Building Craftsman Horizontal Board	Recommended Eligible/Contributing	Oriel projecting from the north facade does not appear to be original.

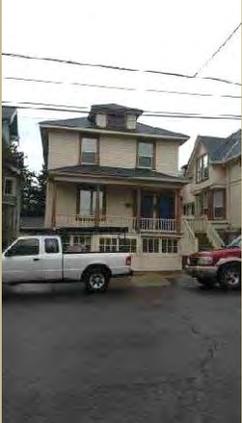
Project ID Survey # Acquisition	Resource Name Address & Assoc. Address Property ID Historic Name	Construction Date Resource Type Primary Style Primary Siding	NRHP Status	Integrity Comments / Notes	Photograph of Resource	Location
SW_2575 B523 NO IMPACT	030-032 SW PORTER ST PORTLAND R140904820	1906 Building Colonial Revival Horizontal Board	Recommended Not Eligible/Non-Contributing	Modern windows diminish the house's historical integrity. The house has no known associations of significance under Criteria A through D.

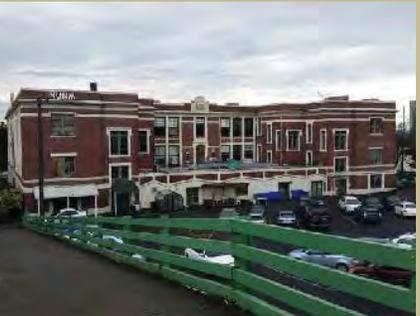
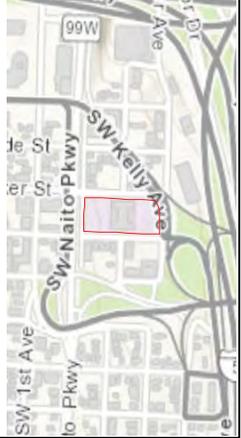
SW_14290 B524 NO IMPACT	National University of Natural Medicine Academic 049 SW PORTER ST PORTLAND R140904550 Failing, Josiah, School	1912 Building Tudor Revival Standard Brick	City of Portland HRI (1984 - Rank II); Recommended Eligible/Contributing	Eligible under Criteria A and C

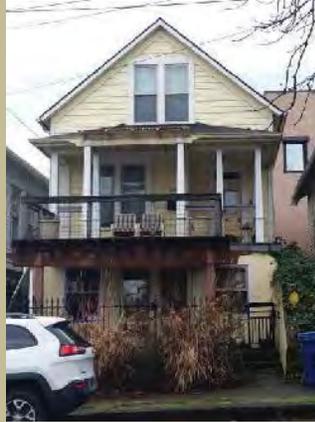
SW_4872 B525 NO IMPACT	022 SW MEADE ST PORTLAND R140904950	1886 Building Vernacular Horizontal Board	Recommended Not Eligible/Non-Contributing	Vinyl windows and porch modifications diminish the house's historical integrity. The house has no known historical associations of significance under Criteria A through D.

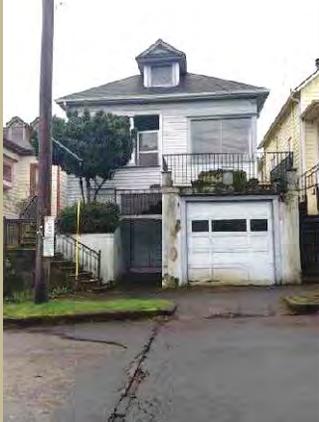
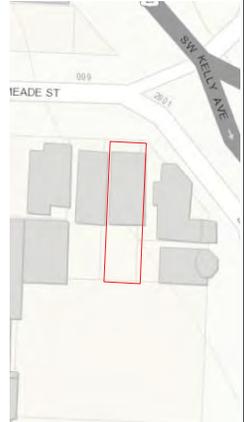
Project ID Survey # Acquisition	Resource Name Address & Assoc. Address Property ID Historic Name	Construction Date Resource Type Primary Style Primary Siding	NRHP Status	Integrity Comments / Notes	Photograph of Resource	Location
SW_3221 B526 NO IMPACT	030 SW MEADE ST PORTLAND R140904960	1898 Building Colonial Revival Horizontal Board	Recommended Not Eligible/Non-Contributing	Vinyl windows and porch modifications diminish the house's historical integrity. The house has no known historical associations of significance under Criteria A through D.

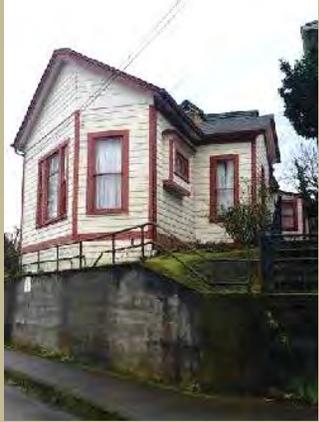
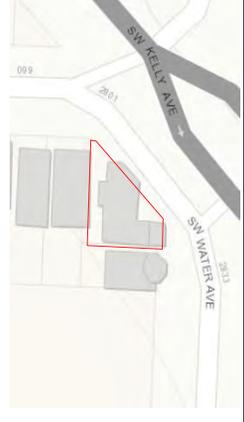
SW_3222 B527 NO IMPACT	2809 SW WATER AVE PORTLAND R140904970	1896 Building Queen Anne Horizontal Board	Recommended Not Eligible/Non-Contributing	A circa 1940s addition with modern board-and-batten siding diminishes the house's historical integrity. The house has no known historical associations of significance under Criteria A through D.

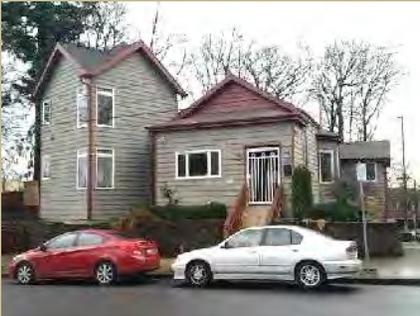
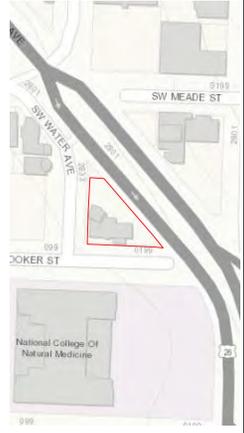
SW_14292 B528 PARTIAL	2828 SW WATER AVE PORTLAND R140904510	1886 Building Vernacular Horizontal Board	Recommended Not Eligible/Non-Contributing	A non-conforming addition, modern siding, and vinyl windows diminish the house's historical integrity. The house has no known historical associations of significance under Criteria A through D.

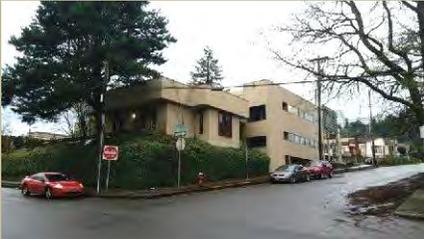
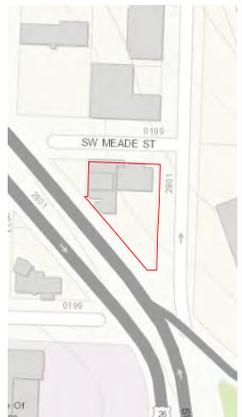
Project ID Survey # Acquisition	Resource Name Address & Assoc. Address Property ID Historic Name	Construction Date Resource Type Primary Style Primary Siding	NRHP Status	Integrity Comments / Notes	Photograph of Resource	Location
SW_12578 B529 NO IMPACT	2828 SW KELLY AVE PORTLAND R140904470	1959 Building Split Level Vertical Board	Recommended Not Eligible/Non-Contributing	Some sections of modern cladding and anodized aluminum metal windows were observed. The building has no known historical associations of significance under Criteria A through D.

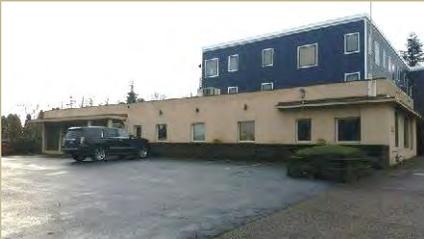
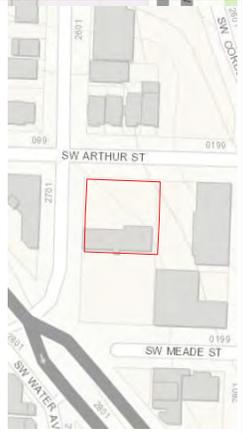
SW_461 B530 NO IMPACT	2718 SW WATER AVE PORTLAND R140904460	1958 Building Other / Undefined Stucco	Recommended Not Eligible/Non-Contributing	The stucco siding and vinyl windows diminish the building's historical integrity. The building has no known historical associations of significance under Criteria A through D.

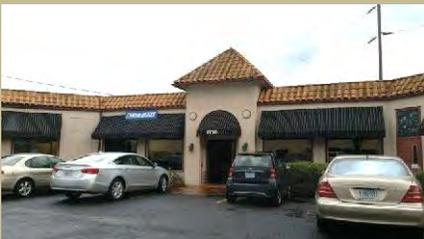
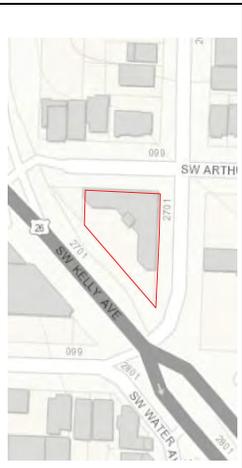
SW_16219 B531 NO IMPACT	2718 SW KELLY AVE PORTLAND R140905080	1931 Building Mediterranean Revival Stucco	Recommended Not Eligible/Non-Contributing	Rear of building has vinyl windows and siding that diminish its historical integrity. The building has no known historical associations of significance under Criteria A through D.

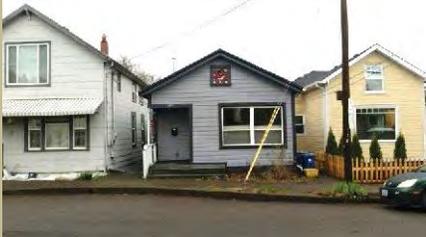
Project ID Survey # Acquisition	Resource Name Address & Assoc. Address Property ID Historic Name	Construction Date Resource Type Primary Style Primary Siding	NRHP Status	Integrity Comments / Notes	Photograph of Resource	Location
SW_3580 B532 NO IMPACT	019 SW ARTHUR ST PORTLAND R140905220	1887 Building Vernacular Horizontal Board	Recommended Not Eligible/Non-Contributing	Vinyl windows diminish the house's historical integrity. The building has no known historical associations of significance under Criteria A through D.

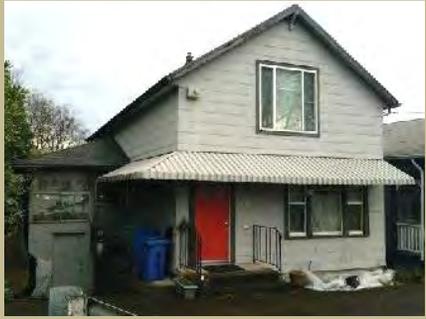
SW_16561 B533 NO IMPACT	013 SW ARTHUR ST PORTLAND R140905230	1886 Building Vernacular Cement Fiber Siding	Recommended Not Eligible/Non-Contributing	Vinyl windows and cement fiber siding diminish the building's historical integrity. The building has no known historical associations of significance under Criteria A through D.

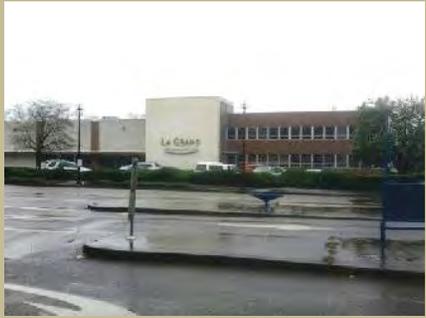
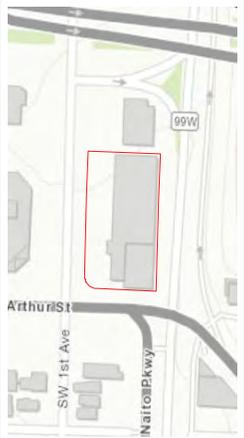
SW_10949 B534 NO IMPACT	La Grand Industrial Supply 2620 SW 1ST AVE PORTLAND R777502100	1947 Building Modern Commercial Standard Brick	Recommended Not Eligible/Non-Contributing	Originally constructed in 1947, the building appears to have been significantly expanded circa 1964. The building has no known historical associations of significance under Criteria A through D.

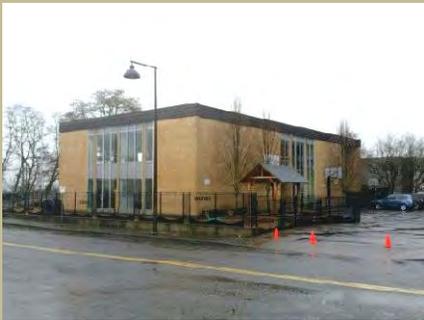
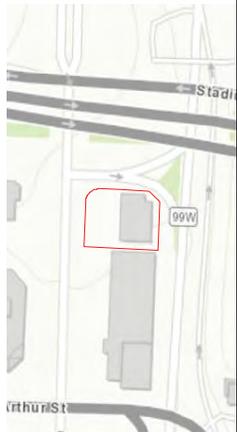
Project ID Survey # Acquisition	Resource Name Address & Assoc. Address Property ID Historic Name	Construction Date Resource Type Primary Style Primary Siding	NRHP Status	Integrity Comments / Notes	Photograph of Resource	Location
SW_11727 B535 NO IMPACT	Summa Institute 2510 SW 1ST AVE PORTLAND R777502030 Addressograph-Multigraph Building	1964 Building Modern Commercial Standard Brick	Recommended Eligible/Contributing	Constructed in South Auditorium Urban Renewal project area and has good historical integrity.

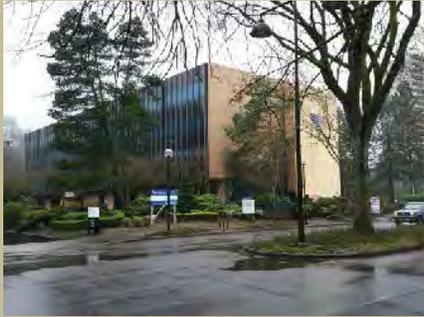
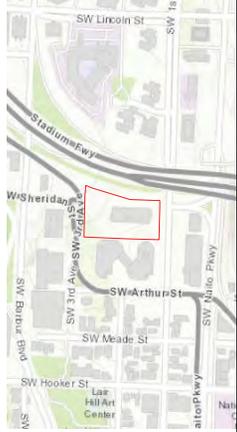
SW_22039 B536 NO IMPACT	Marquam Building 2501 SW 1ST AVE PORTLAND R777501820	1966 Building International Poured Concrete	Previously Recorded as Eligible/Contributing (2011 - Portland Central City Modern Resources RLS 1945-1985); Recommended Eligible/Contributing	Constructed in South Auditorium Urban Renewal project area and has good historical integrity.

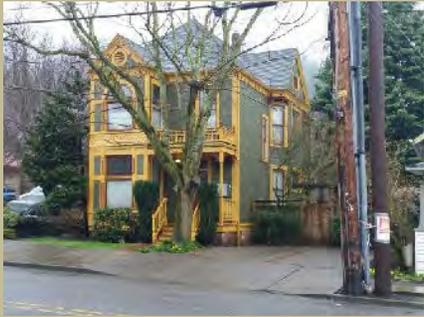
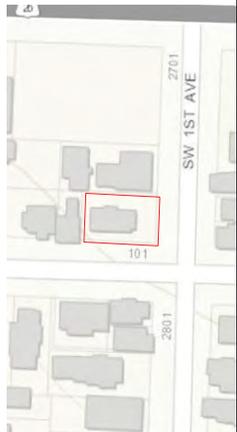
SW_15758 B537 NO IMPACT	2737 SW 1ST AVE PORTLAND R140905960 Mayor Riley House	1894 Building Queen Anne Horizontal Board	Contributing Resource, South Portland Historic District (Listed in 1998)

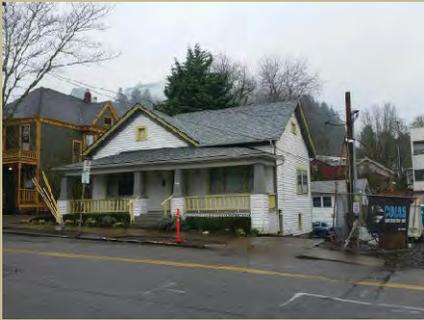
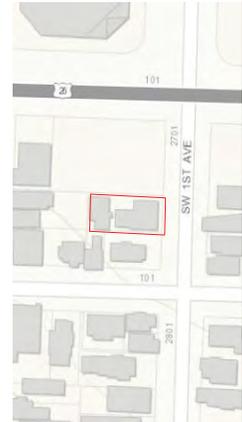
Project ID Survey # Acquisition	Resource Name Address & Assoc. Address Property ID Historic Name	Construction Date Resource Type Primary Style Primary Siding	NRHP Status	Integrity Comments / Notes	Photograph of Resource	Location
SW_19409 B538 NO IMPACT	2721-2725 SW 1ST AVE PORTLAND R140905950 Lakefish, B & Mary, House (2721) and Lamberson, CE House (2725)	1898 Building Craftsman Horizontal Board	Contributing Resource, South Portland Historic District (Listed in 1998)	The 1898 date of construction is derived from tax assessor records for the house at 2725 SW 1st Avenue, which appears to have been remodeled circa 1930 to have a Craftsman appearance. The South Portland Historic District nomination reports the house's date of construction as circa 1905. A second building on the parcel (at 2721 SW 1 st Avenue) was constructed in 1926.

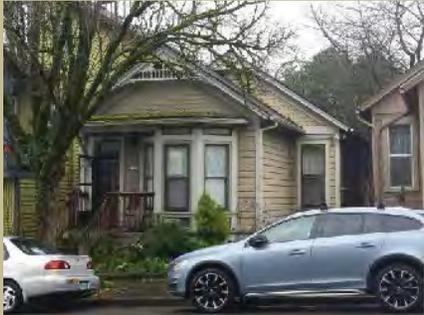
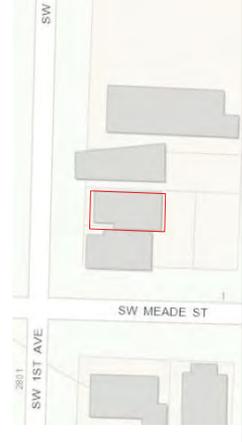
SW_249 B539 NO IMPACT	2732 SW 1ST AVE PORTLAND R140905460 Marquam, Philip Augustus, House #2	1884 Building Queen Anne Horizontal Board	Contributing Resource, South Portland Historic District (Listed in 1998)

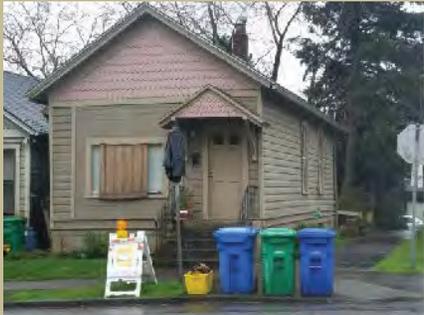
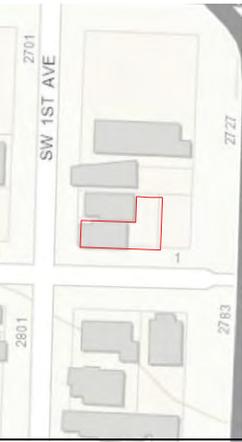
SW_4793 B540 NO IMPACT	2740 SW 1ST AVE PORTLAND R140905450 Marquam, Philip Augustus, House #1	1884 Building Vernacular Horizontal Board	Contributing Resource, South Portland Historic District (Listed in 1998)	Poor integrity. Building contributes to district due to its significant association with Philip Augustus Marquam.

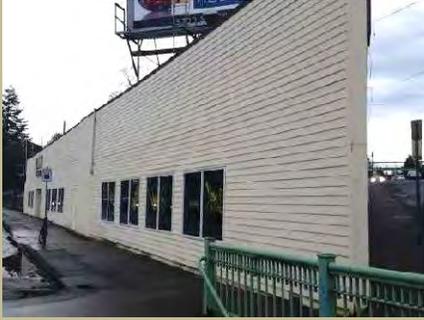
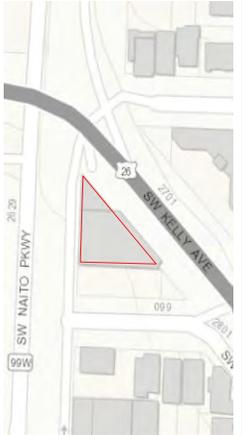
Project ID Survey # Acquisition	Resource Name Address & Assoc. Address Property ID Historic Name	Construction Date Resource Type Primary Style Primary Siding	NRHP Status	Integrity Comments / Notes	Photograph of Resource	Location
SW_14294 B541 NO IMPACT	2715-2719 W/ SW KELLY AVE PORTLAND R140905130	1929 Building Commercial Aluminum Siding	Recommended Not Eligible/Non-Contributing	Boundary includes two parcels: R140905130 and R140905120. Constructed as two separate buildings in 1929 and 1932 that now functionally operate as one building. Has modern siding and vinyl windows that diminish the building's historical integrity.

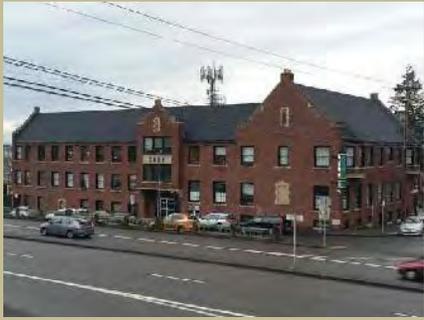
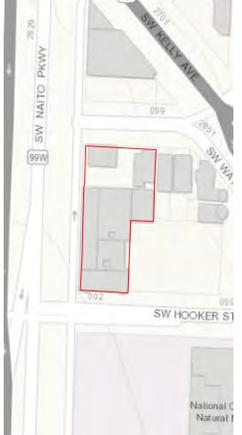
SW_14297 B542 NO IMPACT	National University of Natural Medicine 2828 SW NAITO PKWY PORTLAND R140905050 Helen Kelly Manley Community Center	1929 Building Tudor Revival Standard Brick	Recommended Eligible/Contributing	Craftsman house is on same parcel and appears to be constructed near the same time as the main building, circa 1929. Was a popular community gathering place, particularly for Italian immigrants during the early- to mid-twentieth century.

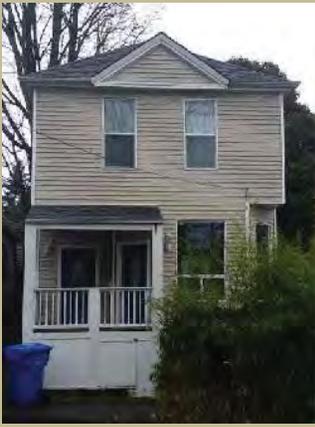
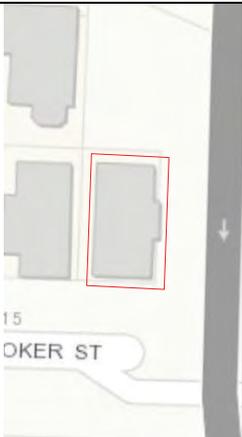
SW_6905 B543 PARTIAL	19-21 SW HOOKER ST PORTLAND R140905520 Dewell, Mary E & Charles, House	1888 Building Queen Anne Vinyl Siding	Contributing Resource, South Portland Historic District (Listed in 1998)	Extensive modifications to the siding and windows of the house have diminished its historical integrity since it was last documented in 1998.

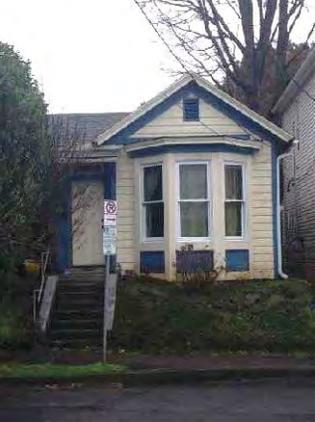
Project ID Survey # Acquisition	Resource Name Address & Assoc. Address Property ID Historic Name	Construction Date Resource Type Primary Style Primary Siding	NRHP Status	Integrity Comments / Notes	Photograph of Resource	Location
SW_11145 B544 PARTIAL	25 SW HOOKER ST PORTLAND R463840200 Warren, Mary, House	1880 Building Queen Anne Horizontal Board	Contributing Resource, South Portland Historic District (Listed in 1998)

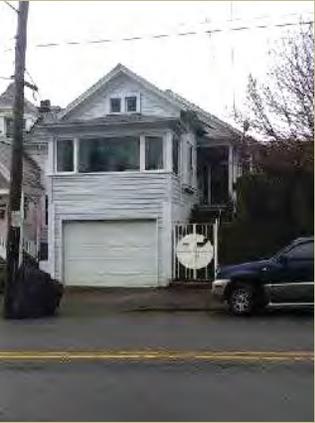
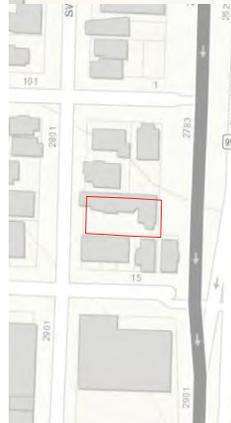
SW_20861 B545 NO IMPACT	2824-2826 SW 1ST AVE PORTLAND R140905540	1905 Building Vernacular Horizontal Board	Contributing Resource, South Portland Historic District (Listed in 1998)	Modifications to the porch and windows of the house have greatly diminished its historical integrity since it was last documented in 1998.

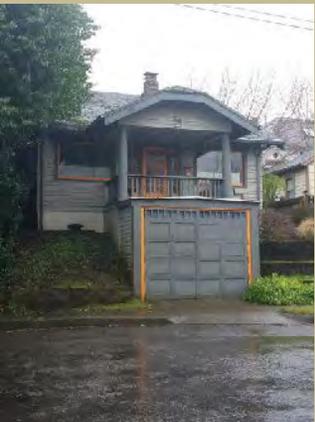
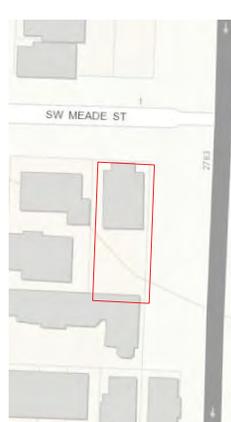
SW_510 B546 NO IMPACT	26 SW MEADE ST PORTLAND R140905560 Rosenfeld, Maris Sophia, House	1923 Building Bungalow Horizontal Board	Contributing Resource, South Portland Historic District (Listed in 1998)

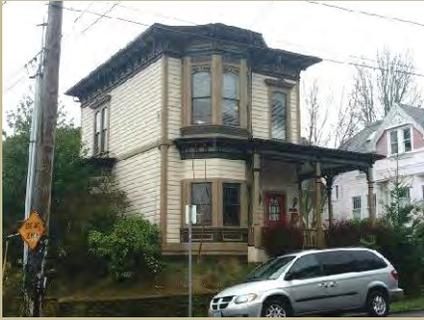
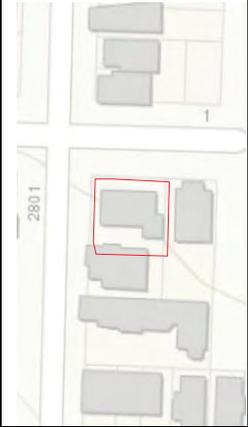
Project ID Survey # Acquisition	Resource Name Address & Assoc. Address Property ID Historic Name	Construction Date Resource Type Primary Style Primary Siding	NRHP Status	Integrity Comments / Notes	Photograph of Resource	Location
SW_20862 B547 NO IMPACT	2806 SW 1ST AVE PORTLAND R140905550 Taylor, Peter & Haehlen, John & Gotlieb House #1	1876 Building Italianate Horizontal Board	Individually Listed in NRHP (1984); Contributing Resource, South Portland Historic District (Listed in 1998); City of Portland Historic Landmark

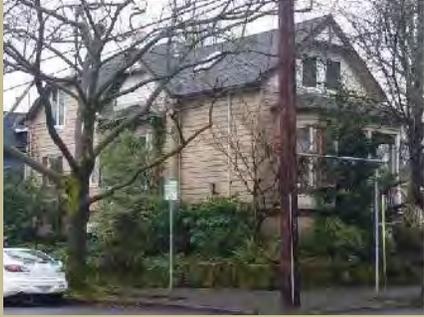
SW_21152 B548 PARTIAL	3004 SW 1ST AVE PORTLAND 26 SW Porter Street R140905660 Pope, Seth L, House	1885 Building Queen Anne Horizontal Board	Contributing Resource, South Portland Historic District (Listed in 1998) g	Historic period modifications to roof and modern modifications to windows diminish the historical integrity of the house; compared to others in the district, it is no longer a good example of a Queen Anne residence.

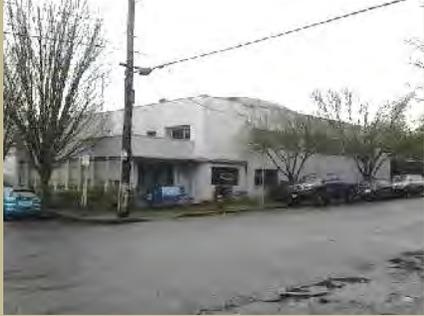
SW_20339 B549 PARTIAL	2904 SW 1ST AVE PORTLAND R140905570	1952 Building Modern Commercial Poured Concrete	Not Eligible/Out of Period, South Portland Historic District (Listed in 1998); Recommended Not Eligible/Non-Contributing as an individual resource	First used by Urban Plumbing and Heating Company. Some original windows have been replaced with anodized aluminum sashes. The building is not individually eligible for listing in the NRHP, as it has no historical associations of significance under Criteria A through D.

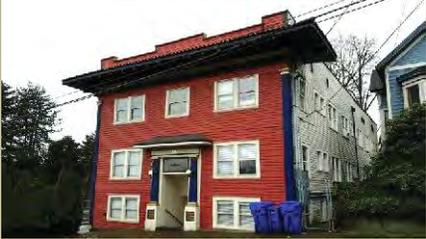
Project ID Survey # Acquisition	Resource Name Address & Assoc. Address Property ID Historic Name	Construction Date Resource Type Primary Style Primary Siding	NRHP Status	Integrity Comments / Notes	Photograph of Resource	Location
SW_11016 B550 PARTIAL	16 SW PORTER ST PORTLAND R140905610 Baldwin, LeGrand M., House	1913 Building Italianate Horizontal Board	Contributing Resource, South Portland Historic District (Listed in 1998)

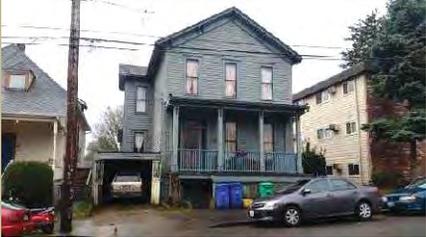
SW_11875 B551 NO IMPACT	018 SW PORTER ST PORTLAND R140904940	1886 Building Italianate Horizontal Board	Recommended Eligible/Contributing	Good historical integrity; the house is representative of its type and period of construction.

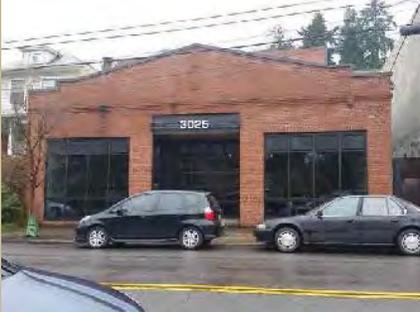
SW_6725 B554 NO IMPACT	3025 SW 1ST AVE PORTLAND R140907820 Wallace, Sidney, Property	1916 Building Commercial Standard Brick	Contributing Resource, South Portland Historic District (Listed in 1998)	Modifications to east facade noted in South Portland Historic District NRHP nomination

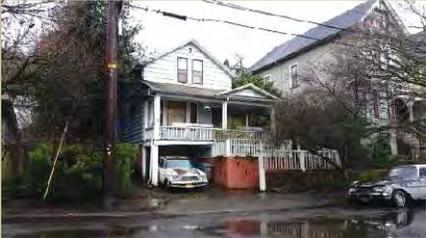
SW_9133 B557 NO IMPACT	3115 SW 1ST AVE PORTLAND R140910290 Barcroft, Anna, House #3	1880 Building Colonial Revival Cement Fiber Siding	Contributing Resource, South Portland Historic District (Listed in 1998)	Modifications to cladding, windows, and east facade porch have diminished the historical integrity of the house.

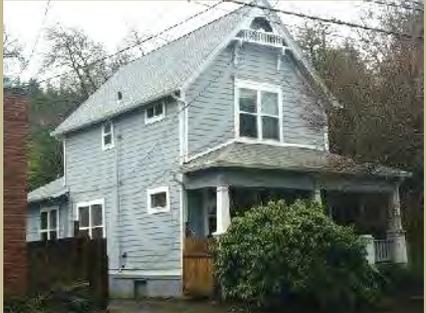
SW_557 B558 NO IMPACT	3125 SW 1ST AVE PORTLAND R140910300 Corner, E.L., House	1888 Building Colonial Revival Horizontal Board	Contributing Resource, South Portland Historic District (Listed in 1998)	All original windows and surrounds have been replaced. The main entry door is modern, and Sanborn Fire Insurance maps indicate that the L-shaped main entry porch was constructed between 1909 and 1950.
