**Section 106 and 4(f) Public Documents
Supplemental Information: Potential Impacts and Mitigation
for Historic Properties and Public Parks
SW Corridor Light Rail Project
Draft – December 15th, 2020**

This technical memo details the potential SW Corridor Light Rail Project impacts to protected historic properties and parks resources, as well as the proposed mitigations. This memo is intended for public review and comment.

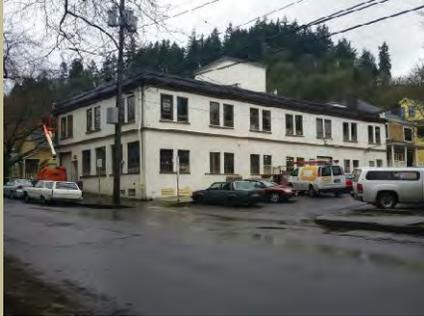
Project ID Survey # Acquisition	Resource Name Address & Assoc. Address Property ID Historic Name	Construction Date Resource Type Primary Style Primary Siding	NRHP Status	Integrity Comments / Notes	Photograph of Resource	Location
SW_11023 B559 NO IMPACT	3207 SW 1ST AVE PORTLAND R140910610 Vance Land Company Warehouse	1913 Building Other / Undefined Stucco	Contributing Resource, South Portland Historic District (Listed in 1998)	Cornice and second floor windows have been modified.

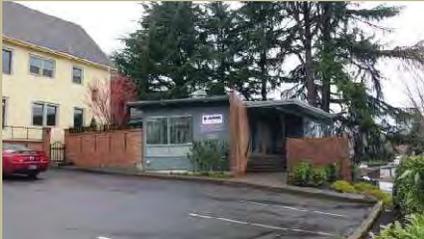
SW_6941 B561 PARTIAL	11 SW GIBBS ST PORTLAND 3223 SW Front Avenue R140910720 Wolfman, A., Building	1952 Building Modern Commercial Vertical Board	Not Eligible/Out of Period, South Portland Historic District (Listed in 1998); Recommended Eligible/Significant as an individual resource	Does not contribute to South Portland Historic District due to date of construction and style. However, the building retains a high level of integrity and is a good example of small-scale modern commercial architecture.

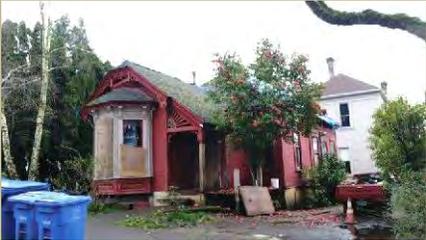
Project ID Survey # Acquisition	Resource Name Address & Assoc. Address Property ID Historic Name	Construction Date Resource Type Primary Style Primary Siding	NRHP Status	Integrity Comments / Notes	Photograph of Resource	Location
SW_18982 B562 NO IMPACT	015 SW GIBBS ST PORTLAND R140910820 Carlson, John and Sophia, House	1888 Building Victorian Eclectic Horizontal Board	Contributing Resource, South Portland Historic District (Listed in 1998)	Condition is poor; integrity remains adequate.

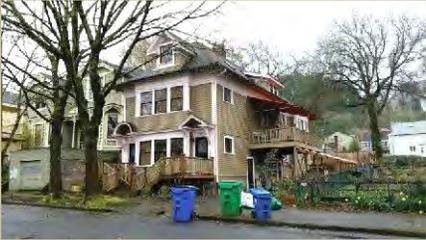
SW_6544 B566 NO IMPACT	3317-3319 SW WATER AVE PORTLAND R140911990 Gavurtz, J., House	1908 Building Colonial Revival Horizontal Board	Contributing Resource, South Portland Historic District (Listed in 1998)	A modern shed is situated within a large garden north of the house; this shed is non- contributing.

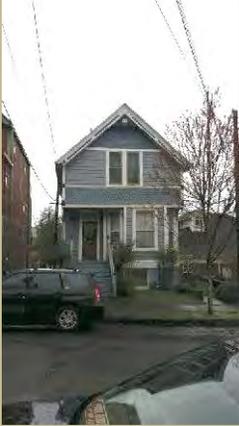
SW_5441 B572 NO IMPACT	17 SW WHITAKER ST PORTLAND R140912110 Rudy, Marcus, House #1	1890 Building Queen Anne Horizontal Board	Contributing Resource, South Portland Historic District (Listed in 1998)

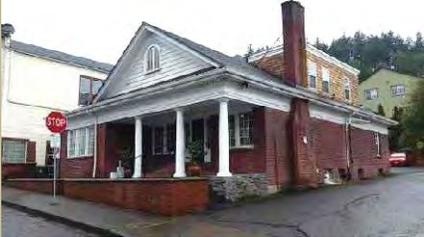
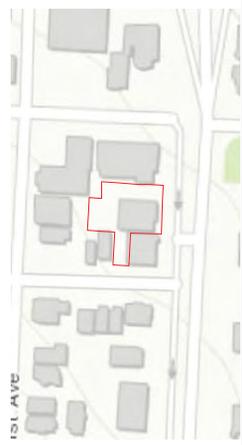
SW_9924 B573 NO IMPACT	3323 SW NAITO PKWY PORTLAND R649752420 Maxwell, Mary L., House	1904 Building Colonial Revival Standard Brick	Contributing Resource, South Portland Historic District (Listed in 1998)	Modern stone, shingles, and vinyl windows. The South Portland Historic District nomination documents the building as a house, but it was a fire station for Portland Fire Department Engine Company No. 5 according to 1908-1909 Sanborn Fire Insurance maps.

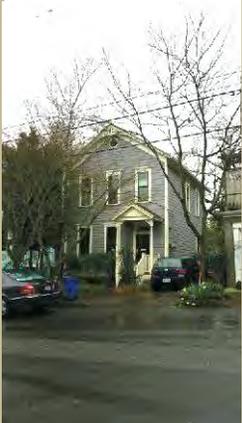
Project ID Survey # Acquisition	Resource Name Address & Assoc. Address Property ID Historic Name	Construction Date Resource Type Primary Style Primary Siding	NRHP Status	Integrity Comments / Notes	Photograph of Resource	Location
SW_20938 B574 NO IMPACT	24 SW WHITAKER ST PORTLAND R140912540 Strauss, Charles A. & R. F., House	1890 Building Victorian Era Horizontal Board	Contributing Resource, South Portland Historic District (Listed in 1998)

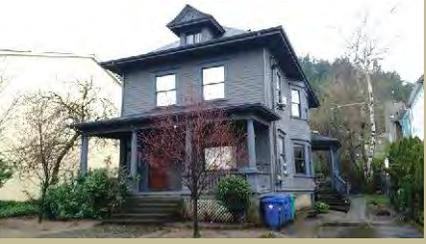
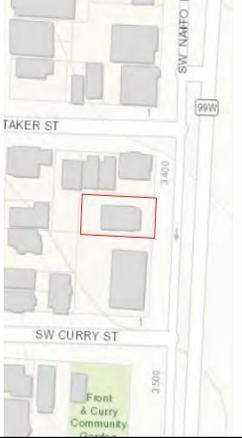
SW_18381 B575 NO IMPACT	3417 SW NAITO PKWY PORTLAND R140912470 Foulkes, Robert, House	1902 Building Colonial Revival Horizontal Board	Contributing Resource, South Portland Historic District (Listed in 1998)

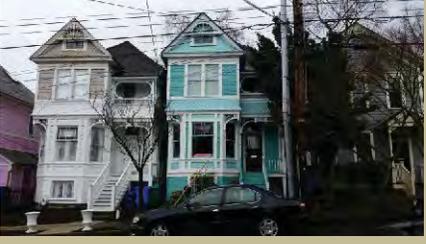
SW_19015 B576 NO IMPACT	16 SW WHITAKER ST PORTLAND R140912460 Foulkes, Laura, House #2	1892 Building Queen Anne Horizontal Board	City of Portland HRI (1984 - Rank III); Contributing Resource, South Portland Historic District (Listed in 1998)

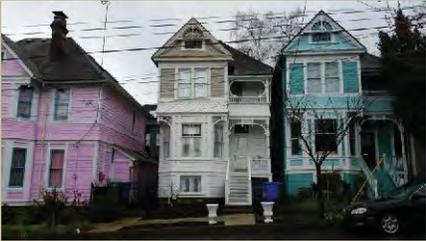
Project ID Survey # Acquisition	Resource Name Address & Assoc. Address Property ID Historic Name	Construction Date Resource Type Primary Style Primary Siding	NRHP Status	Integrity Comments / Notes	Photograph of Resource	Location
SW_9621 B577 NO IMPACT	14 SW WHITAKER ST PORTLAND R140912450 Foulkes, Laura, House #1	1892 Building Queen Anne Horizontal Board	Contributing Resource, South Portland Historic District (Listed in 1998)

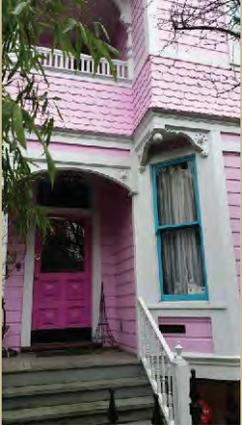
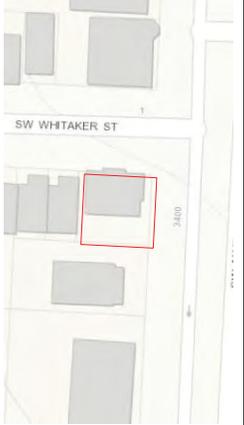
SW_18005 B578 NO IMPACT	3405 SW NAITO PKWY PORTLAND R140912440 Long, H. R. and S. E., House	1890 Building Queen Anne Horizontal Board	Contributing Resource, South Portland Historic District (Listed in 1998)

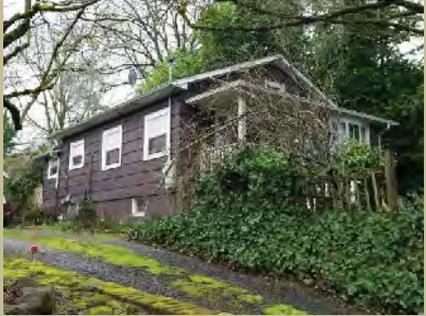
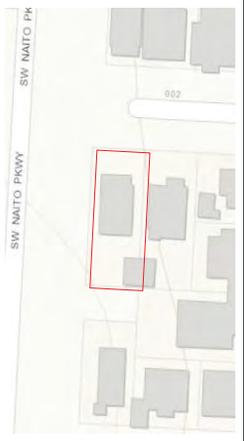
SW_20351 B579 NO IMPACT	016 SW WHITAKER ST PORTLAND R140912640 Rice, Alice R., House	1926 Building Vernacular Cedar Shake Shingle	Contributing Resource, South Portland Historic District (Listed in 1998)	Description of this building in the South Portland Historic District nomination does not match this house. Modifications to the windows, porch, and siding of the house have diminished its historical integrity. A detached garage is located to the southeast.

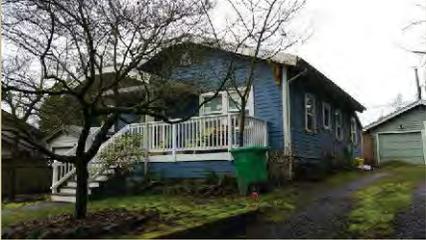
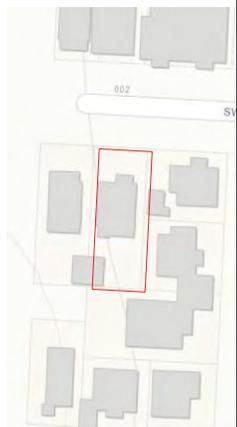
Project ID Survey # Acquisition	Resource Name Address & Assoc. Address Property ID Historic Name	Construction Date Resource Type Primary Style Primary Siding	NRHP Status	Integrity Comments / Notes	Photograph of Resource	Location
SW_18178 B580 NO IMPACT	024 SW WHITAKER ST PORTLAND R140912570 Anderson, Richard & Beda, House	1926 Building Craftsman Horizontal Board	Contributing Resource, South Portland Historic District (Listed in 1998)	Since this house was last documented in 1998, siding, window, and porch modifications have been completed that diminish its historical integrity. A detached garage is located to the southwest.

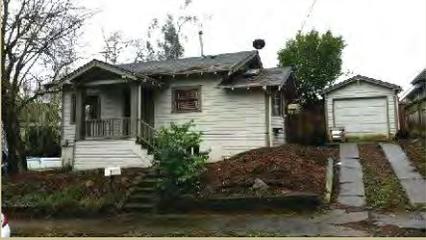
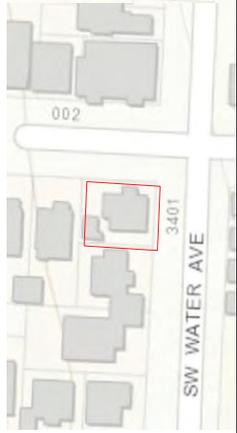
SW_15995 B581 NO IMPACT	036 SW WHITAKER ST PORTLAND R140912590 Francone, Marie, House	1926 Building Craftsman Horizontal Board	Contributing Resource, South Portland Historic District (Listed in 1998)	Original siding and windows have been modified. A detached garage is west of the house.

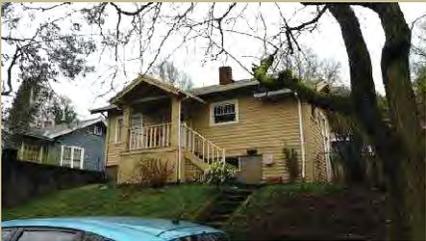
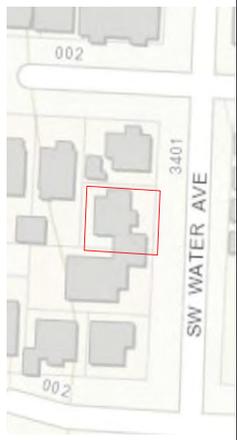
SW_19546 B582 NO IMPACT	3415 SW WATER AVE PORTLAND R140912580 Hope, John B., House	1926 Building Craftsman Horizontal Board	Contributing Resource, South Portland Historic District (Listed in 1998)	The house has a detached garage with a modern door

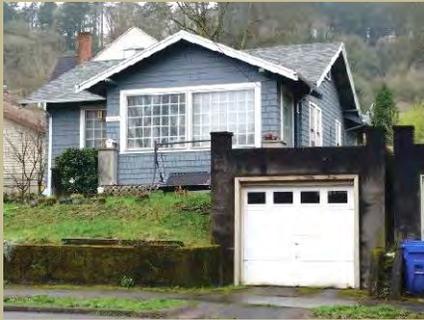
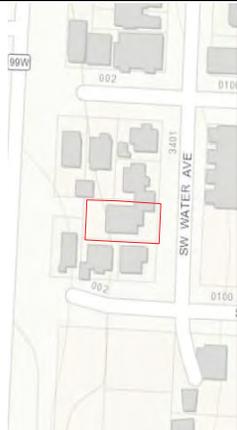
Project ID Survey # Acquisition	Resource Name Address & Assoc. Address Property ID Historic Name	Construction Date Resource Type Primary Style Primary Siding	NRHP Status	Integrity Comments / Notes	Photograph of Resource	Location
SW_21854 B583 NO IMPACT	3425 SW WATER AVE PORTLAND R140912600 Smith, Earl P. and Marvel E., House	1920 Building Craftsman Shingle	Contributing Resource, South Portland Historic District (Listed in 1998)	A detached garage is east of the house.

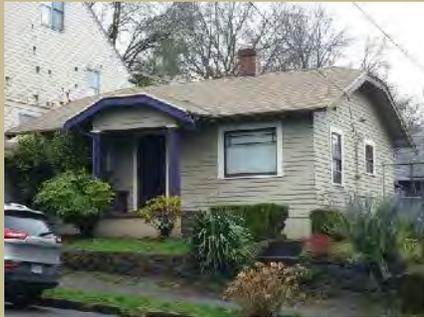
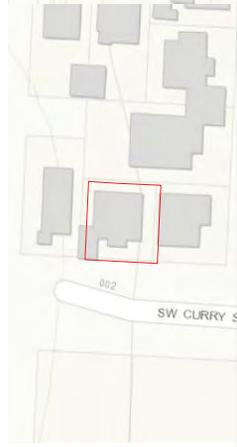
SW_20931 B584 NO IMPACT	025 SW CURRY ST PORTLAND R140912620 McGlashan, James C., House	1927 Building Craftsman Horizontal Board	Compatible Non- Contributing, South Portland Historic District (Listed in 1998); Recommended Not Eligible/Non-Contributing as an individual resources	House retains adequate integrity. It is not included as a contributing resource in the South Portland Historic District due to its date of construction (1927), which is outside of the period of significance. As an individual resource, the house has no known historical associations of significance under Criteria A through D. A detached garage is situated southwest of the house.

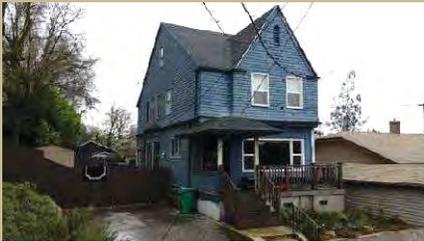
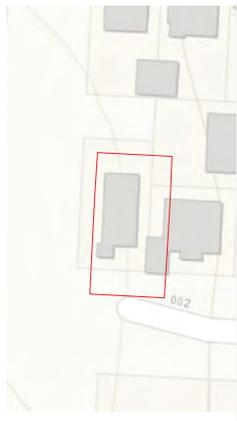
SW_9099 B585 NO IMPACT	017 SW CURRY ST PORTLAND R140912630 Bronaugh, Earl C. and Carter, Lorenzo E., House	1904 Building Queen Anne Horizontal Board	Contributing Resource, South Portland Historic District (Listed in 1998)	The windows and south facade porch have been modified; it is possible that the steeply pitched gables of the roof are not original.

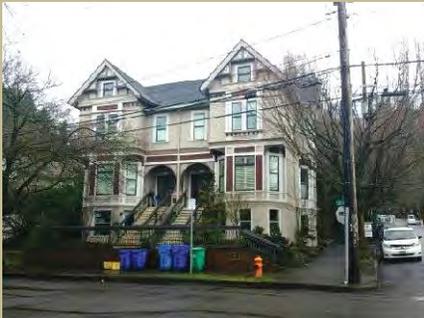
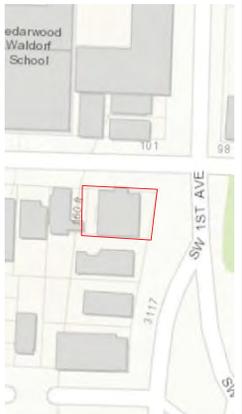
Project ID Survey # Acquisition	Resource Name Address & Assoc. Address Property ID Historic Name	Construction Date Resource Type Primary Style Primary Siding	NRHP Status	Integrity Comments / Notes	Photograph of Resource	Location
SW_19149 B586 NO IMPACT	Lair Hill Historical Condominiums 3101 SW 1ST AVE PORTLAND R463860040 Buckman Apartments	1890 Building Queen Anne Shingle	Contributing Resource, South Portland Historic District (Listed in 1998)

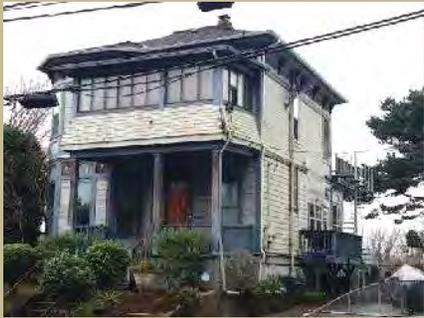
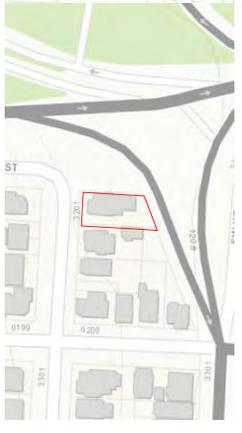
SW_6635 B587 PARTIAL	3204 SW CORBETT AVE PORTLAND R140911030 Heubner, Julius, House	1876 Building Italianate Horizontal Board	Contributing Resource, South Portland Historic District (Listed in 1998)

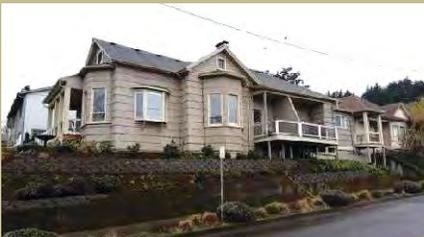
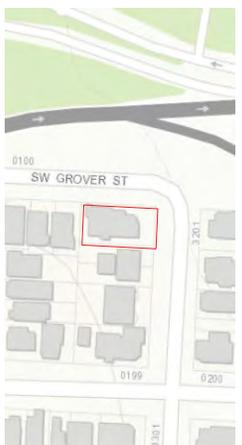
SW_12348 B588 PARTIAL	3205 SW CORBETT AVE PORTLAND R140910830 Heimes, George and A. F., House	1894 Building Queen Anne Cedar Rake Shingle	Contributing Resource, South Portland Historic District (Listed in 1998)	Several modifications were observed: an addition to rear (west) elevation; all original windows have been replaced; shingle siding not original to construction; porch modifications.

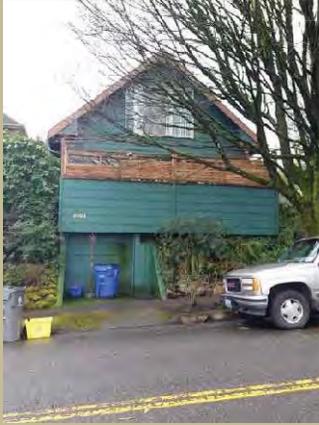
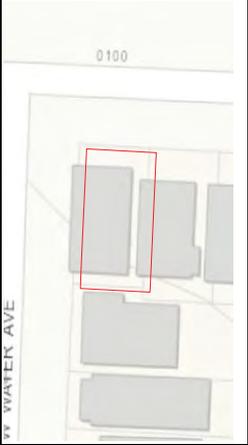
Project ID Survey # Acquisition	Resource Name Address & Assoc. Address Property ID Historic Name	Construction Date Resource Type Primary Style Primary Siding	NRHP Status	Integrity Comments / Notes	Photograph of Resource	Location
SW_13829 B589 PARTIAL	0104 SW GROVER ST PORTLAND R140910930 Cardwell, H. R., House	1903 Building Vernacular Cement Fiber Siding	Not Eligible/Non-Contributing, South Portland Historic District (Listed in 1998)

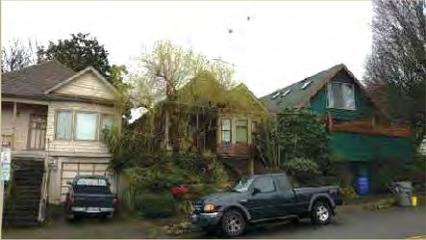
SW_18390 B590 PARTIAL	0110 SW GROVER ST PORTLAND R140910920 Cardwell, B. P., House	1903 Building Queen Anne Shingle	Contributing Resource, South Portland Historic District (Listed in 1998)

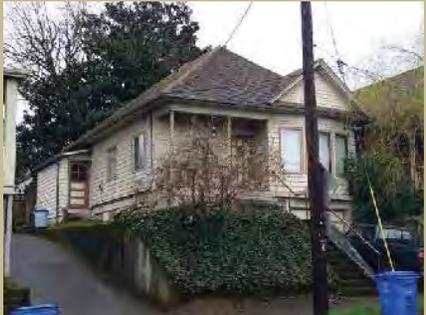
SW_1682 B591 PARTIAL	0116 SW GROVER ST PORTLAND R140910910 Smith, A. P., House	1903 Building Queen Anne Shingle	Contributing Resource, South Portland Historic District (Listed in 1998)	Original windows have been replaced with aluminum sashes.

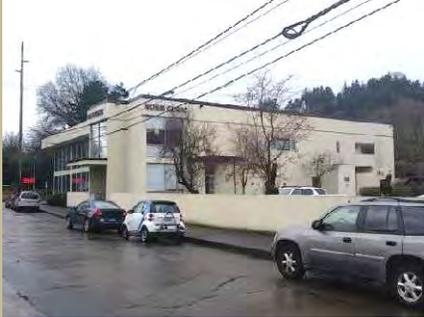
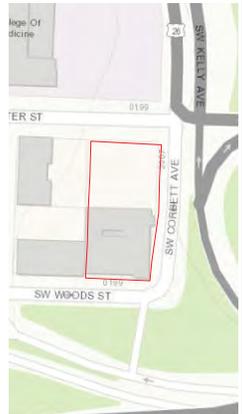
Project ID Survey # Acquisition	Resource Name Address & Assoc. Address Property ID Historic Name	Construction Date Resource Type Primary Style Primary Siding	NRHP Status	Integrity Comments / Notes	Photograph of Resource	Location
SW_14298 B592 PARTIAL	NUNM Health Centers - Lair Hill 3025 SW CORBETT AVE PORTLAND R140904710	1968 Building Modern Period Other Stucco	Recommended Not Eligible/ Non-Contributing	Extensive modifications to the windows and siding diminish the building's historical integrity and give it a modern appearance. The building has no known historical associations of significance under Criteria A through D.

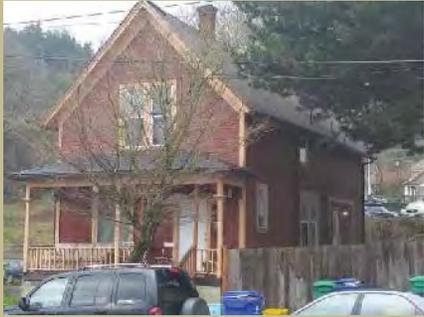
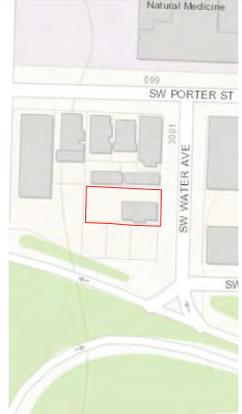
SW_14304 B593 NO IMPACT	3029 SW WATER AVE PORTLAND R140904860	1890 Building Victorian Era Horizontal Board	Recommended Not Eligible/ Non-Contributing	All original windows have been replaced with vinyl, and porch modifications have occurred during the modern era. The house has no historical associations of significance under Criteria A through D.

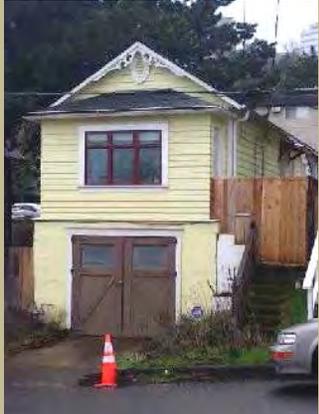
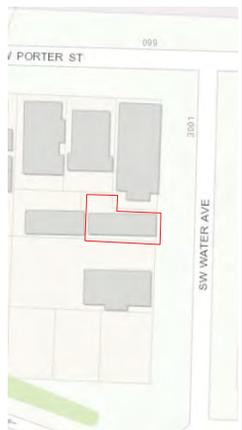
SW_1783 B594 NO IMPACT	3017 SW WATER AVE PORTLAND R140904850	1880 Building Victorian Era Horizontal Board	Recommended Not Eligible/ Non-Contributing	The infilled front porch and vinyl window replacements diminish the house's historical integrity and its eligibility for listing in the NRHP.

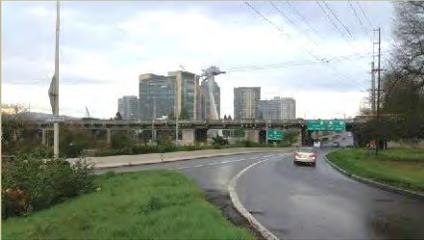
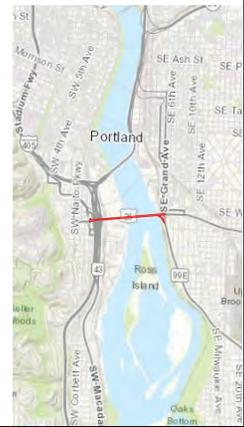
Project ID Survey # Acquisition	Resource Name Address & Assoc. Address Property ID Historic Name	Construction Date Resource Type Primary Style Primary Siding	NRHP Status	Integrity Comments / Notes	Photograph of Resource	Location
Bridge B595 NA	Ross Island Bridge	1926 Structure Not Applicable Not Applicable	City of Portland HRI (1984 - Rank III); Determined Eligible for Listing in NRHP (1985 - Historic Highway Bridges of Oregon Thematic Resources);	Included in Multiple Property Document for Willamette River Highway Bridges of Portland, Oregon (2011)

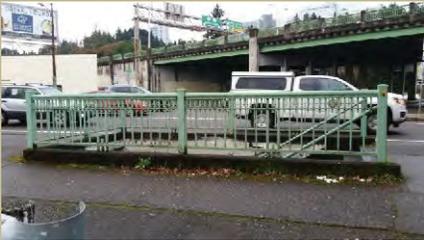
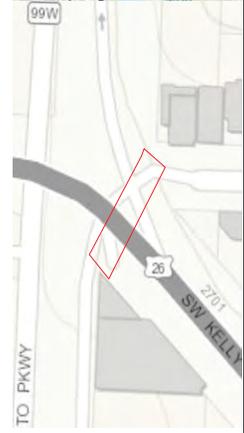
Lane B596 NA	Hwy 26 over Kelly St Pedestrian Tunnel Bridge #06946	1945 Structure Not Applicable Not Applicable	Recommended Not Eligible/Non-Contributing	Reinforced concrete box culvert pedestrian tunnel with stairs at north and south ends. Not included in Oregon's Historic Bridge Field Guide (2013).

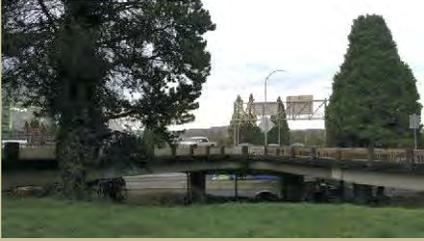
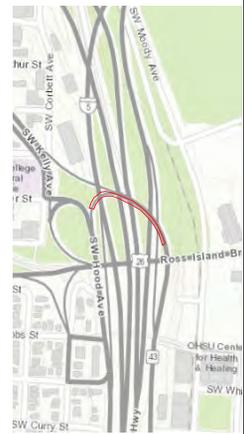
Lane B597 NA	Hwy 3 NB Conn to Hwy 3 SB (SW Hood Ave) (Ross Island) Bridge #08194R	1959 Structure Not Applicable Not Applicable	Recommended Not Eligible/Non-Contributing	Reinforced concrete box girder; immediately south of Bridge #08194. Not included in Oregon's Historic Bridge Field Guide (2013).

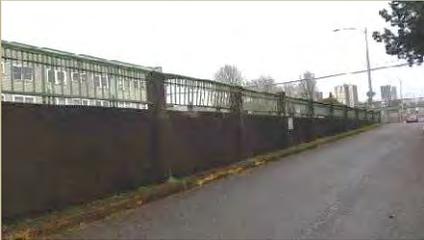
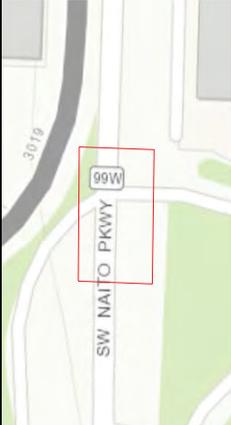
Project ID Survey # Acquisition	Resource Name Address & Assoc. Address Property ID Historic Name	Construction Date Resource Type Primary Style Primary Siding	NRHP Status	Integrity Comments / Notes	Photograph of Resource	Location
Lane B598 NA	Hwy 1W over Hwy 26 WB Conn #1 to Hwy 1 SB Bridge #06896	1946 Structure Not Applicable Not Applicable	Recommended Not Eligible/ Non-Contributing	Reinforced concrete rigid frame bridge. Not included in Oregon's Historic Bridge Field Guide (2013)

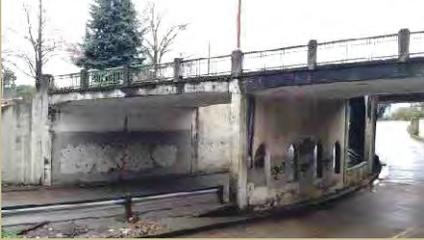
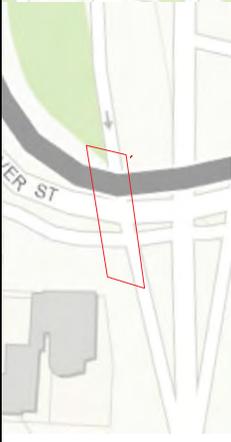
Overpass B599 NA	Hwy 26 WB Conn #1 to Hwy 1W over Hwy 26 EB & SW Bridge #06895R	1948 Structure Not Applicable Not Applicable	Recommended Not Eligible/ Non-Contributing	Reinforced concrete rigid frame bridge. Not included in Oregon's Historic Bridge Field Guide (2013).

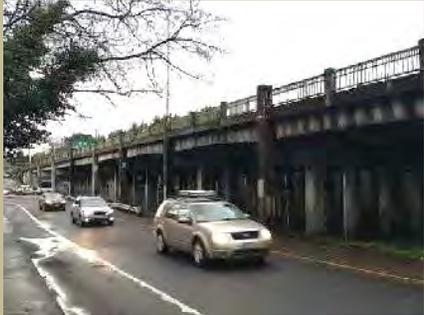
Overpass B600 NA	Hwy 1W Bridge over SW Arthur St Bridge #05194	1946 Structure Not Applicable Not Applicable	Recommended Not Eligible/ Non-Contributing	Reinforced concrete deck girder partial viaduct with a section of steel deck girder. Not included in Oregon's Historic Bridge Field Guide (2013).

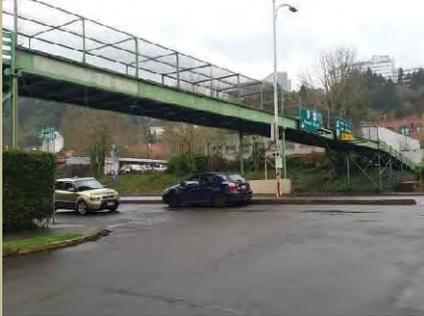
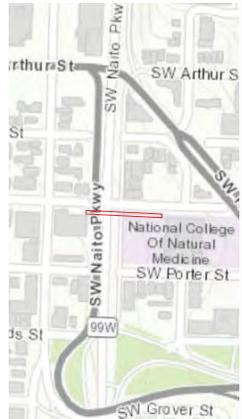
Project ID Survey # Acquisition	Resource Name Address & Assoc. Address Property ID Historic Name	Construction Date Resource Type Primary Style Primary Siding	NRHP Status	Integrity Comments / Notes	Photograph of Resource	Location
Overpass B601 NA	Pedestrian Bridge (SW Hooker St) over Hwy 1W & Bridge #05239; City of Portland Bridge #043	1948 Structure Not Applicable Not Applicable	Recommended Not Eligible/ Non-Contributing	Steel girder pedestrian bridge. Not included in Oregon's Historic Bridge Field Guide (2013); categorized as "not historic" in PBOT's Crossing the Divide Bridge Inventory (2015).

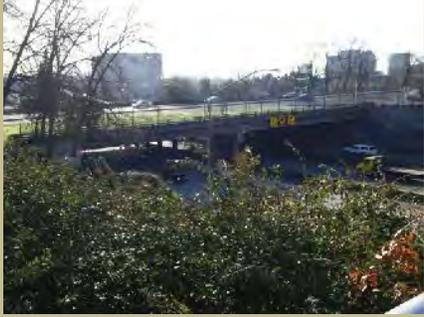
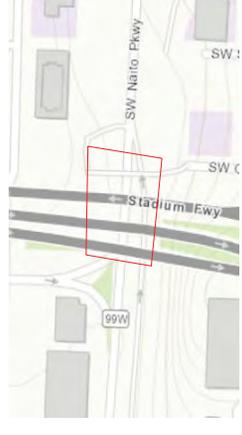
Overpass B602 NA	Hwy 1W over Hwy 61 Bridge #09153	1964 Structure Not Applicable Not Applicable	Recommended Not Eligible/ Non-Contributing	Reinforced concrete deck girder. Not included in Oregon's Historic Bridge Field Guide (2013).

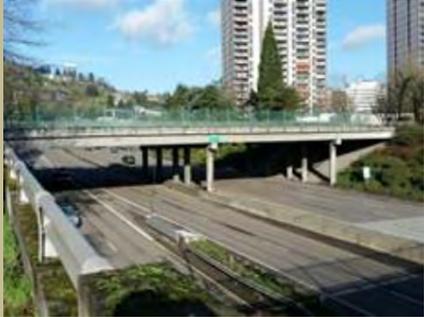
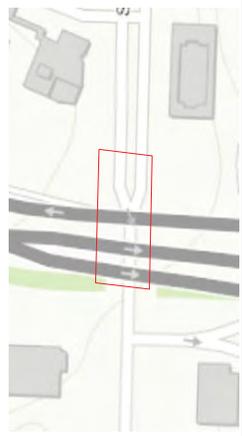
Overpass B603 NA	SW 1st Ave over Hwy 61 Bridge #09154	1964 Structure Not Applicable Not Applicable	Recommended Not Eligible/ Non-Contributing	Reinforced concrete box girder. Not included in Oregon's Historic Bridge Field Guide (2013).

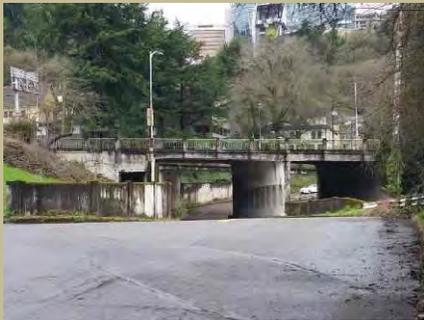
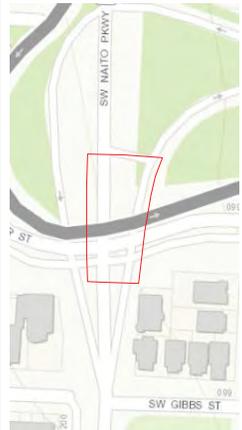
Project ID Survey # Acquisition	Resource Name Address & Assoc. Address Property ID Historic Name	Construction Date Resource Type Primary Style Primary Siding	NRHP Status	Integrity Comments / Notes	Photograph of Resource	Location
Overpass B604 NA	Hwy 1 over Hwy 26 EB & SW Grover St Bridge #06895	1948 Structure Not Applicable Not Applicable	Category III Bridge, ODOT Historic Bridge Field Guide (2013); Recommended Not Eligible/Non-Contributing	Reinforced concrete slab bridge

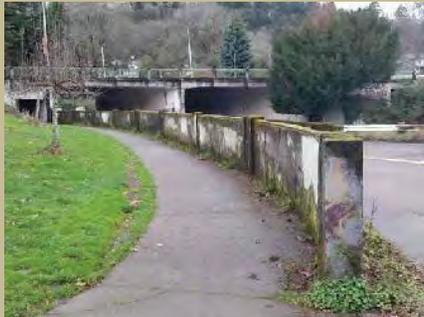
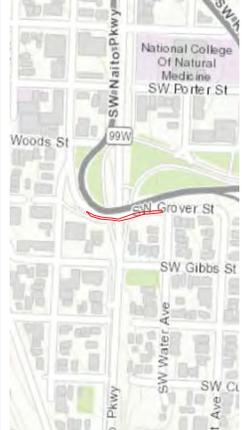
Overpass B605 NA	Retaining Wall at SW Grover Street	Circa 1948 Structure Other / Undefined Concrete Other / Undefined	Recommended Not Eligible/Non-Contributing	Not a distinctive example of a type, period, or method of construction. Situated below two historic bridges (#06895 and 06895R) that are not eligible for listing in the NRHP.

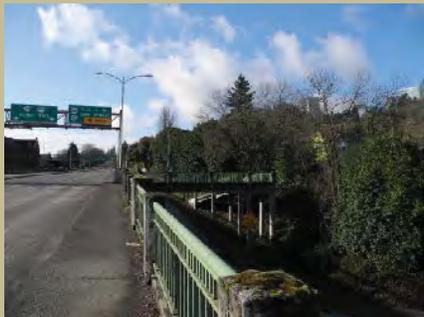
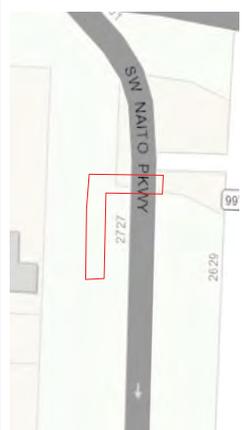
Pedestrian B606 NA	Pedestrian Bridge (SW Arthur St) over Hwy 1W Bridge #05194S	1947 Structure Not Applicable Not Applicable	Recommended Not Eligible/Non-Contributing	Pedestrian bridge providing access to Bridge #05194 (constructed in 1946). Not included in Oregon's Historic Bridge Field Guide (2013).

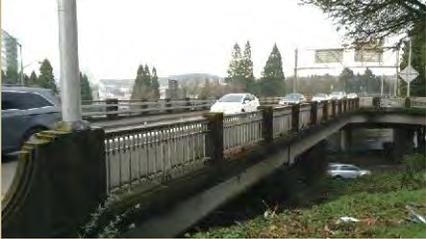
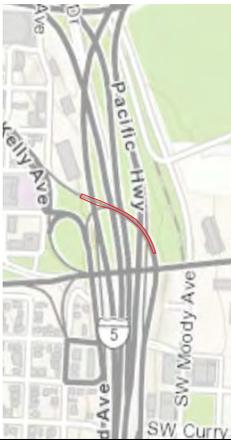
Project ID Survey # Acquisition	Resource Name Address & Assoc. Address Property ID Historic Name	Construction Date Resource Type Primary Style Primary Siding	NRHP Status	Integrity Comments / Notes	Photograph of Resource	Location
Overpass B607 NA	Hwy 3 NB over Hwy 1 & Conns (Ross Island Interchange) Bridge #08194	1959 Structure Not Applicable Not Applicable	Recommended Not Eligible/ Non-Contributing	Reinforced concrete deck and bridge girder; immediately north of Bridge #08194R. Not included in Oregon's Historic Bridge Field Guide (2013).

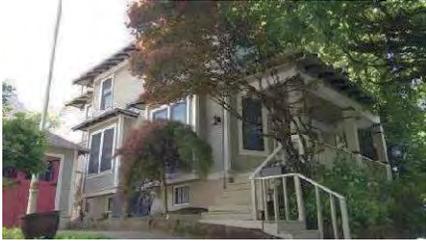
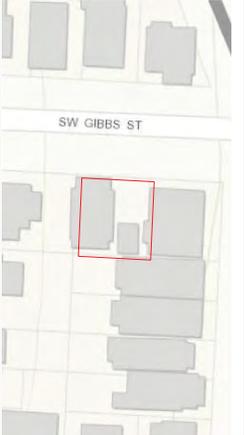
Project ID Survey # Acquisition	Resource Name Address & Assoc. Address Property ID Historic Name	Construction Date Resource Type Primary Style Primary Siding	NRHP Status	Integrity Comments / Notes	Photograph of Resource	Location
SW_3908 B608 NO IMPACT	0222 SW GIBBS ST PORTLAND R140911720 Forsythe, Maria L., House	1908 Building Italianate Horizontal Board	Contributing Resource, South Portland Historic District (1998)	Windows are anodized aluminum replacements. A detached garage is situated east of the house.

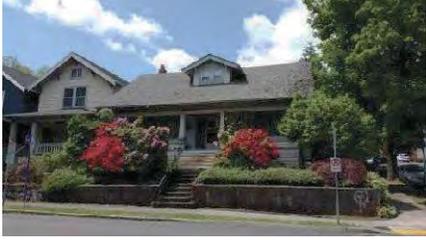
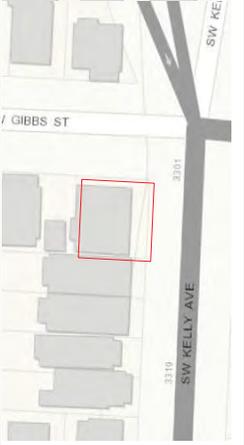
SW_11576 B609 NO IMPACT	3303 SW KELLY AVE PORTLAND R140911730 Deuschel, Emma L., House	1910 Building Craftsman Horizontal Board	Contributing Resource, South Portland Historic District (Listed in 1998)	Windows are obscured by aluminum storm windows. The house's lap siding appears to be original to the date of construction.

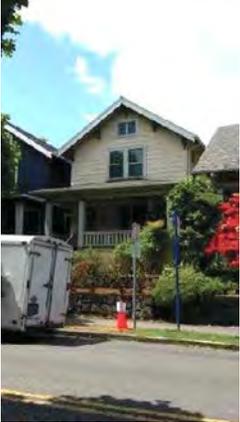
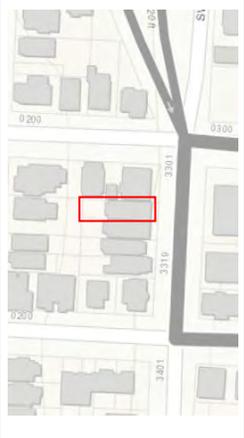
SW_7211 B610 NO IMPACT	3315 SW KELLY AVE PORTLAND R140911750 Hughes, Julia M., House #3	1910 Building Craftsman Shingle	Contributing Resource, South Portland Historic District (1998)	The house appears to retain most all of its original wood windows, but is clad with a mixture of wood and fiber cement shingles that are not original to the date of construction. A house of the same design is located immediately south at 3317 SW Kelly Avenue.

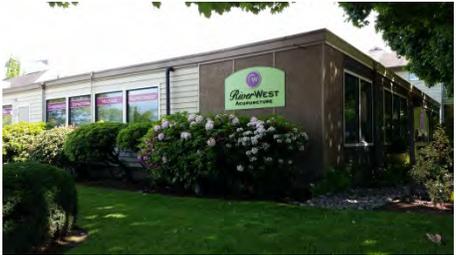
Project ID Survey # Acquisition	Resource Name Address & Assoc. Address Property ID Historic Name	Construction Date Resource Type Primary Style Primary Siding	NRHP Status	Integrity Comments / Notes	Photograph of Resource	Location
SW_17344 B611 NO IMPACT	3312-3314 SW KELLY AVE PORTLAND R140911700 Omaha Industries, Inc. Building	1965 Building Contemporary Horizontal Board	Non-Contributing Resource, South Portland Historic District (Listed in 1998)	Anodized aluminum windows have replaced most all original windows, with exception to the east (rear) elevation. Modern lap siding has been added to several elevations. Not eligible for listing in the NRHP as an individual resource.

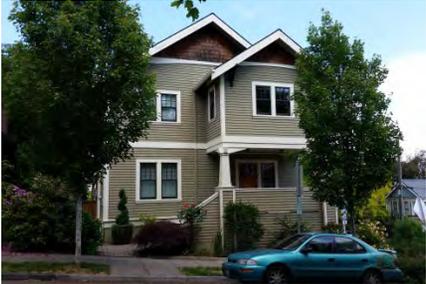
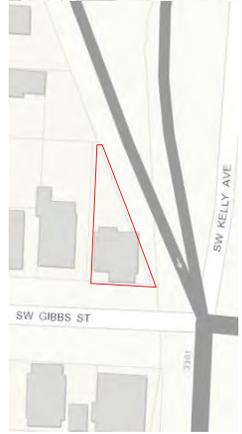
SW_7560 B612 PARTIAL	0231 SW GIBBS ST PORTLAND R140910970 The Reed Institute Building #1	1920 Building Craftsman Horizontal Board	Contributing Resource, South Portland Historic District (1998)	This building has changed significantly since 1998. A second story has been added, and the original siding and windows have been replaced. The South Portland Historic District nomination notes that the house was moved in 1926 to accommodate Ross Island Bridge construction.

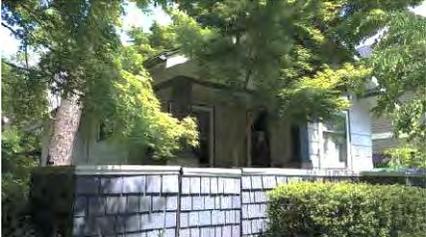
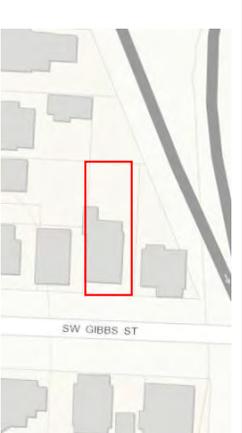
SW_18055 B613 NO IMPACT	0223 SW GIBBS ST PORTLAND R140910980 The Reed Institute Building #2	1920 Building Craftsman Shingle	Contributing Resource, South Portland Historic District (1998)	Aluminum storm windows obscure original wood windows. Shingles were added to the house exterior during the historic period, but are not original.

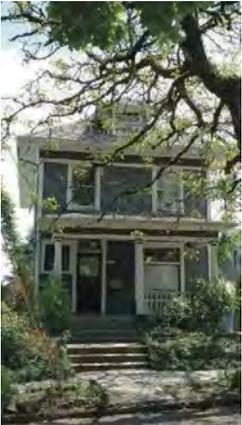
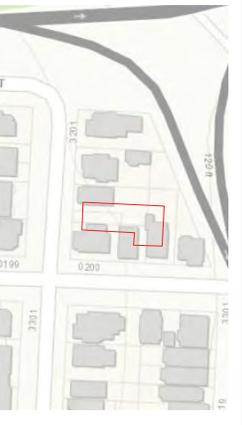
Project ID Survey # Acquisition	Resource Name Address & Assoc. Address Property ID Historic Name	Construction Date Resource Type Primary Style Primary Siding	NRHP Status	Integrity Comments / Notes	Photograph of Resource	Location
SW_22962 B614 NO IMPACT	3222 SW CORBETT AVE PORTLAND R140911010 Failing, Jesse, House #2	1906 Building Colonial Revival Horizontal Board	Contributing Resource, South Portland Historic District (1998)	Some original windows have been replaced, while others remain in place.

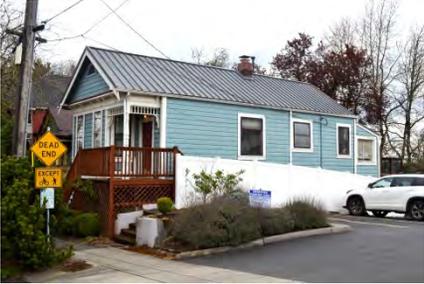
SW_3176 B615 PARTIAL	3224 SW KELLY AVE PORTLAND R140911110 Sprover, Dora, House	1885 Building Victorian Era Horizontal Boards	Contributing Resource, South Portland Historic District (1998)	Windows are original wood sashes with anodized aluminum storm windows. Standing seam metal has been placed on the roof.

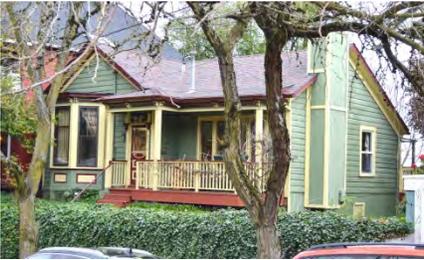
SW_12901 B616 PARTIAL	3214 SW KELLY AVE PORTLAND R140911120 Donovan, R.M., House	1889 Building Victorian Eclectic Horizontal Boards	Contributing Resource, South Portland Historic District (1998)	Wood sash windows are covered by storm windows; at least one vinyl replacement is on the south elevation.

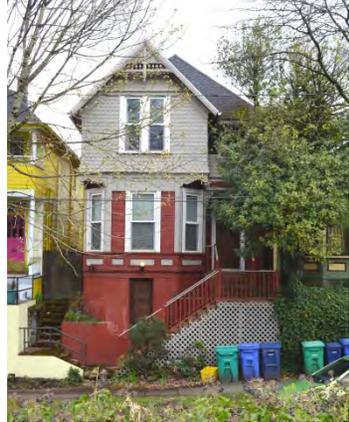
Project ID Survey # Acquisition	Resource Name Address & Assoc. Address Property ID Historic Name	Construction Date Resource Type Primary Style Primary Siding	NRHP Status	Integrity Comments / Notes	Photograph of Resource	Location
SW_4673 B617 PARTIAL	3206-3208 SW KELLY AVE PORTLAND R140911150 Findley, May, House #3	1889 Building Queen Anne Horizontal Boards	Contributing Resource, South Portland Historic District (1998)	Vinyl windows have replaced original wood windows since the South Portland Historic District was listed in the NRHP in 1998. The house, which has been converted for use as a duplex, has a nearly identical plan to the adjacent house at 3204 SW Kelly Avenue.

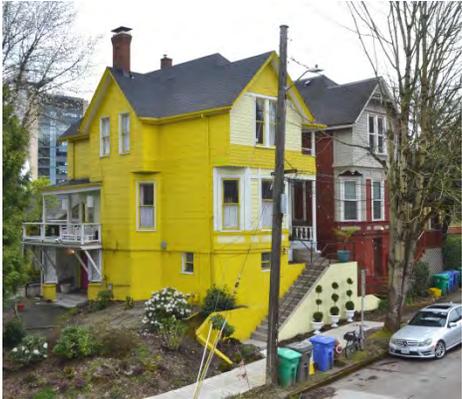
SW_22784 B618 PARTIAL	3204 SW KELLY AVE PORTLAND R140911140 Findley, May, House #2	1889 Building Queen Anne Asbestos Shingles	Documented as a Non-Contributing Resource, South Portland Historic District (1998); Recommended Eligible/Contributing	The primary facade has fish scale-shingles and horizontal board siding. Remaining elevations are clad in asbestos shingles. Original wood windows are retained. The building has a nearly identical design to the adjacent house at 3206-3208 SW Kelly Avenue.

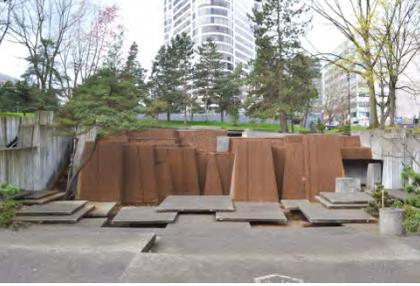
B619 NO IMPACT	Halprin Open Space Sequence	1966-1970 District	Listed in NRHP (2013)	The discontinuous district is listed under Criteria A and C, and meets Criteria Consideration G. The APE crosses the easternmost section of the district at SW Naito Parkway.
